Charter Township of Texas Flood Study

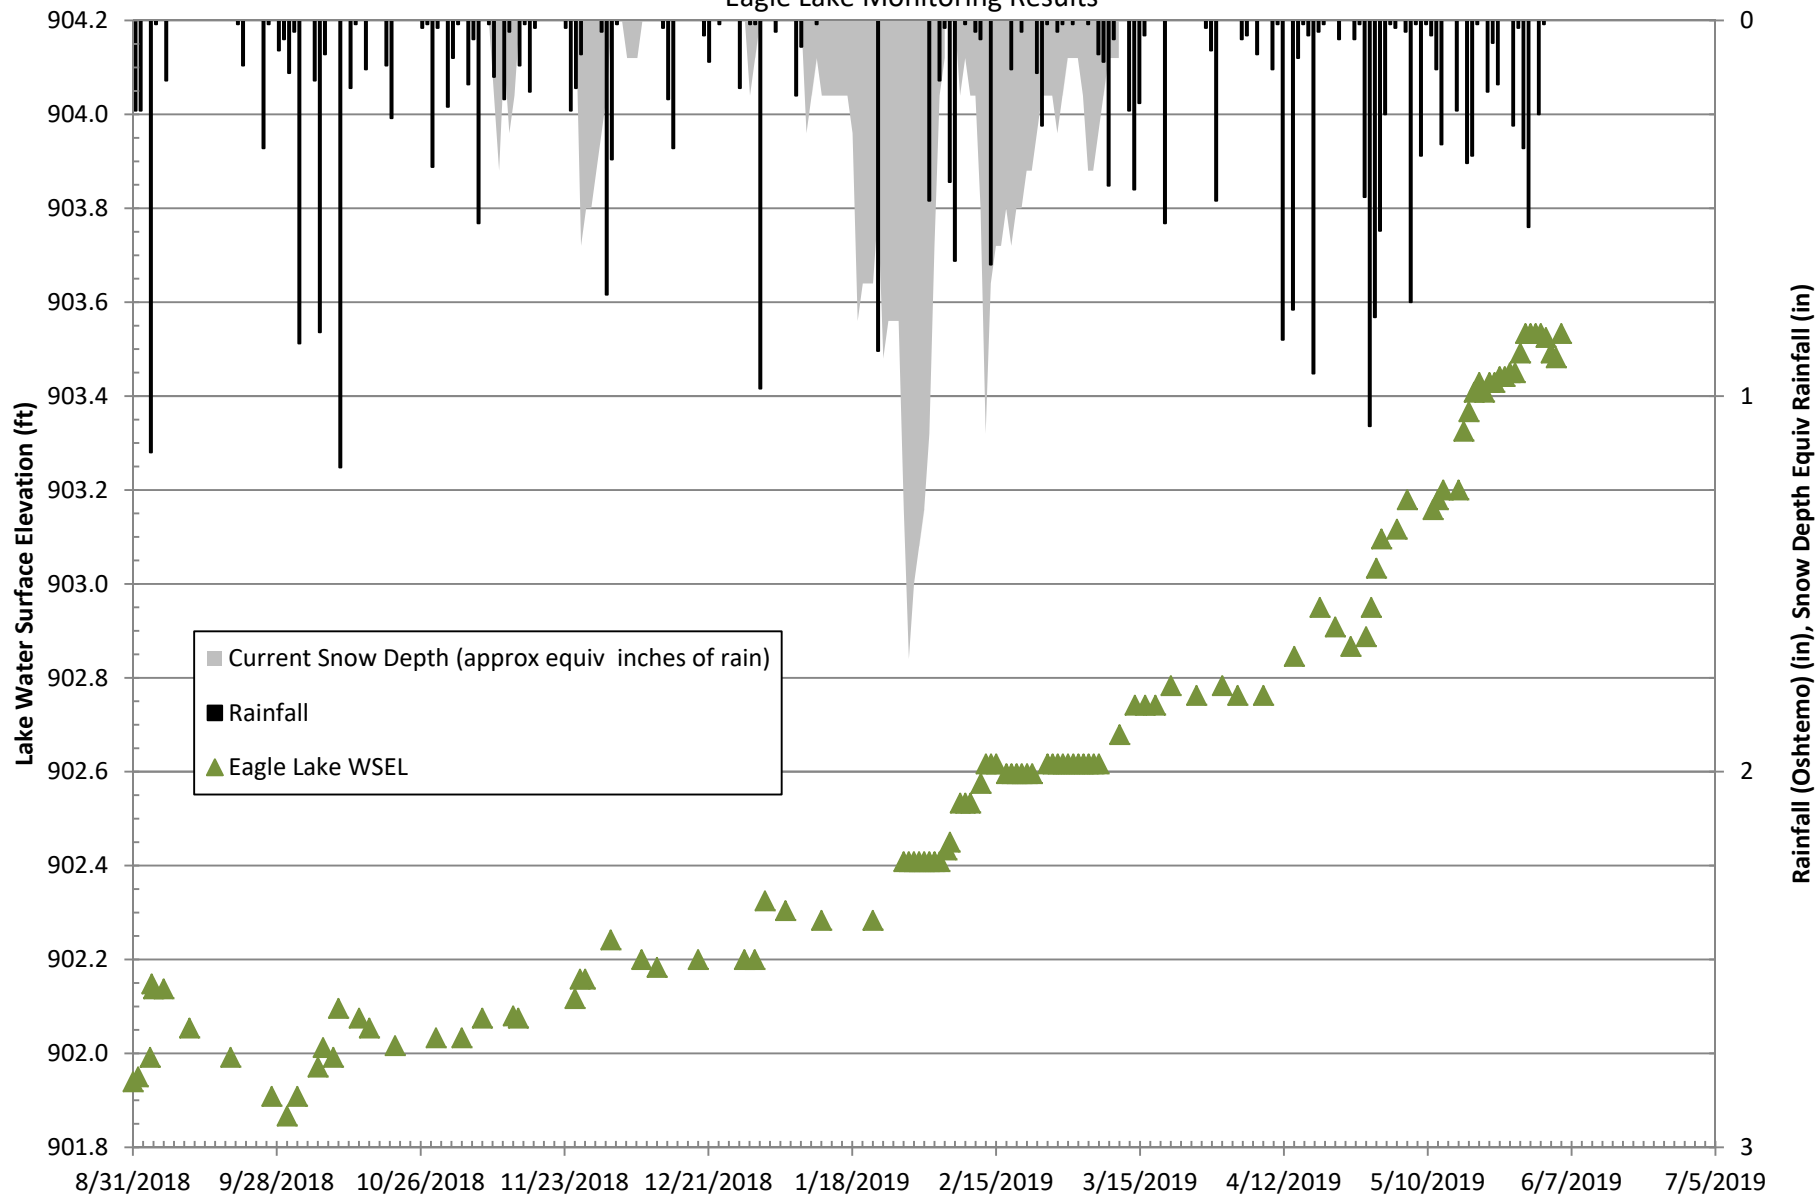
Figure

Eagle Lake Monitoring Results

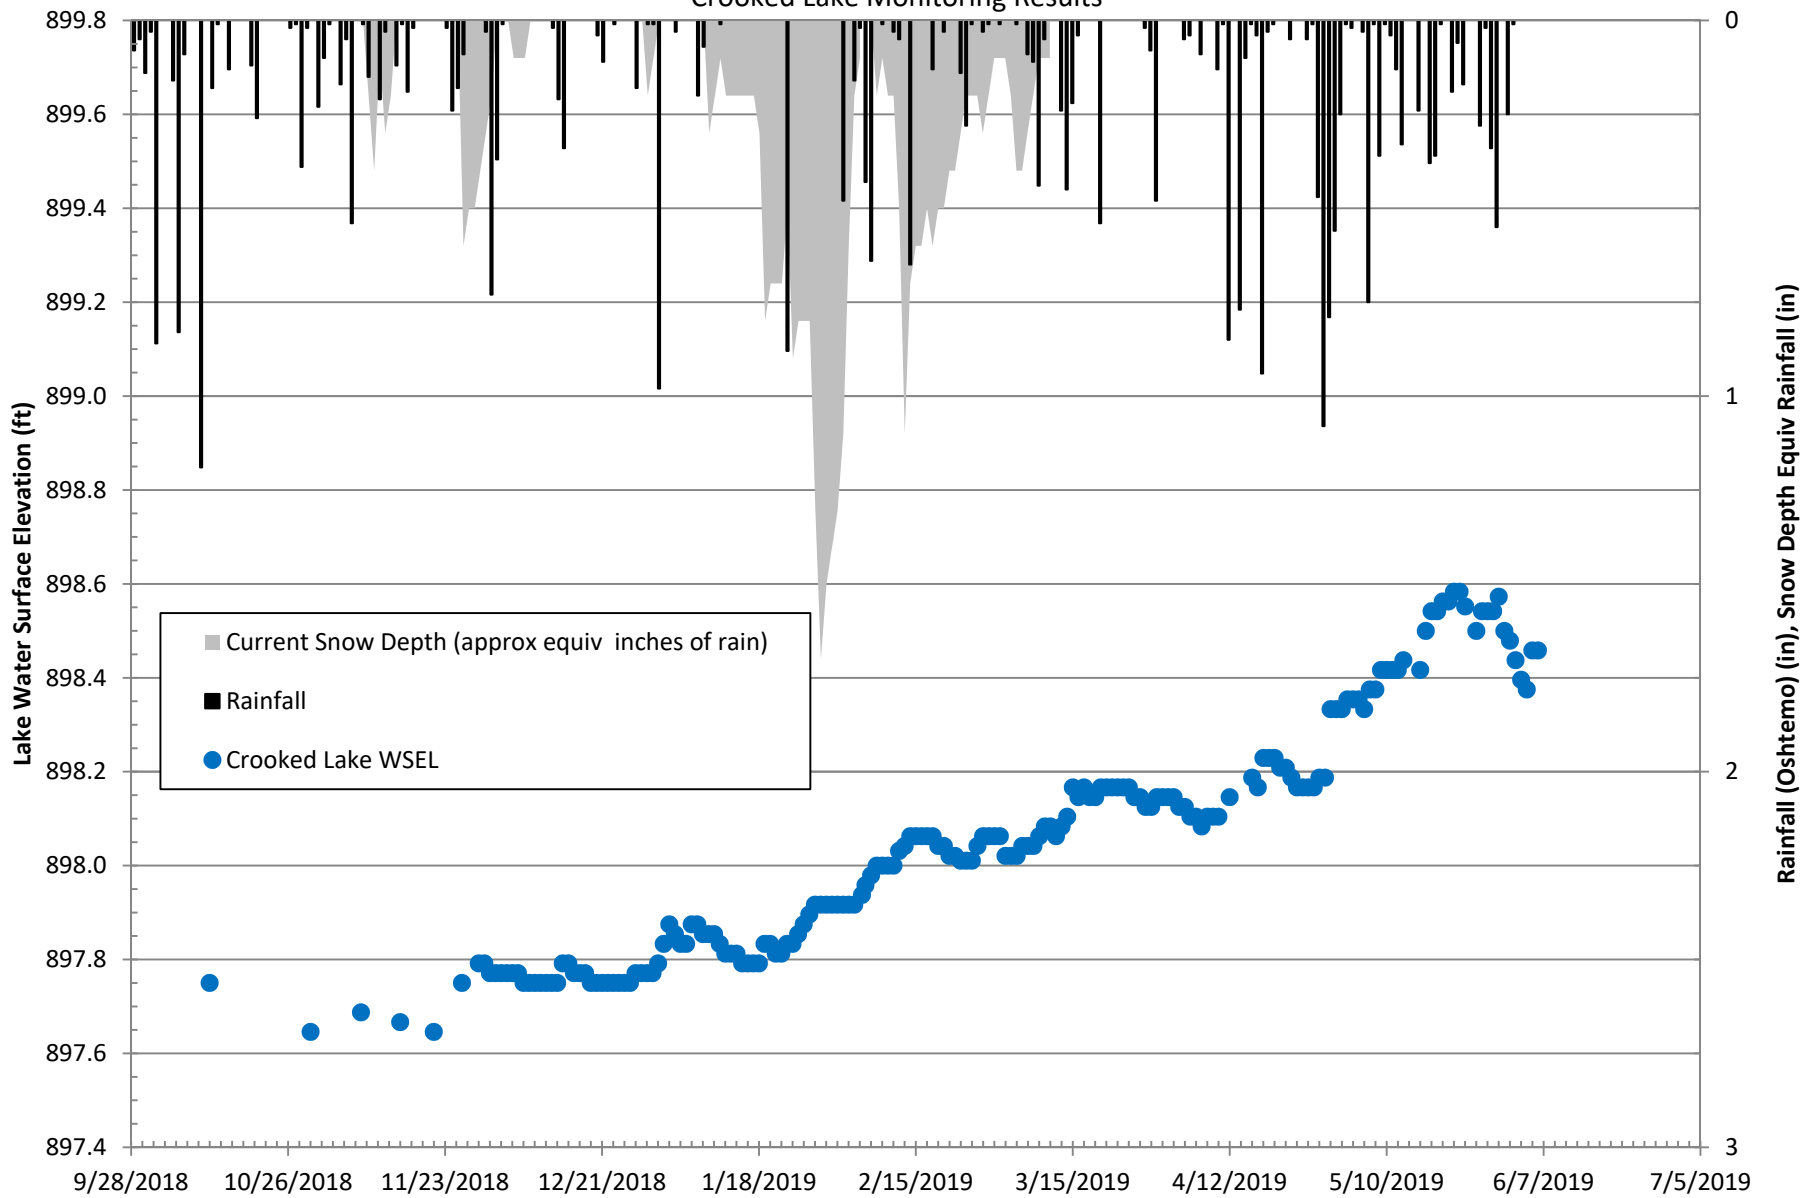
Figure

Crooked Lake Monitoring Results

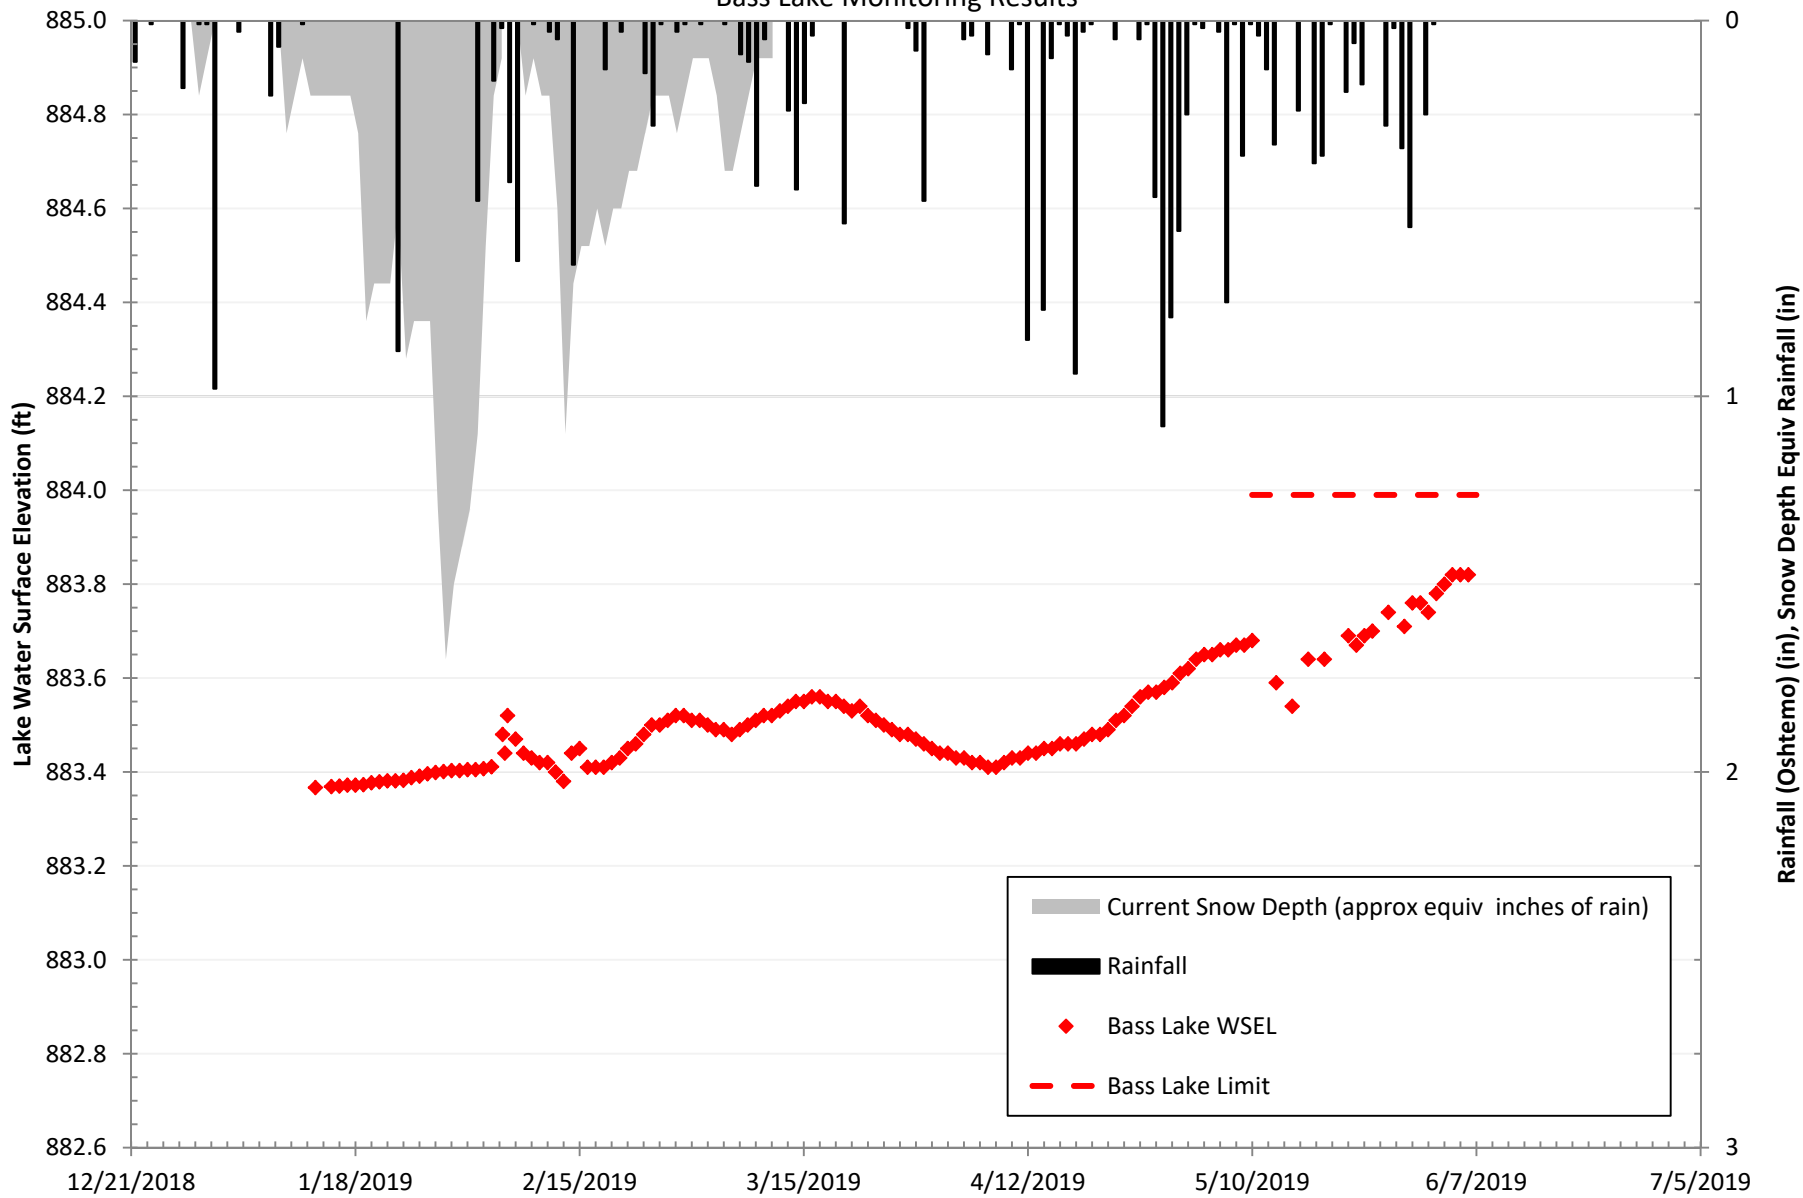
Figure

Bass Lake Monitoring Results

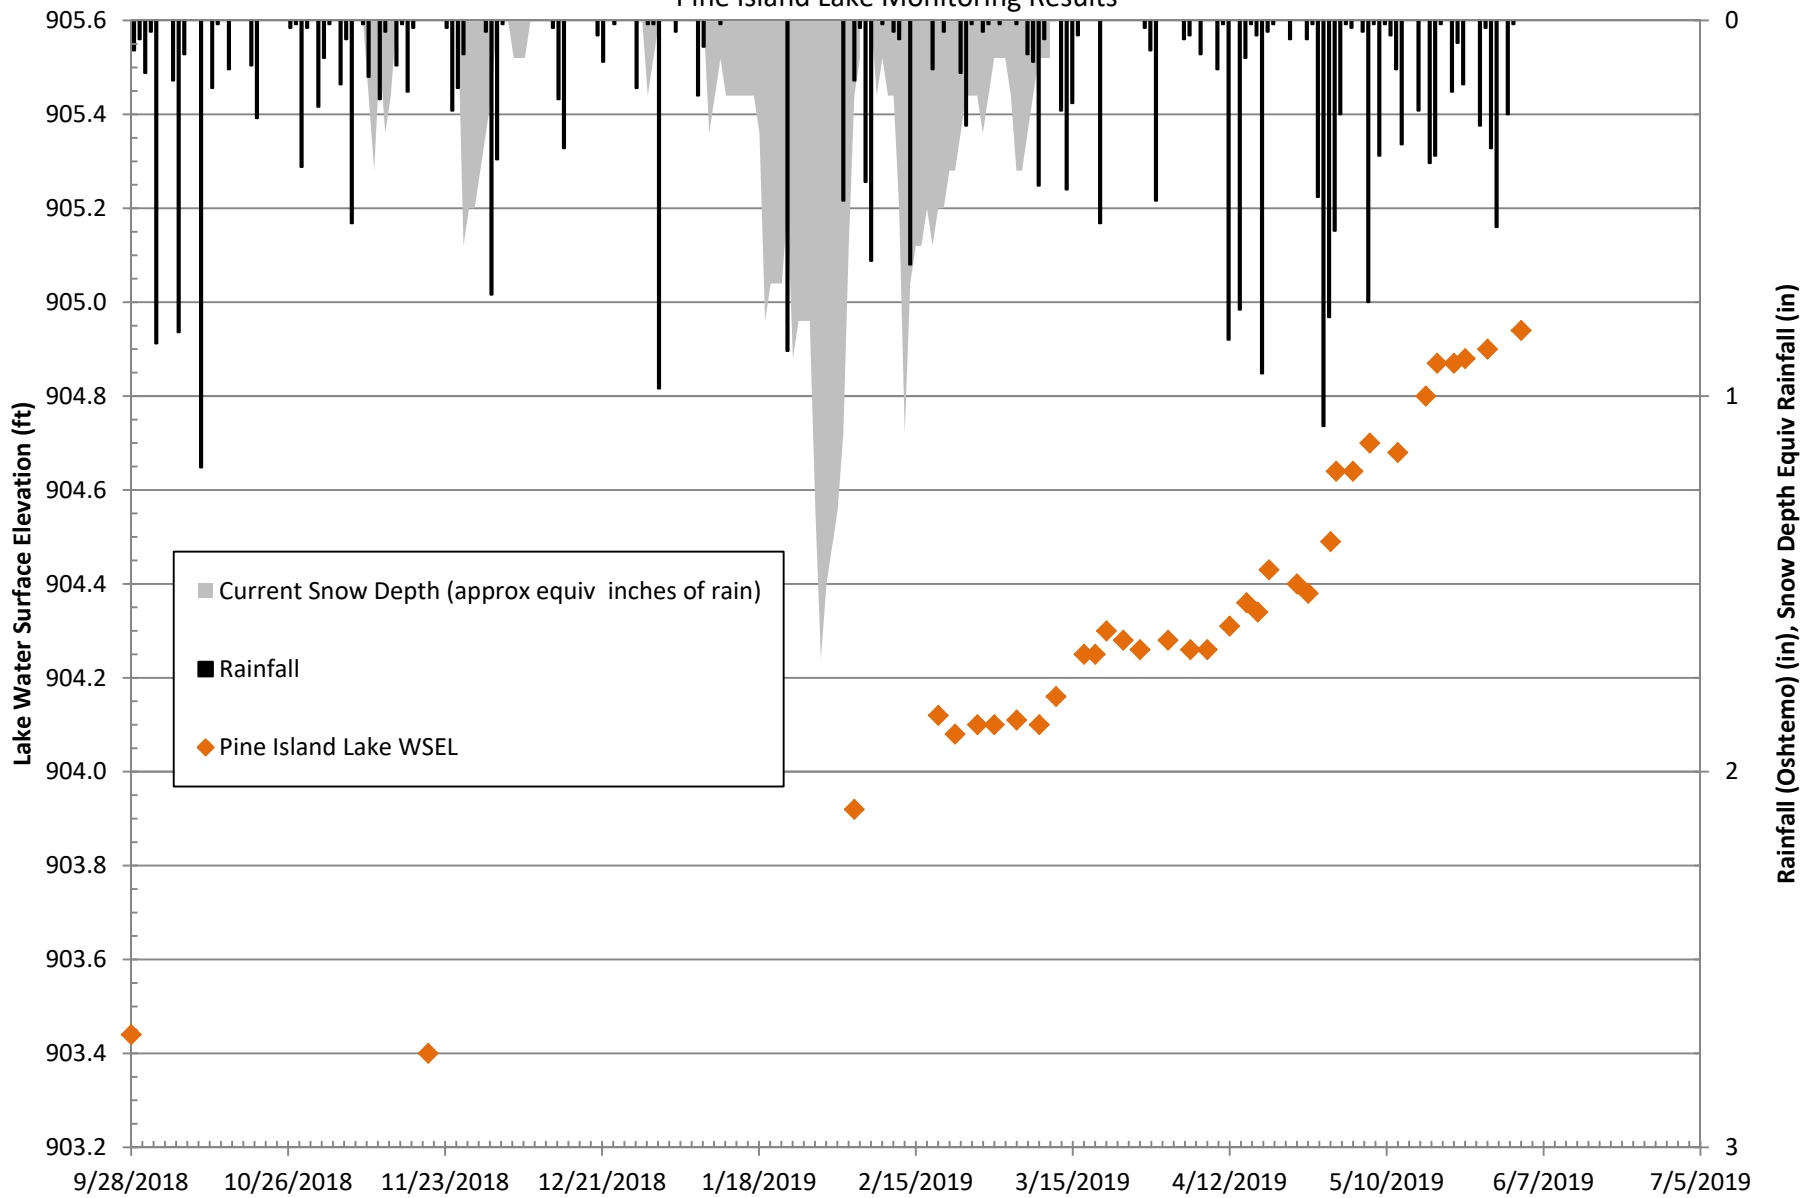
Figure

Pine Island Lake Monitoring Results

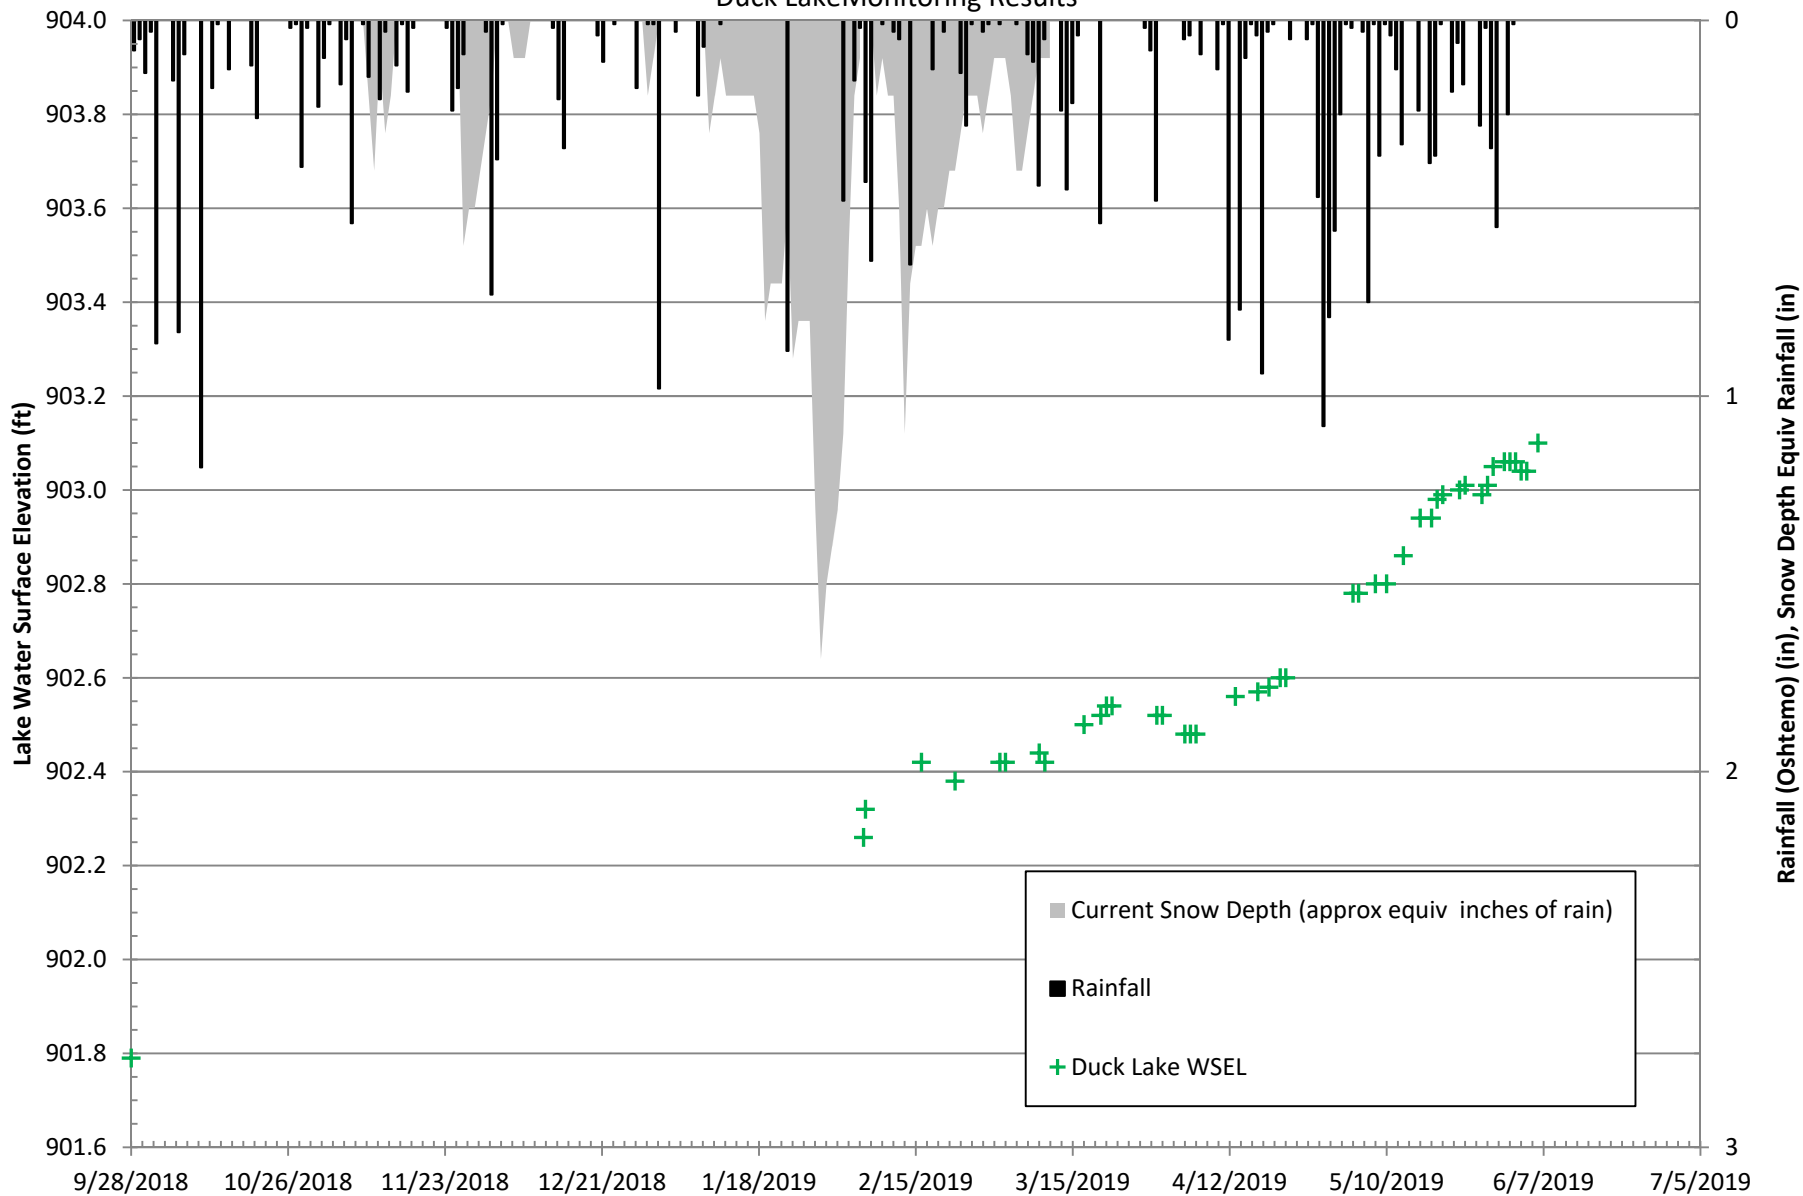
Figure

Duck Lake Monitoring Results

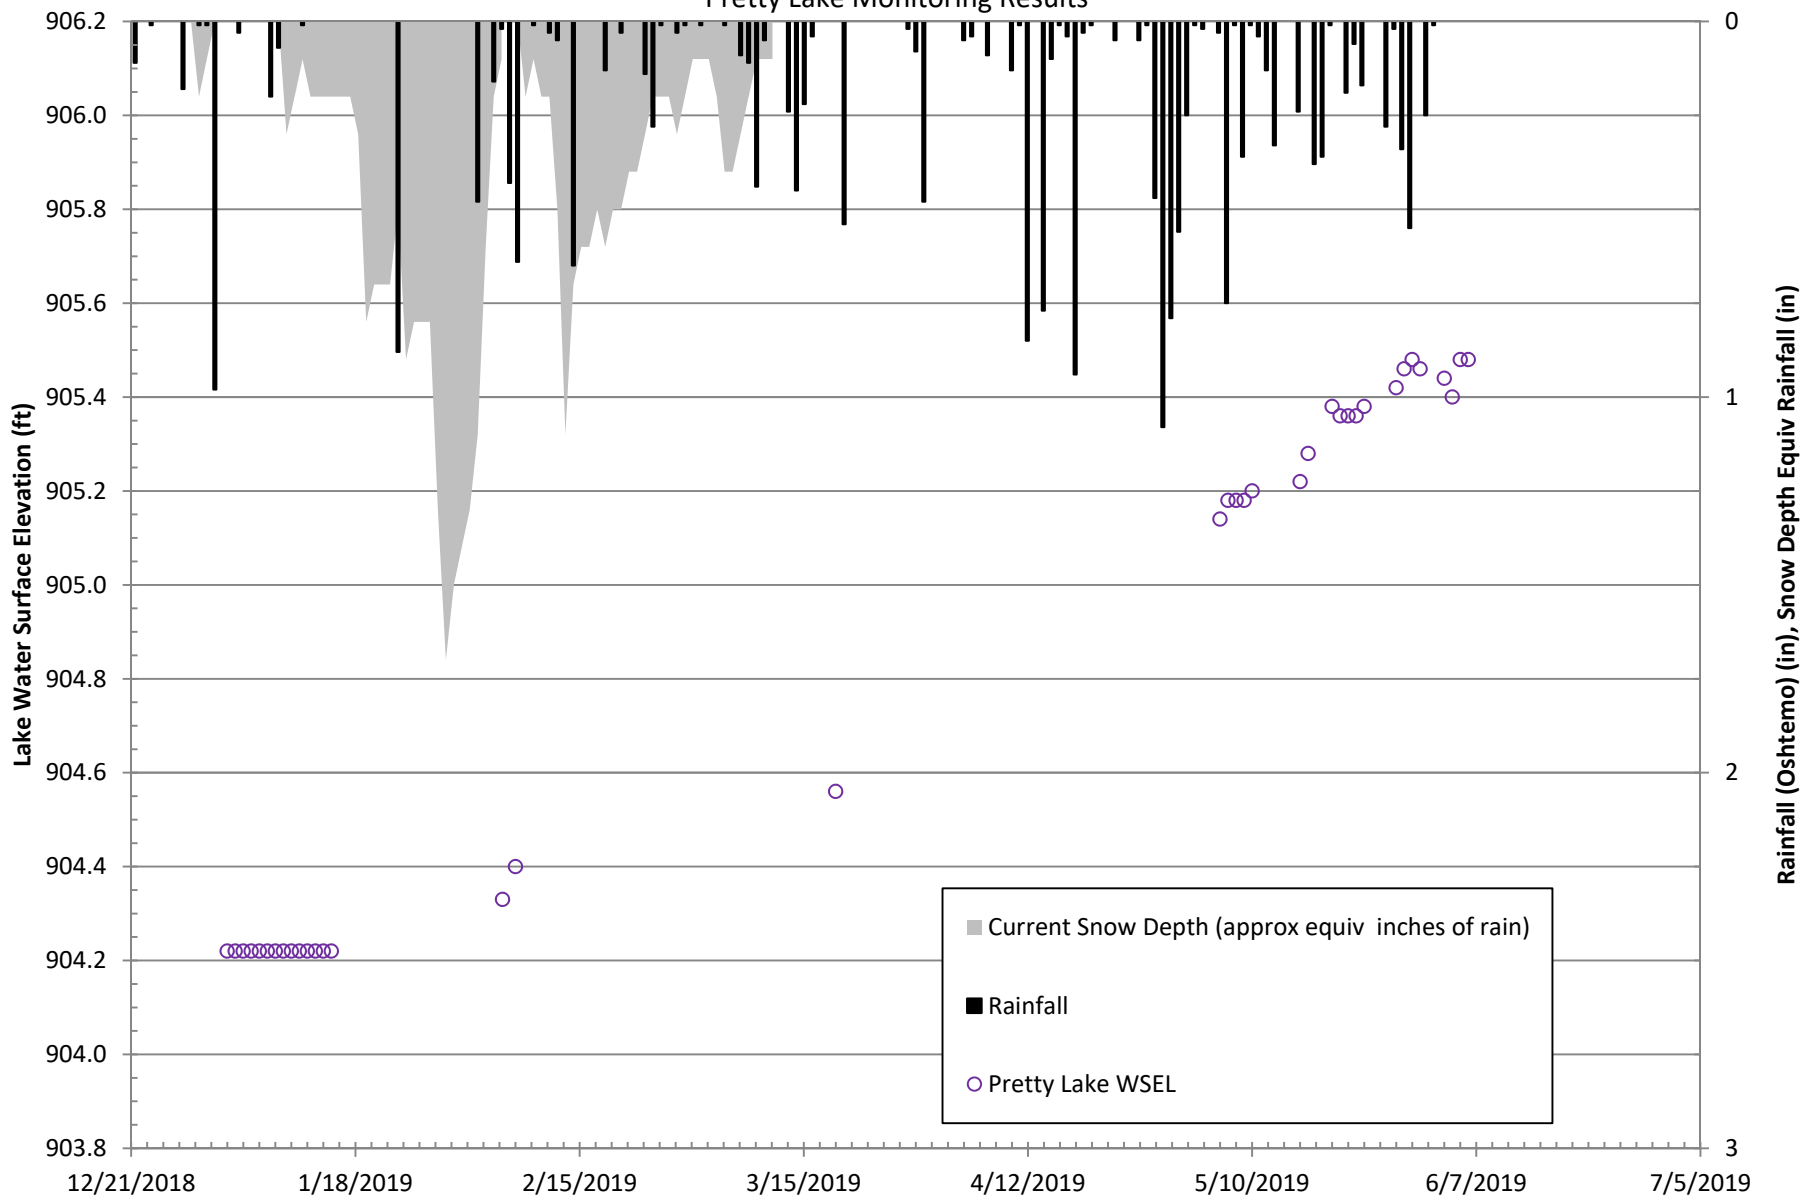
Figure

Pretty Lake Monitoring Results

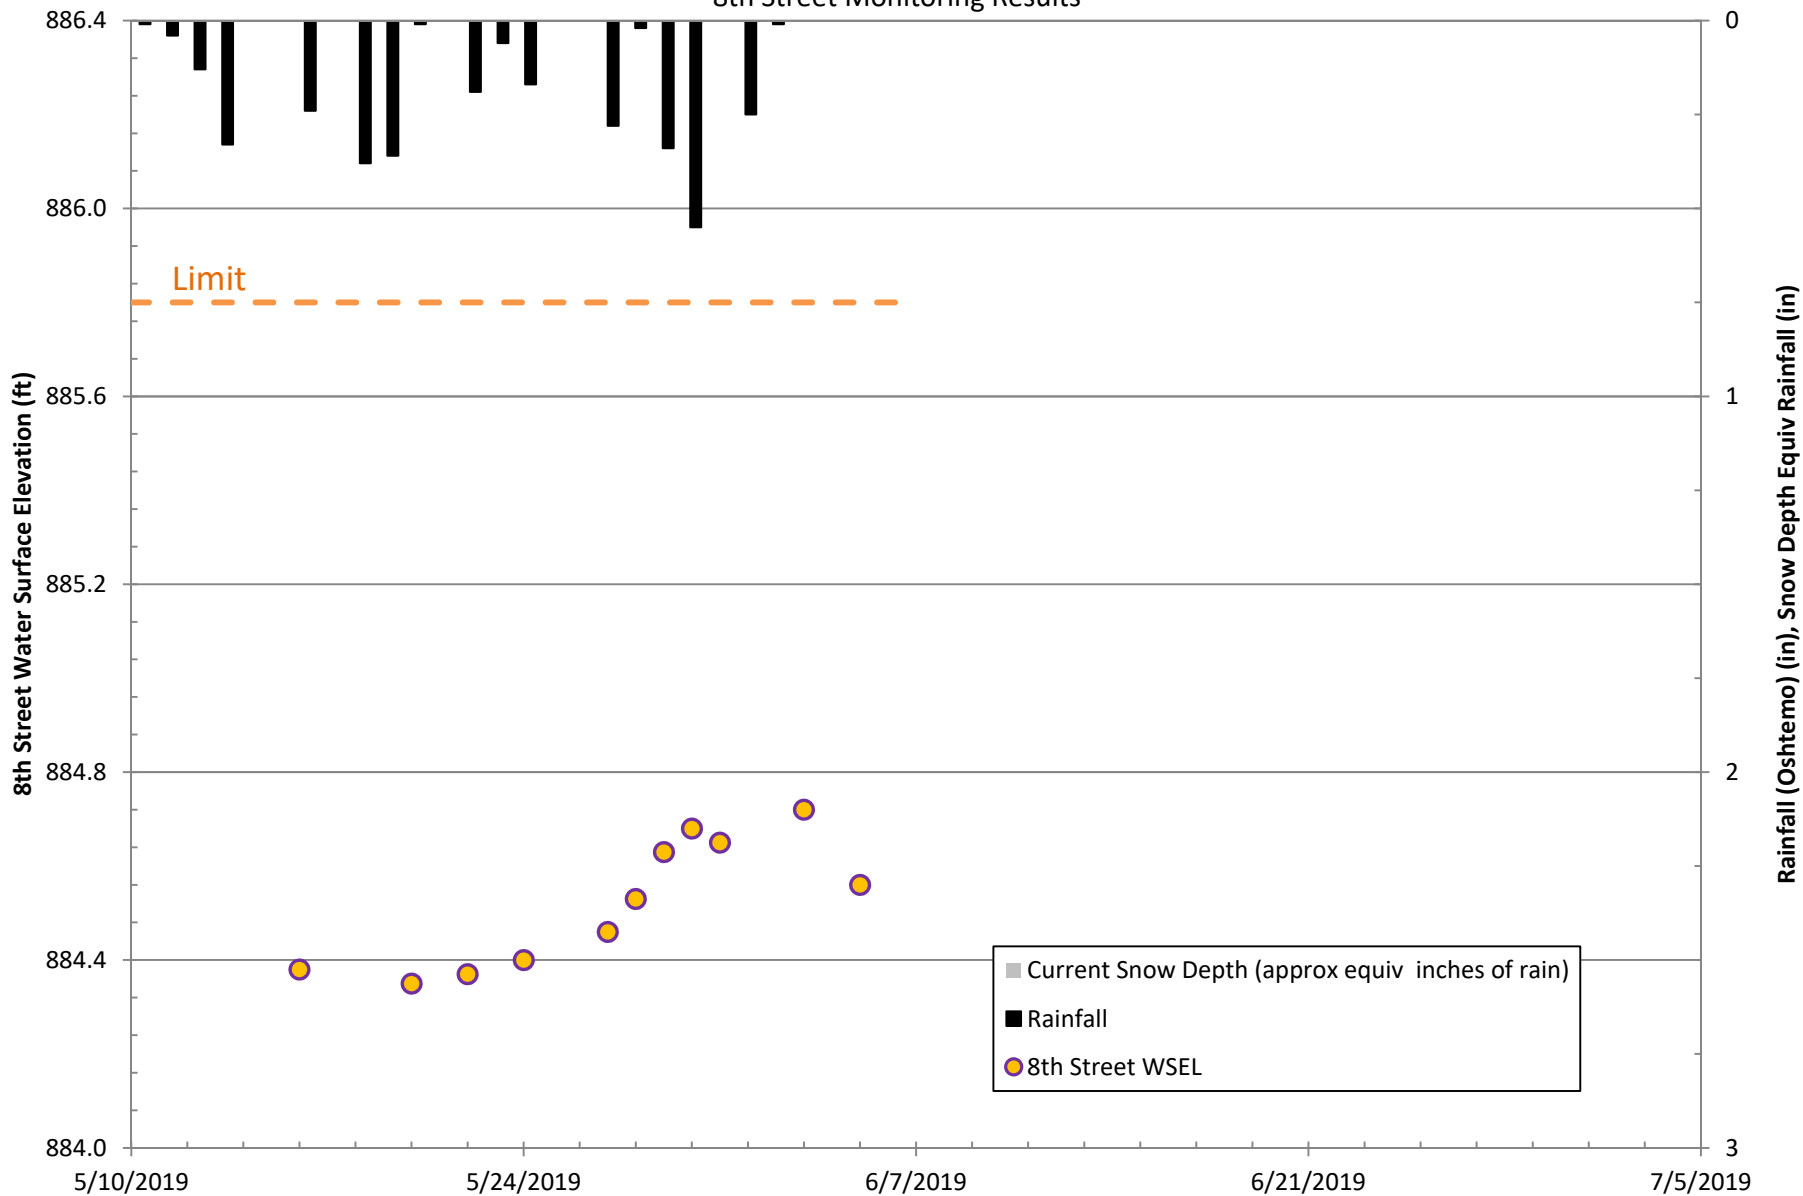
Figure

8th Street Monitoring Results

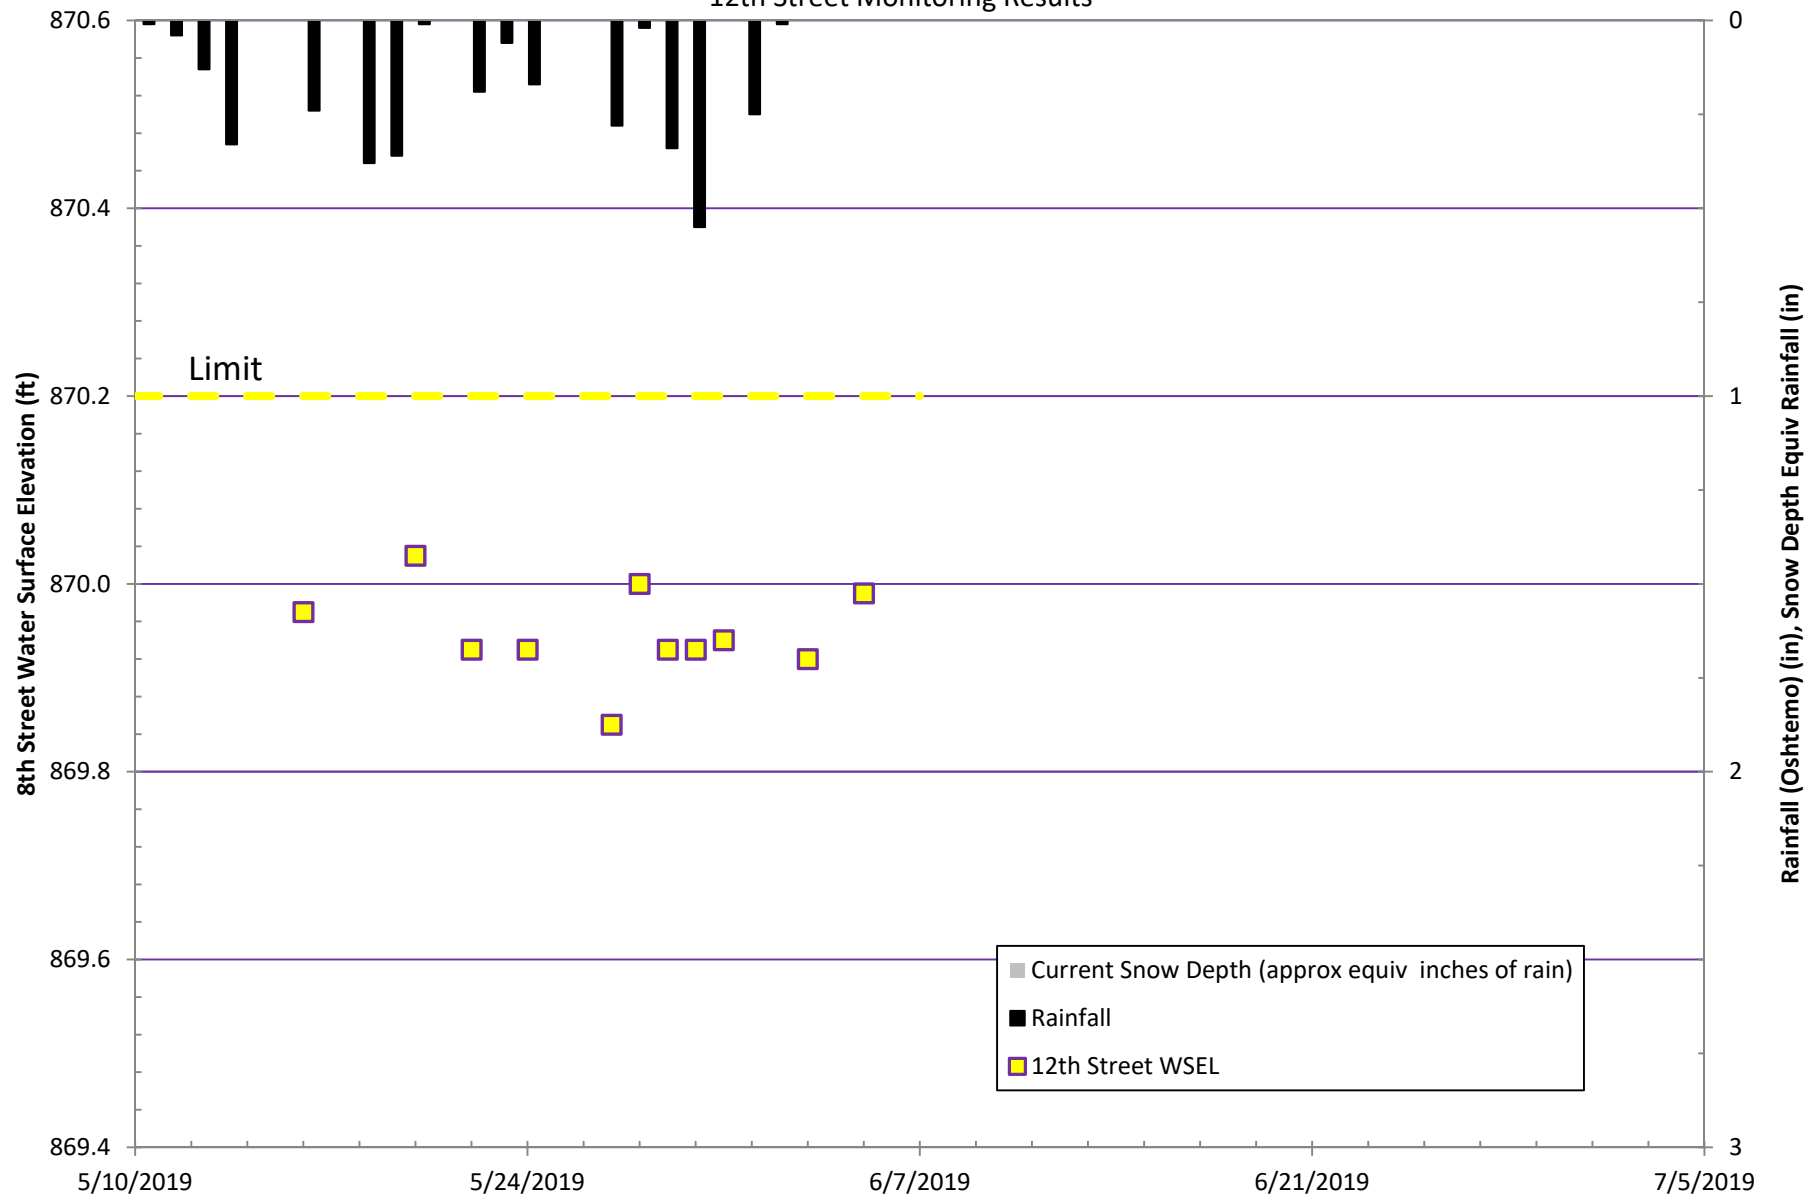
Figure

12th Street Monitoring Results

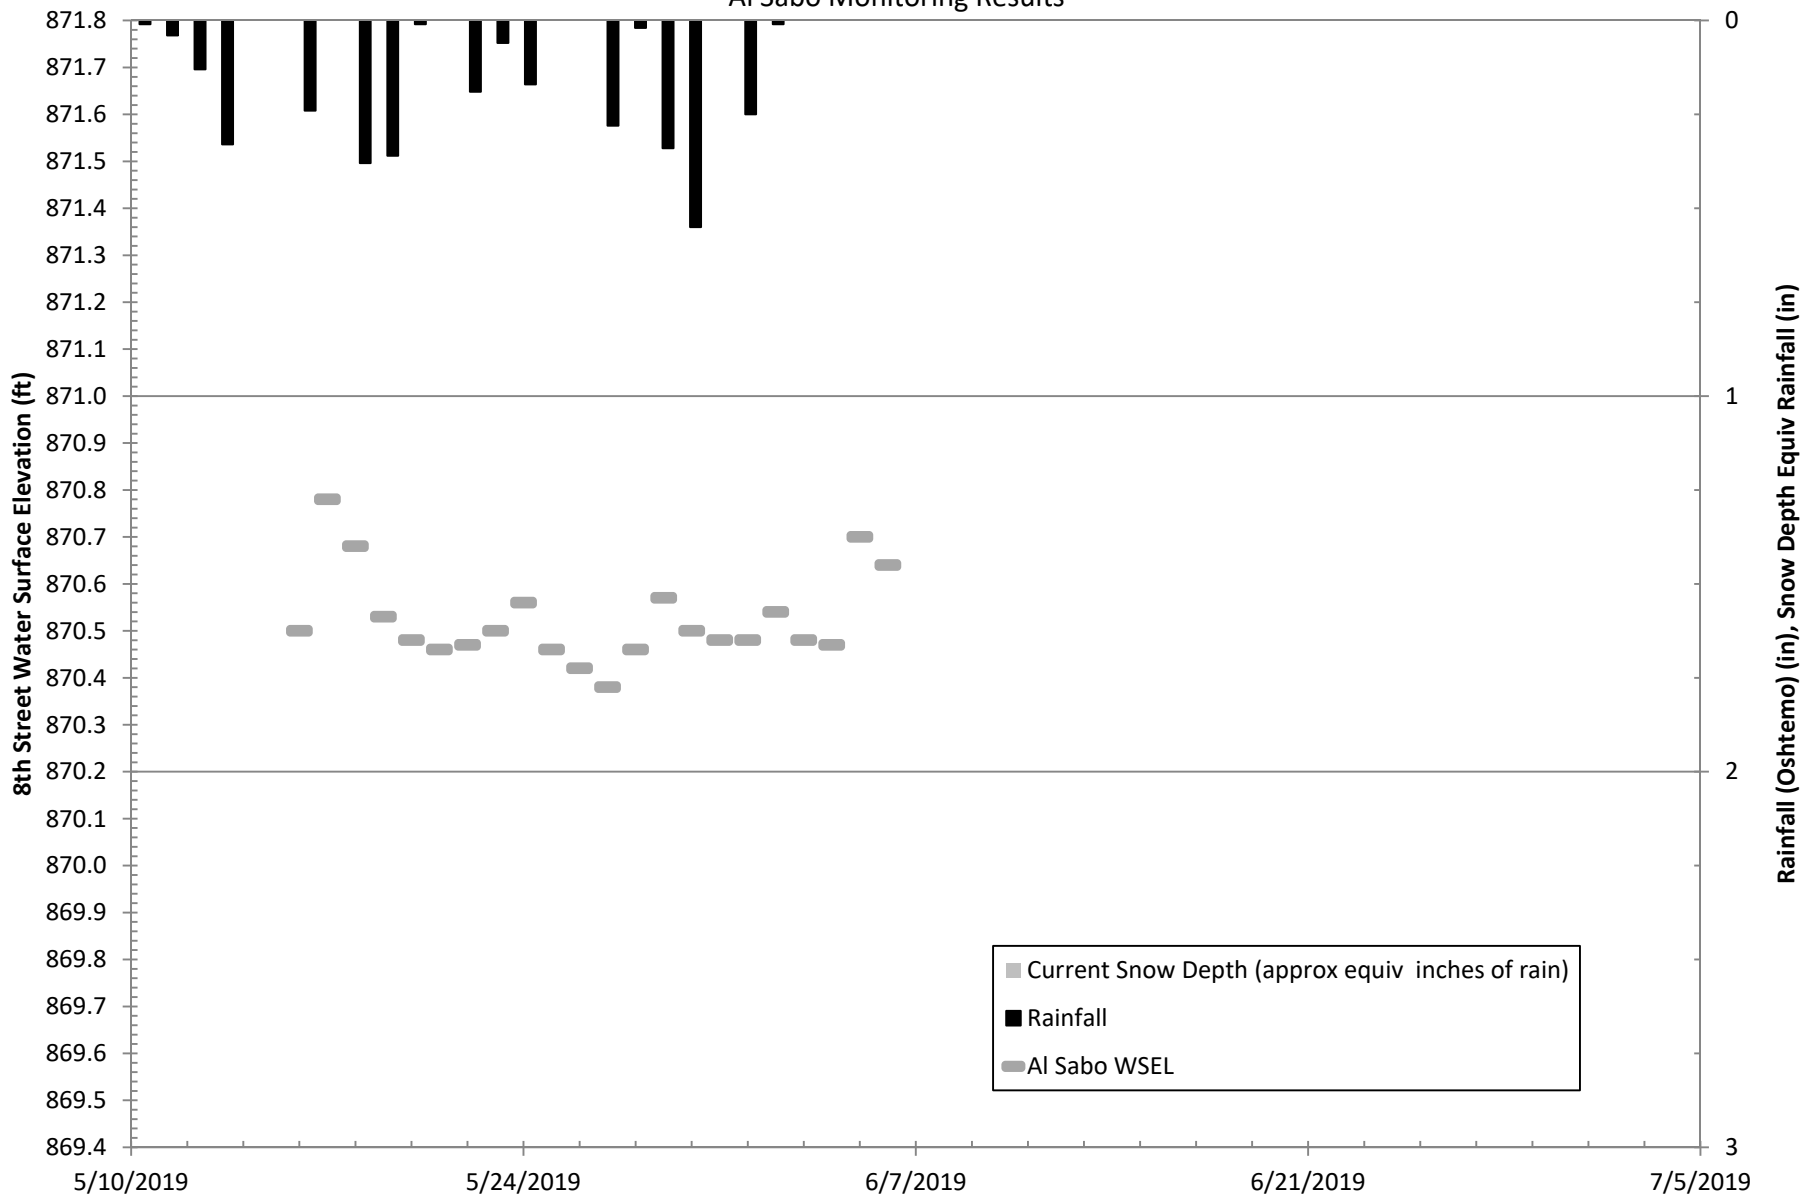
Figure

Al Sabo Monitoring Results

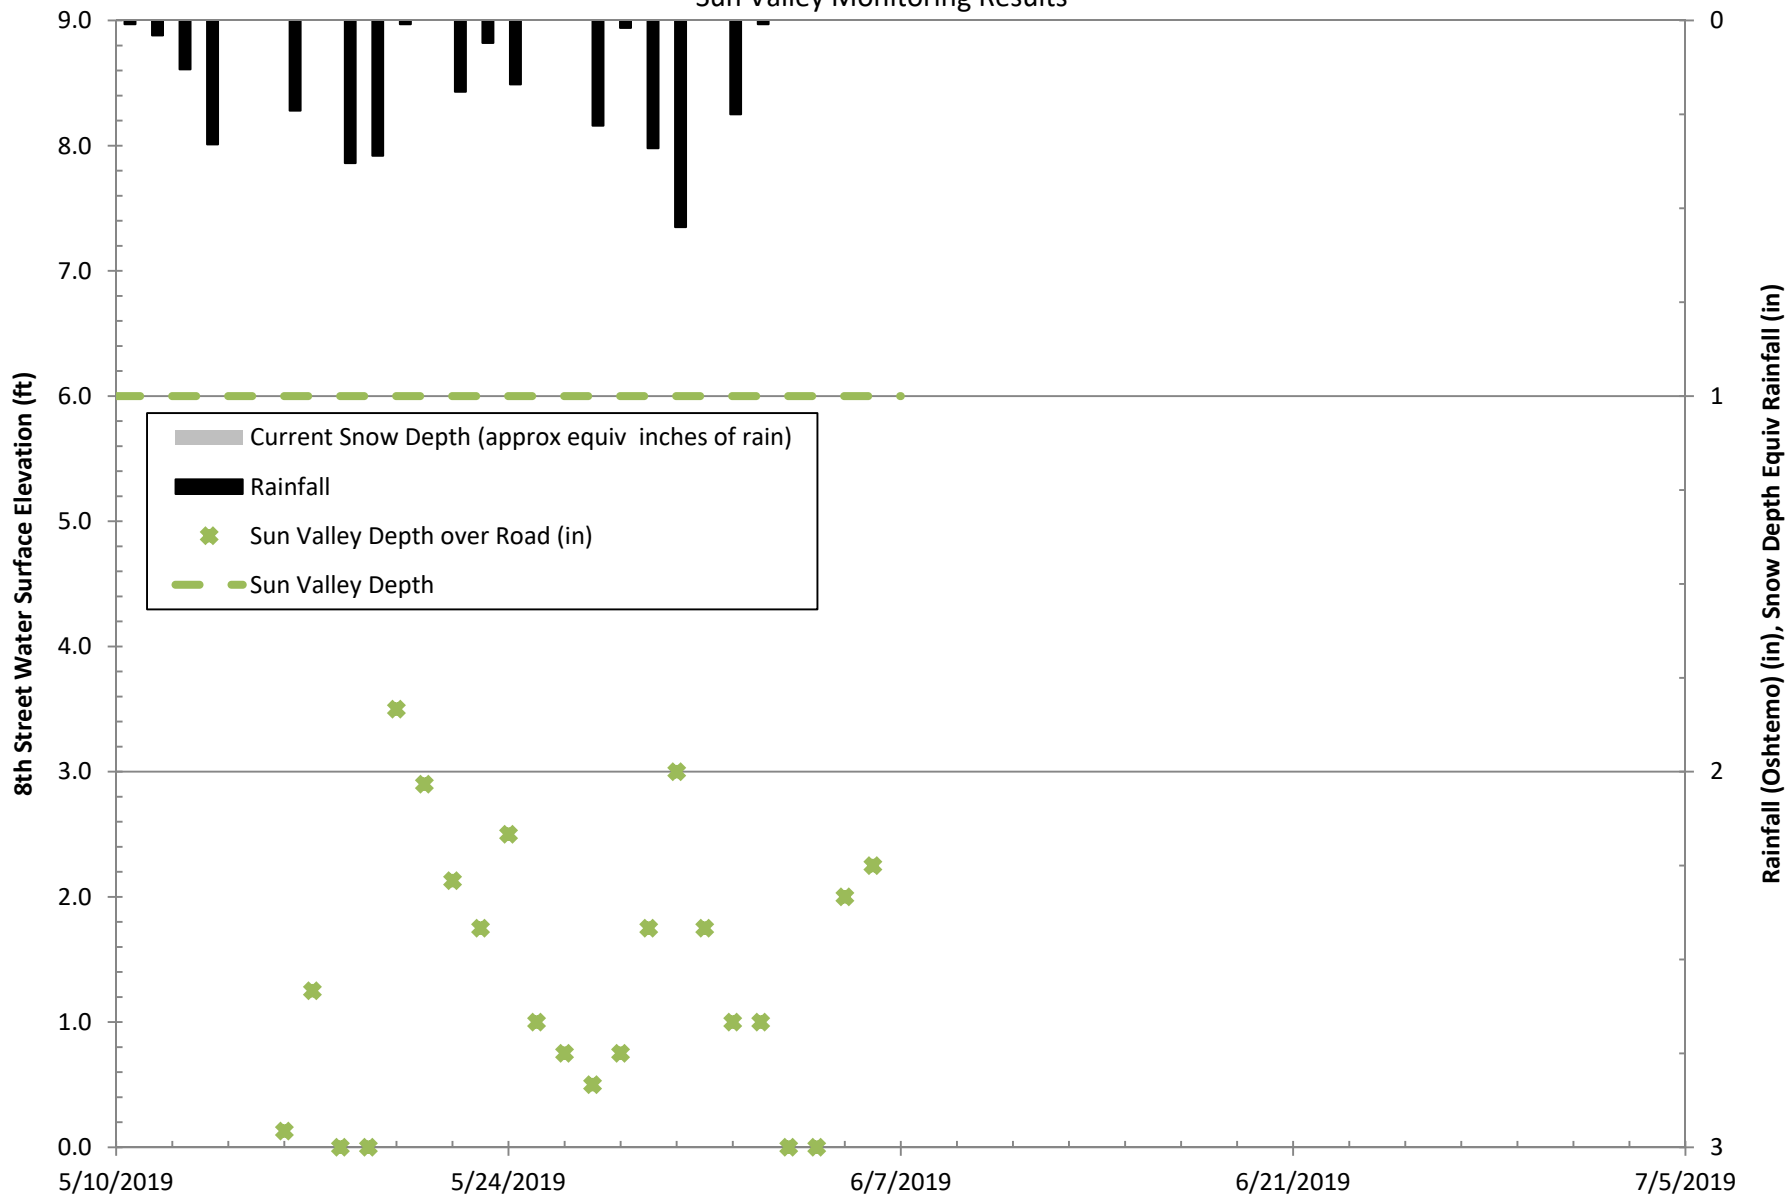
Figure

Sun Valley Monitoring Results
