Charter Township of Texas Flood Study

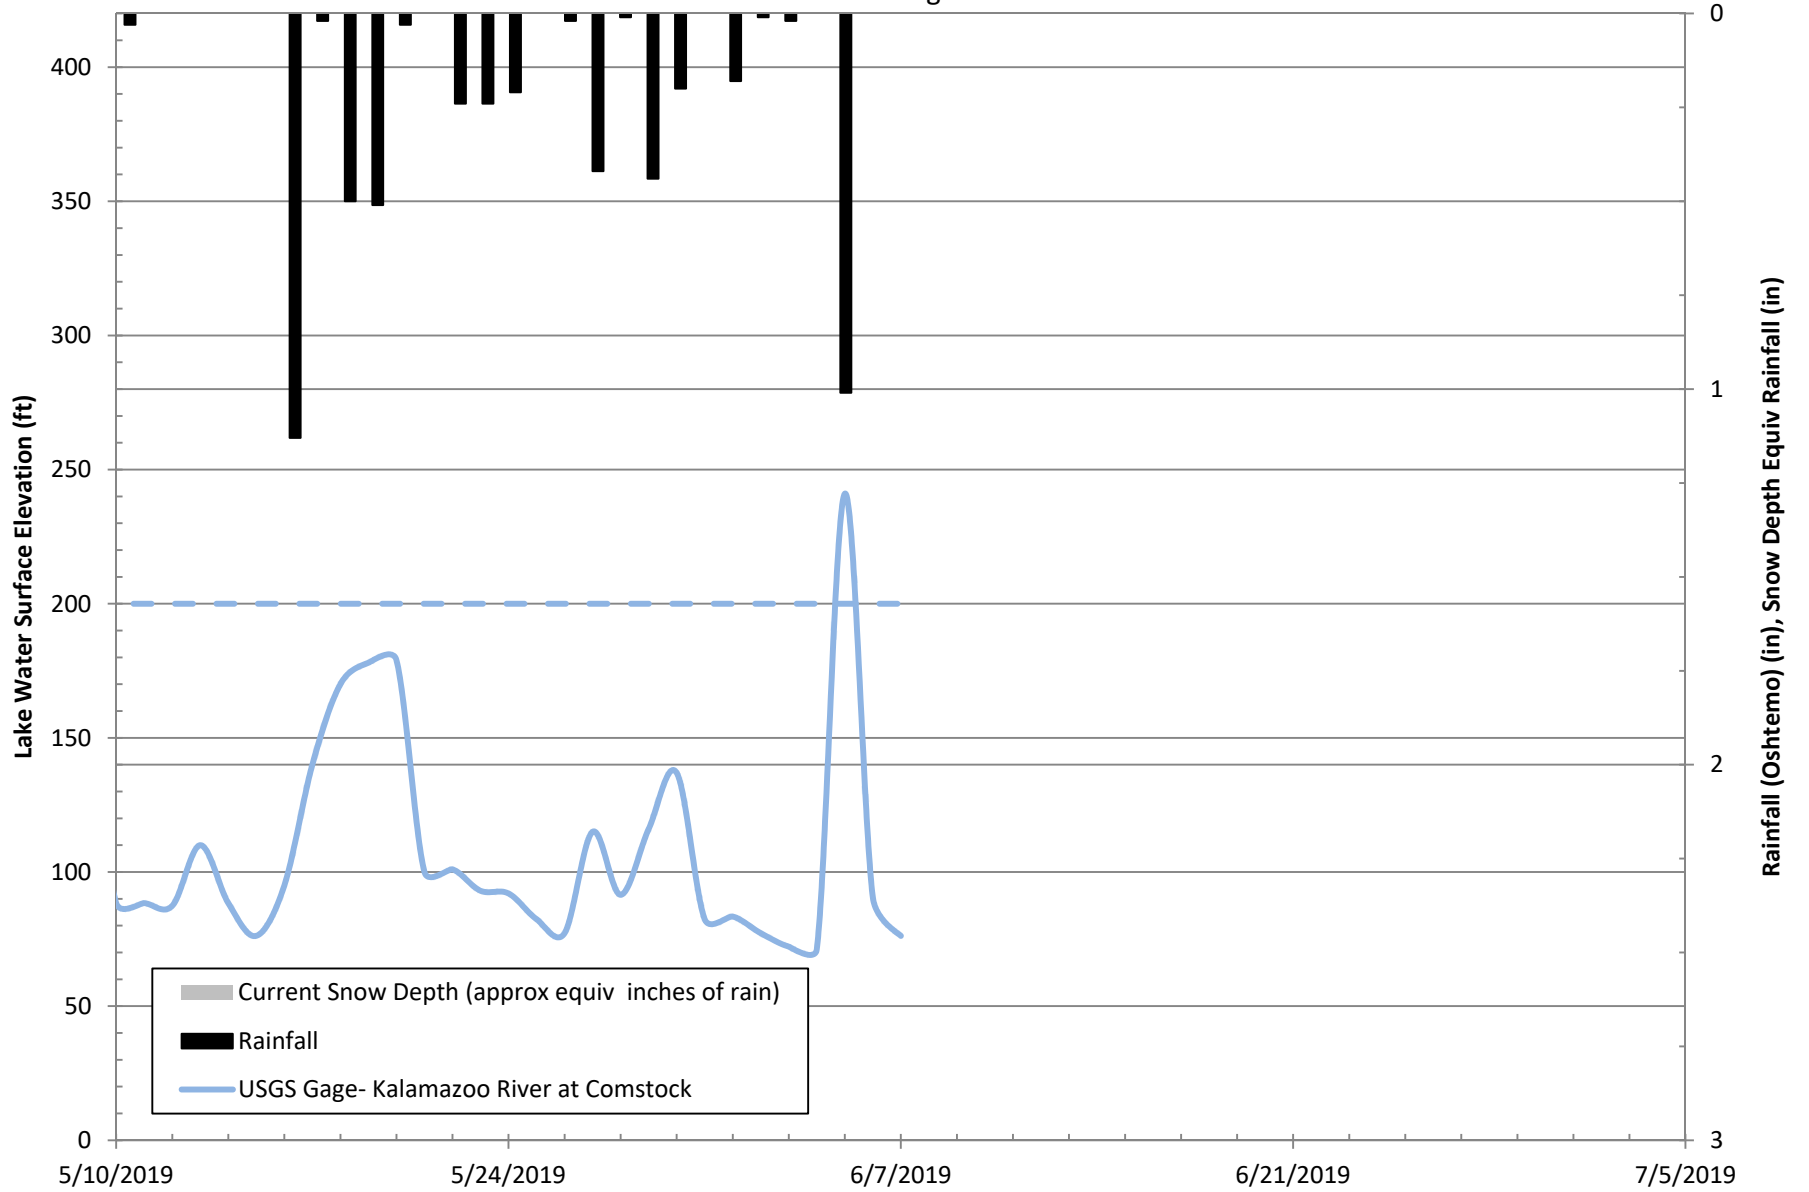
Figure
USGS Monitoring Results

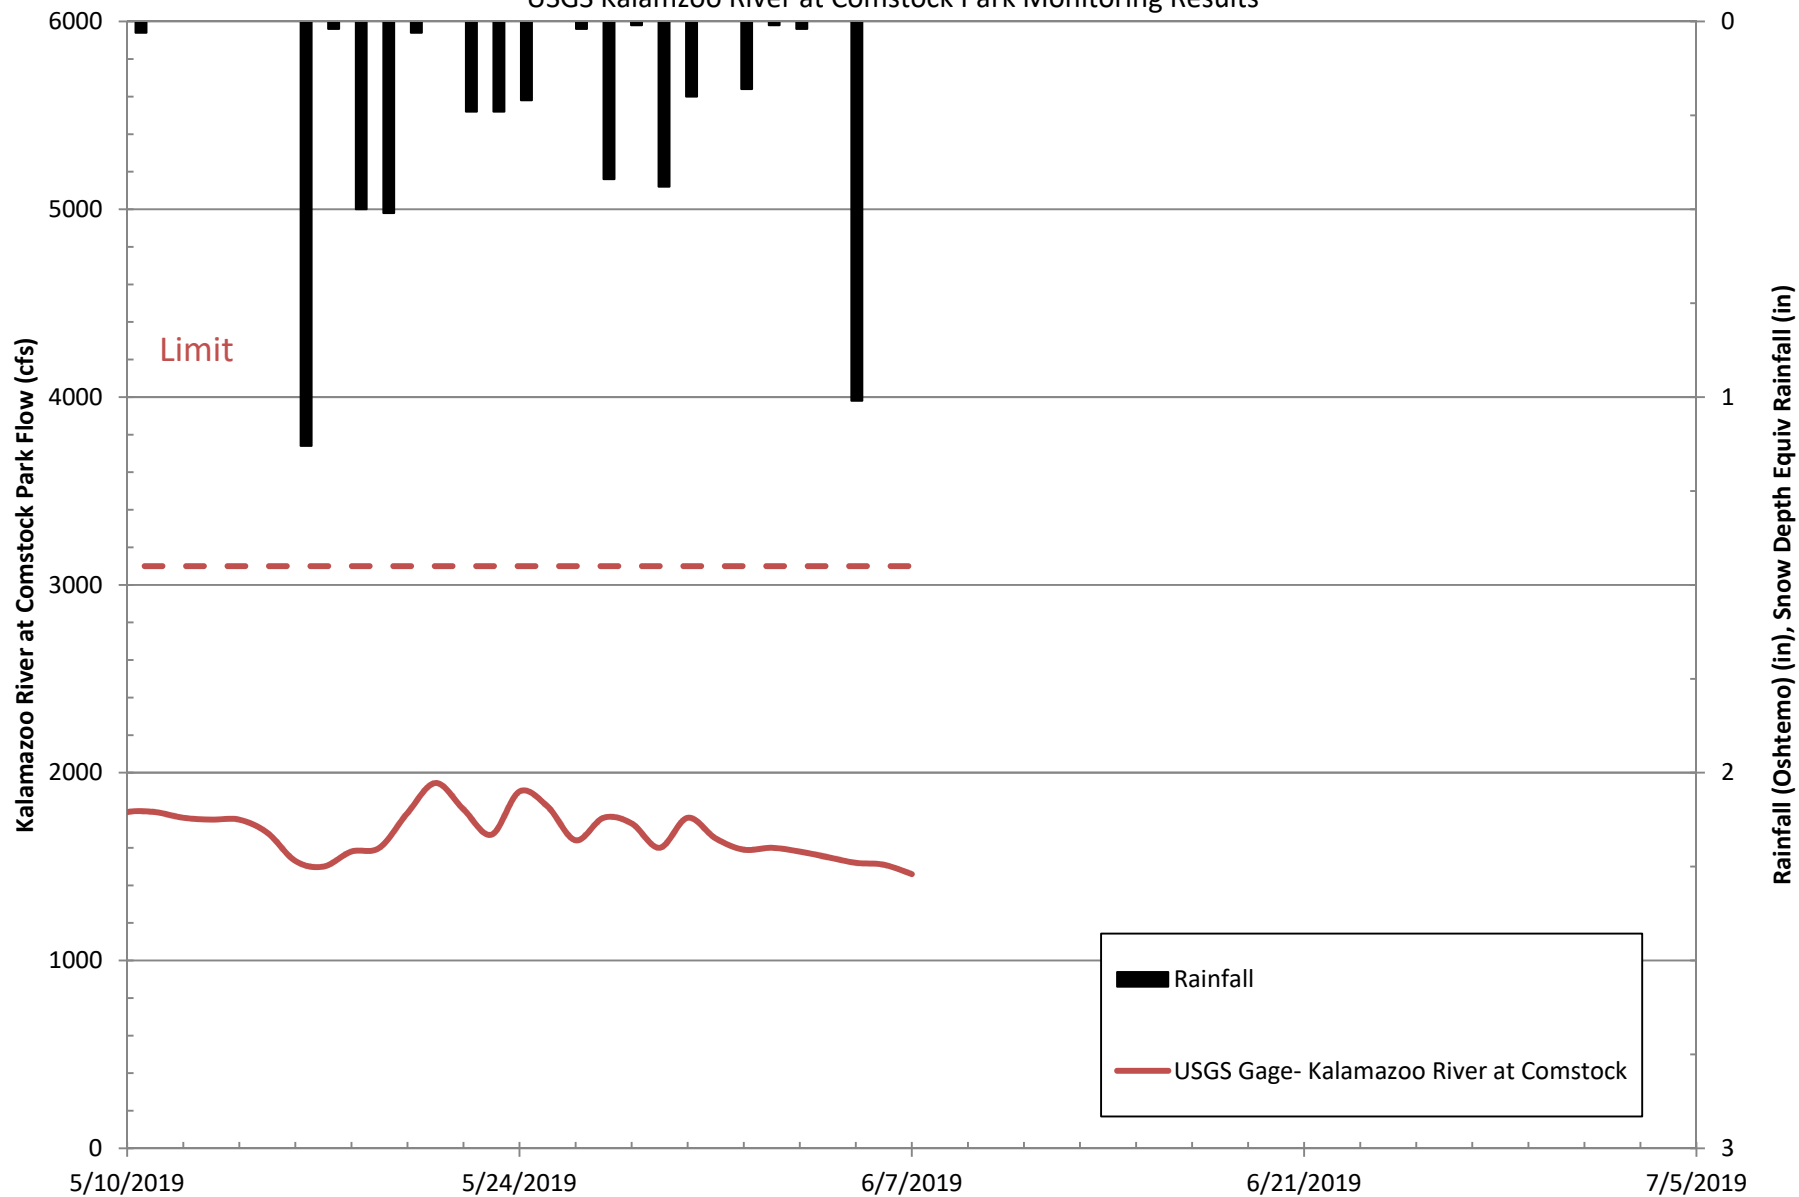
Figure

USGS Kalamzoo River at Comstock Park Monitoring Results
