Preliminary Engineering Study

**Consideration of a Normal Lake Level for Eagle and Crooked Lakes
in accordance with MCL 324.307 et seq. Inland Lake Levels, Part 307, Act 451 of 1994.**

**Prepared for
The Office of the Kalamazoo County Drain Commissioner**

January 2021

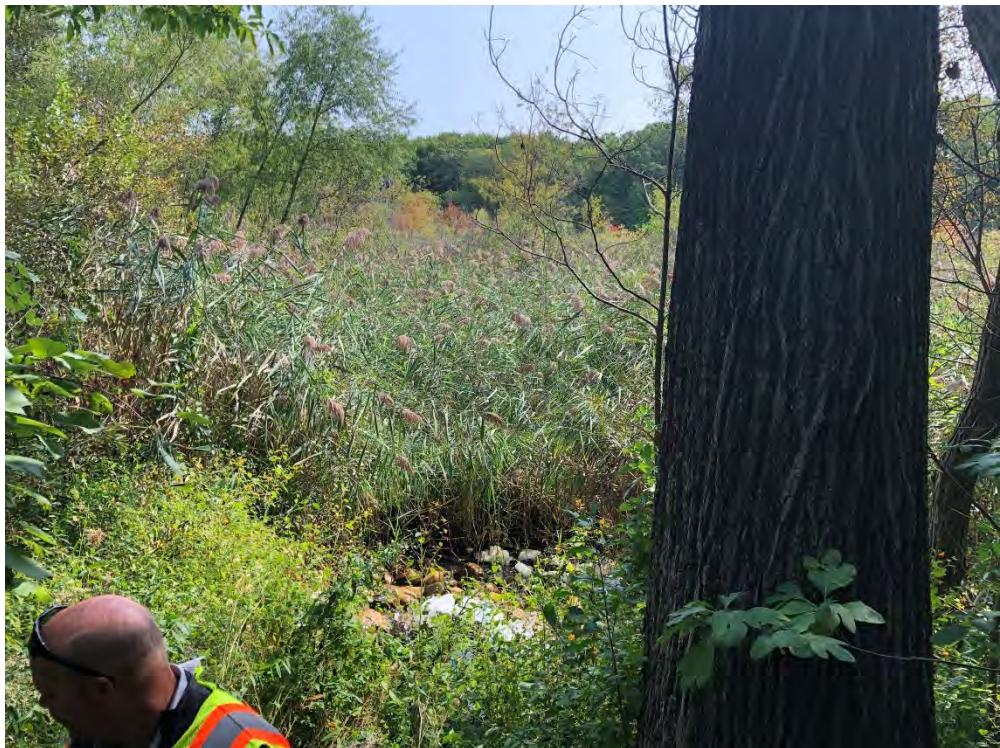
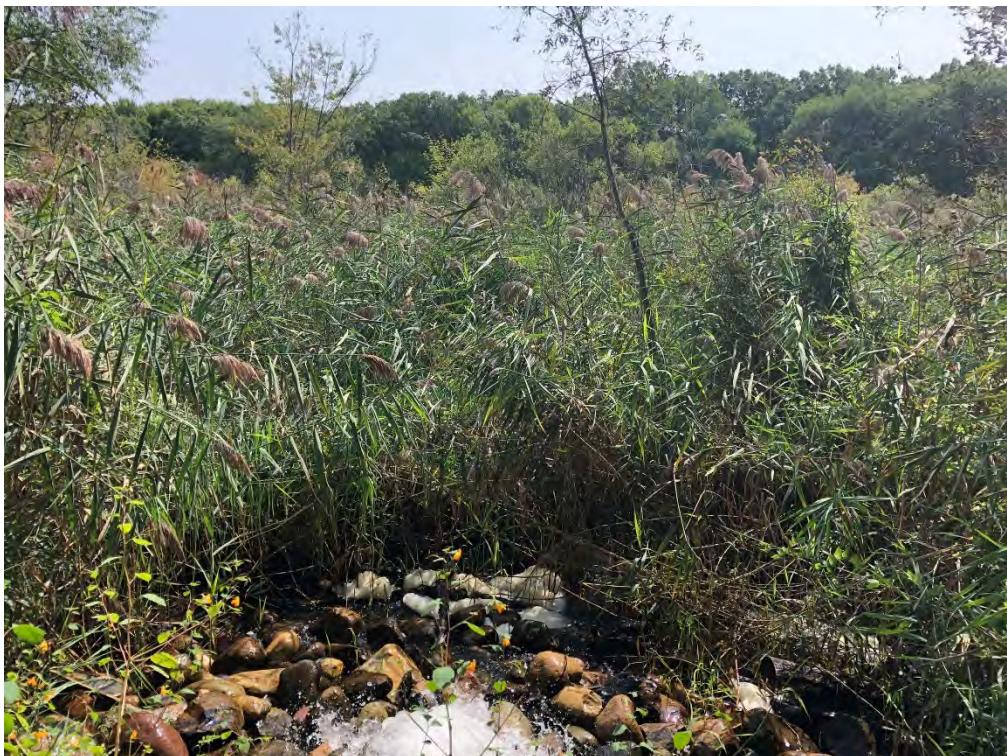
Photo 1. Crooked Lake Outfall Structure: 9/15/2020

Photo 2. Crooked Lake Outfall Structure: 9/15/2020

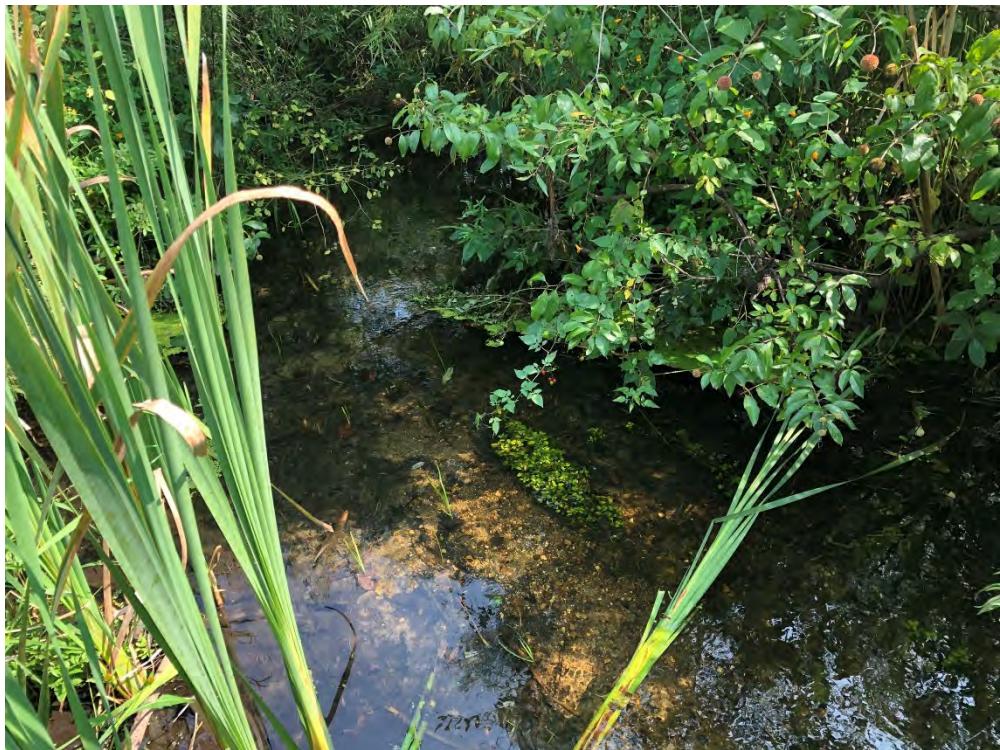
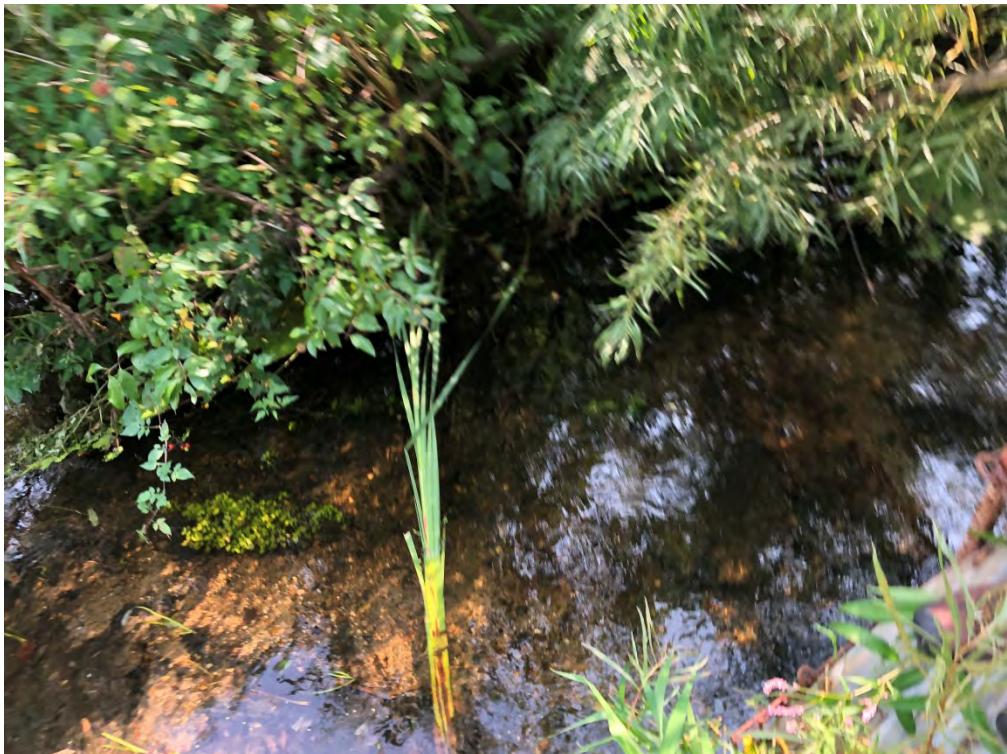
Photo 3. East side of S. 8th Street Culvert: 9/15/2020

Photo 4. East side of S. 8th Street Culvert: 9/15/2020

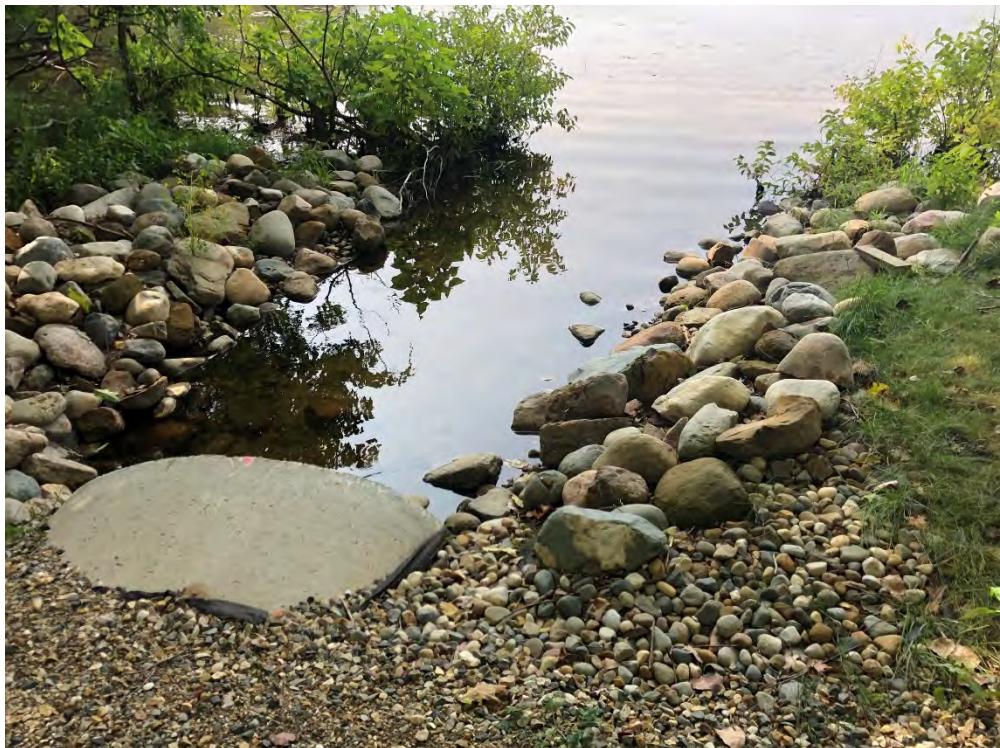
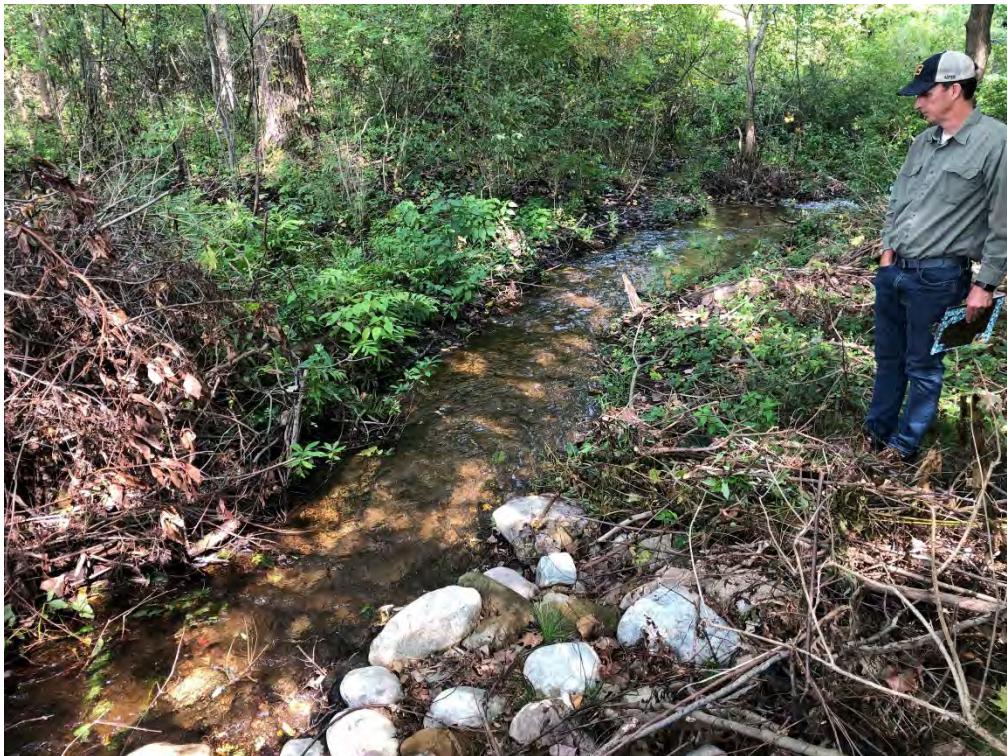
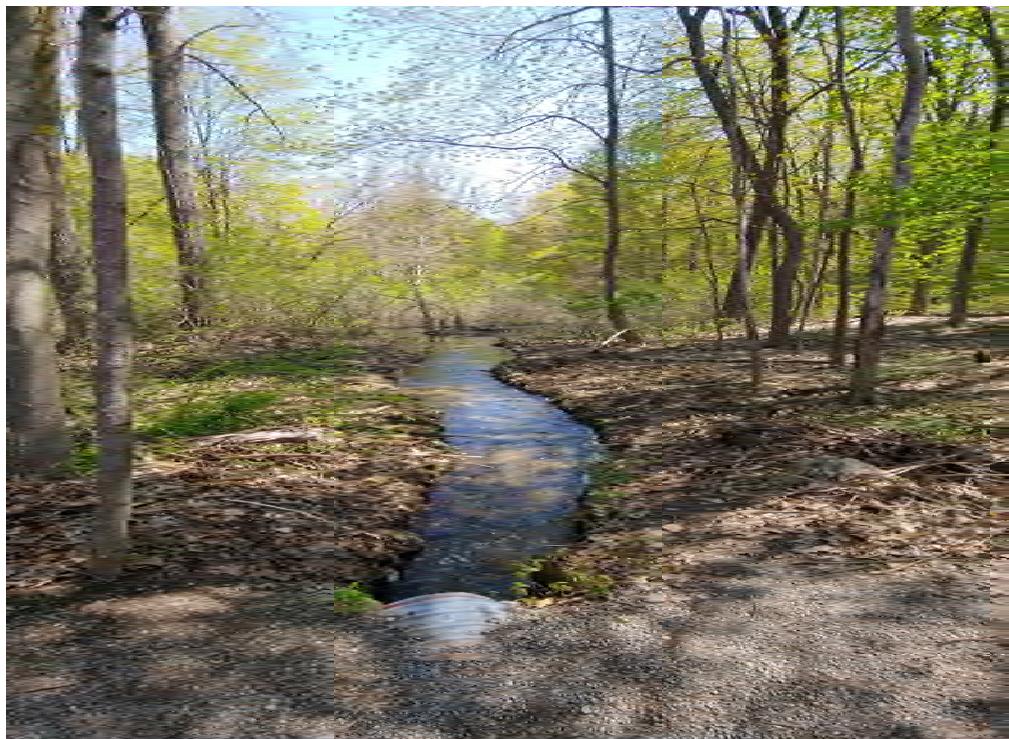
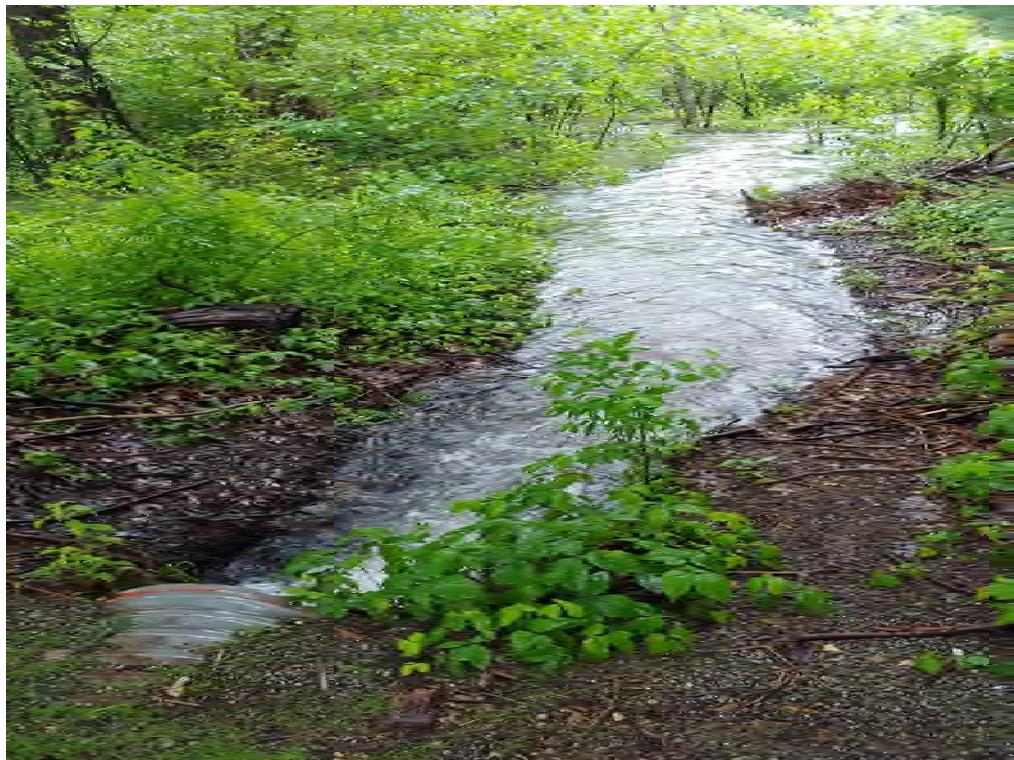
Photo 5. Bass Lake Outlet: 9/15/2020

Photo 6. Bass Lake Outlet: 9/15/2020

Photo 7. Bass Lake Outlet: 5/2019

Photo 8. Bass Lake Outlet: 6/2019

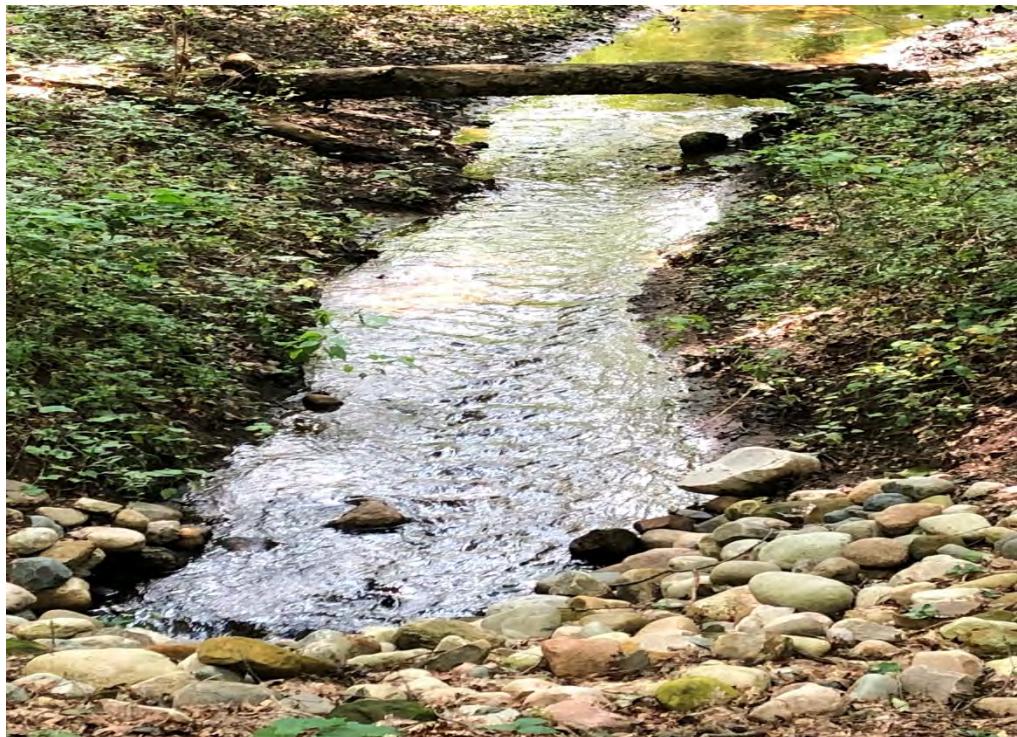
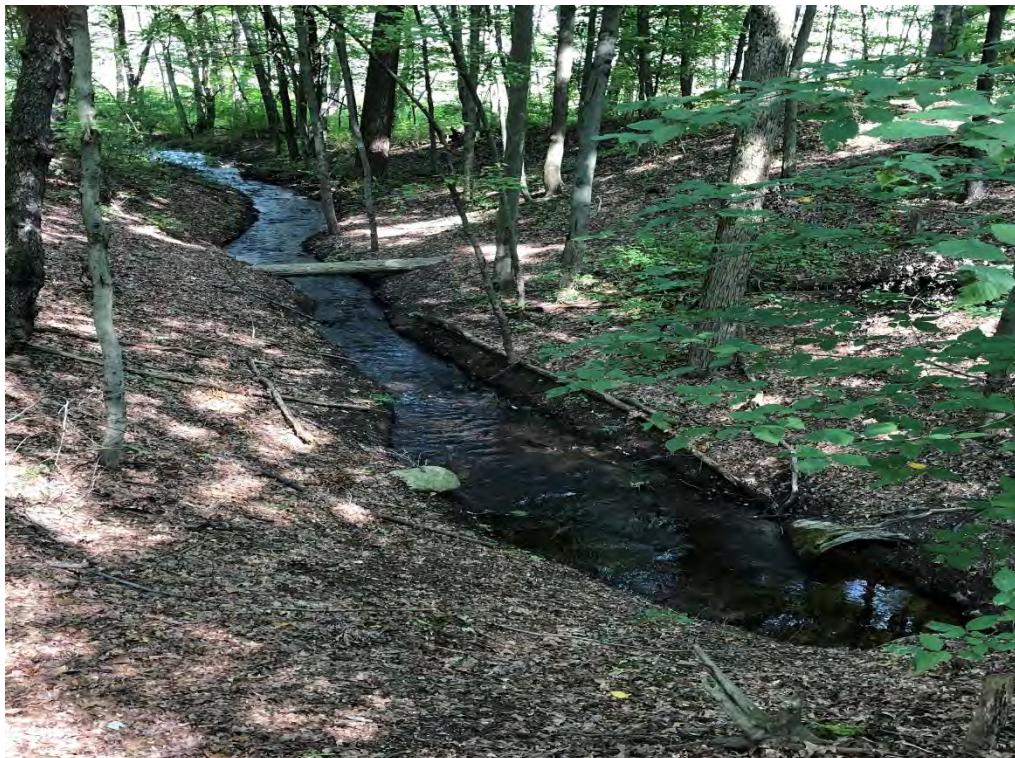
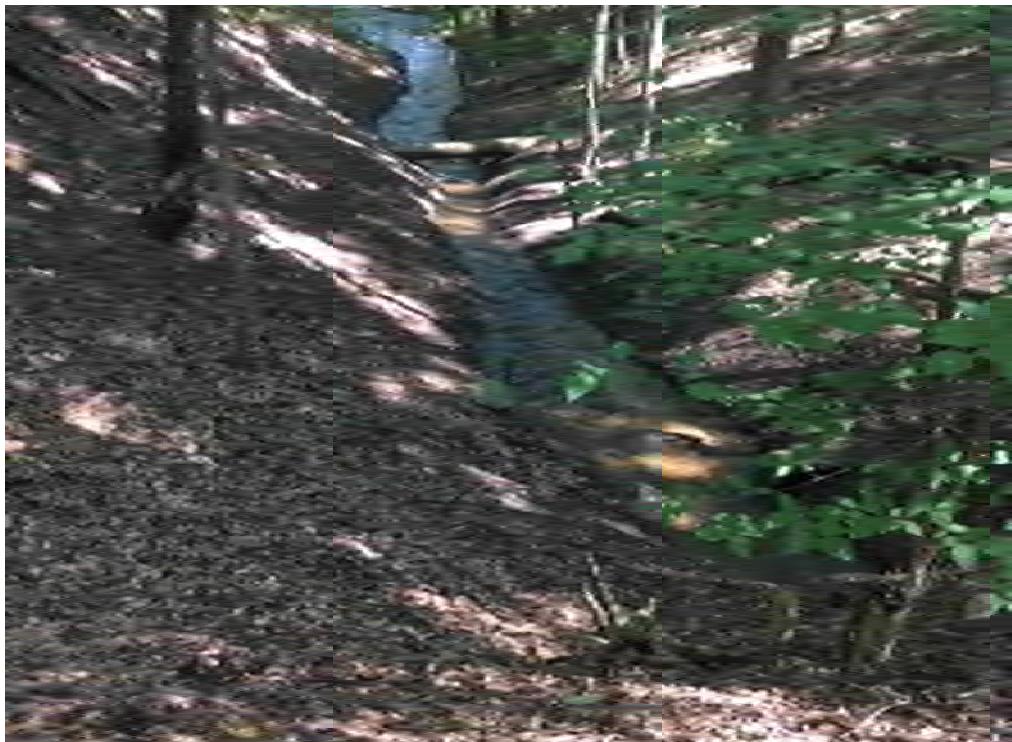
Photo 9. Boy Scout Road Culvert: 9/15/2020

Photo 10. Boy Scout Road Culvert: 9/15/2020

Photo 11. Boy Scout Road Culvert: 6/2019

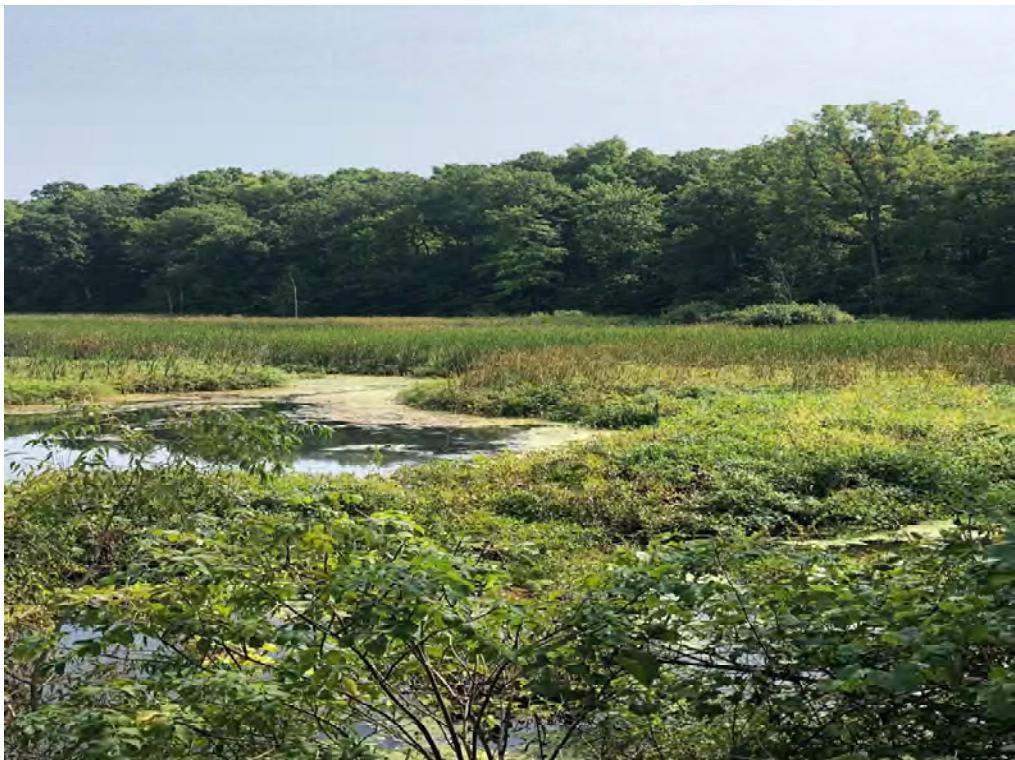
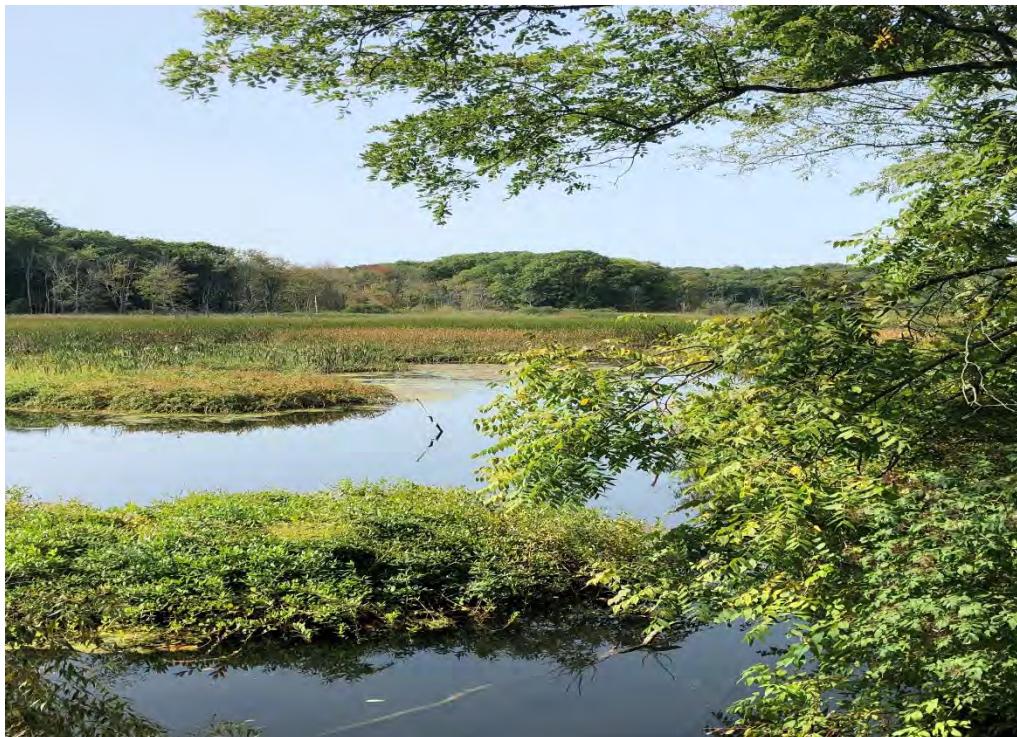
Photo 12. El Sabo Land Preserve Culvert: 9/15/2020

Photo 13. El Sabo Land Preserve Culvert: 9/15/2020

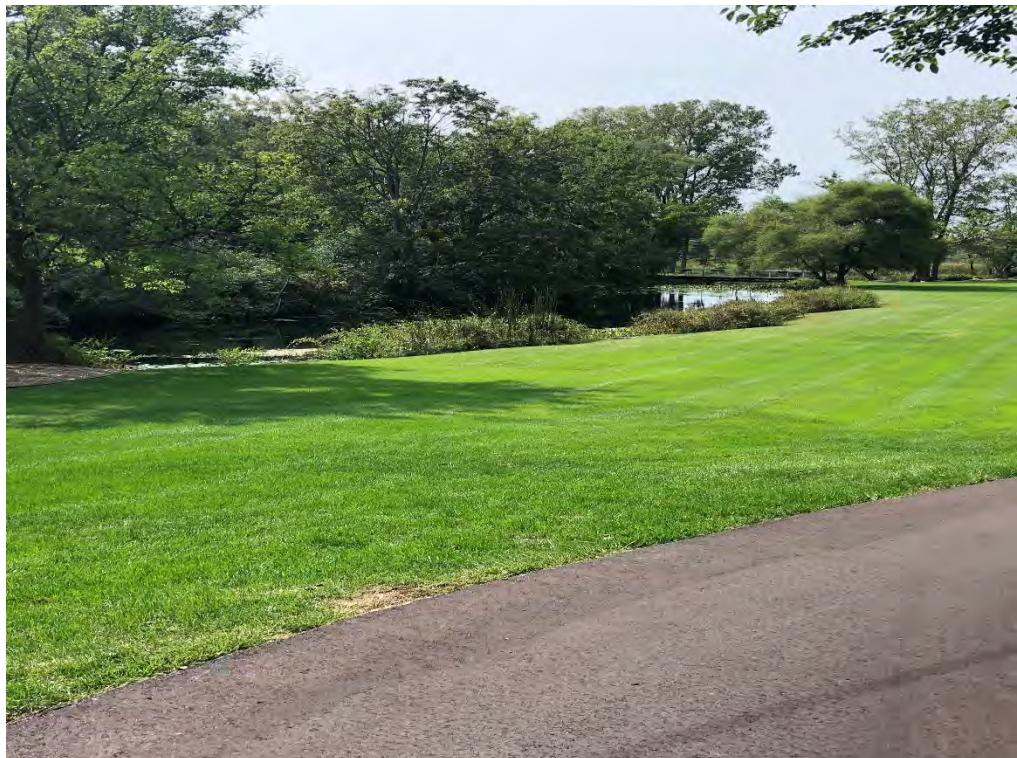
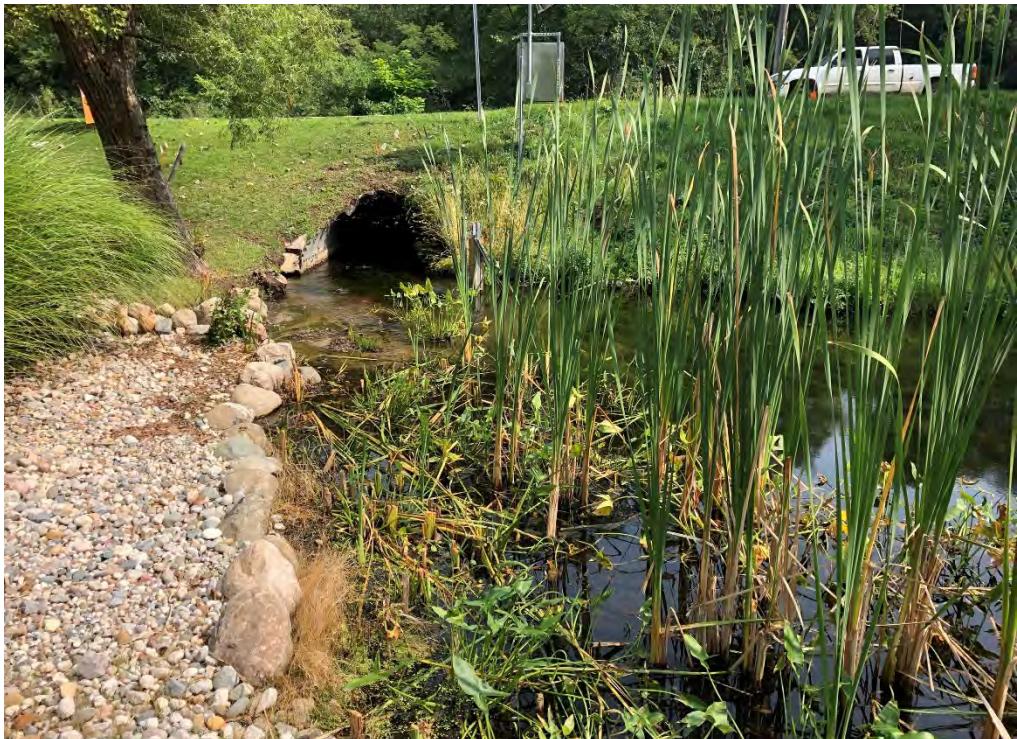
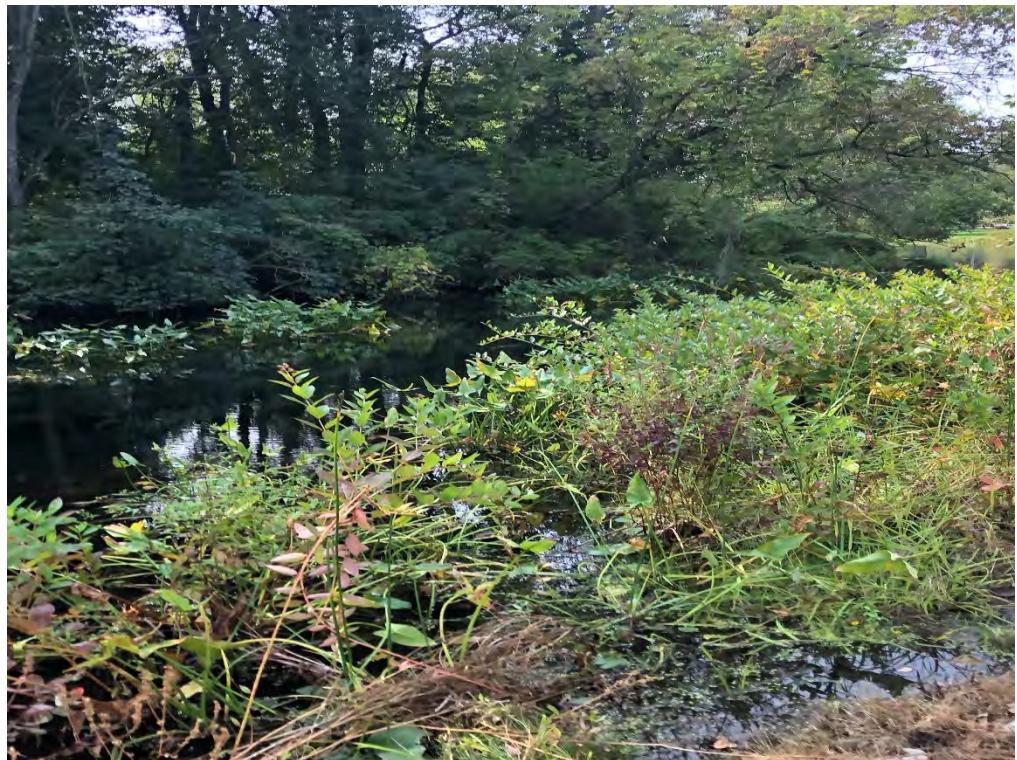
Photo 14. S. 12th Street Culvert: 9/15/2020

Photo 15. S. 12th Street Culvert: 9/15/2020

Photo 16. S. 12th Street Culvert: 9/15/2020

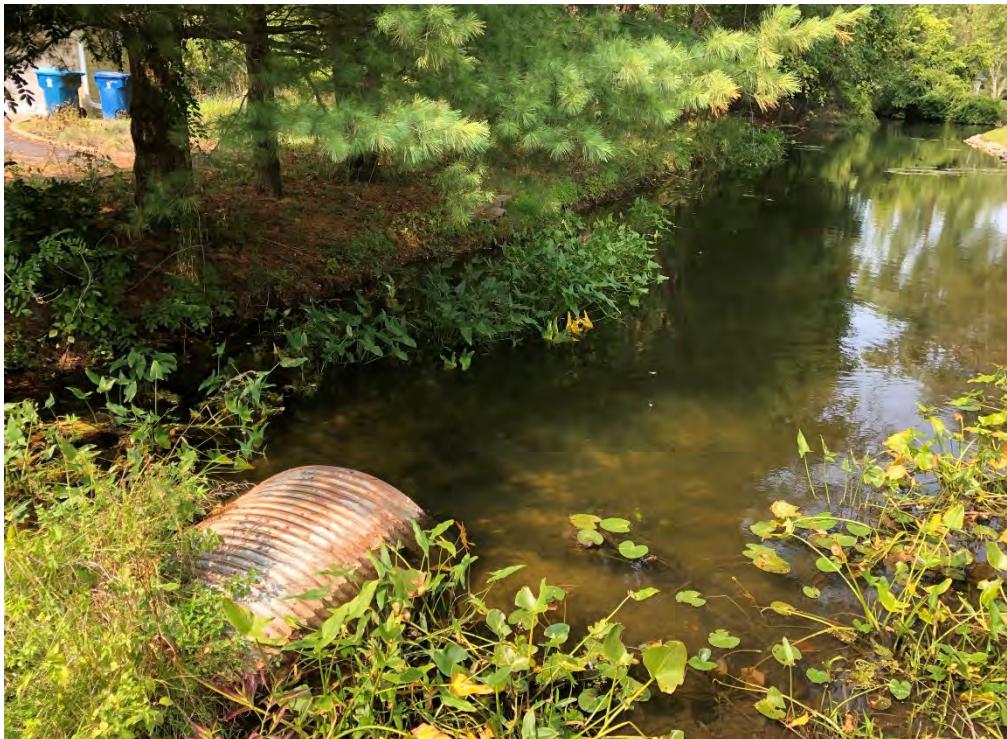
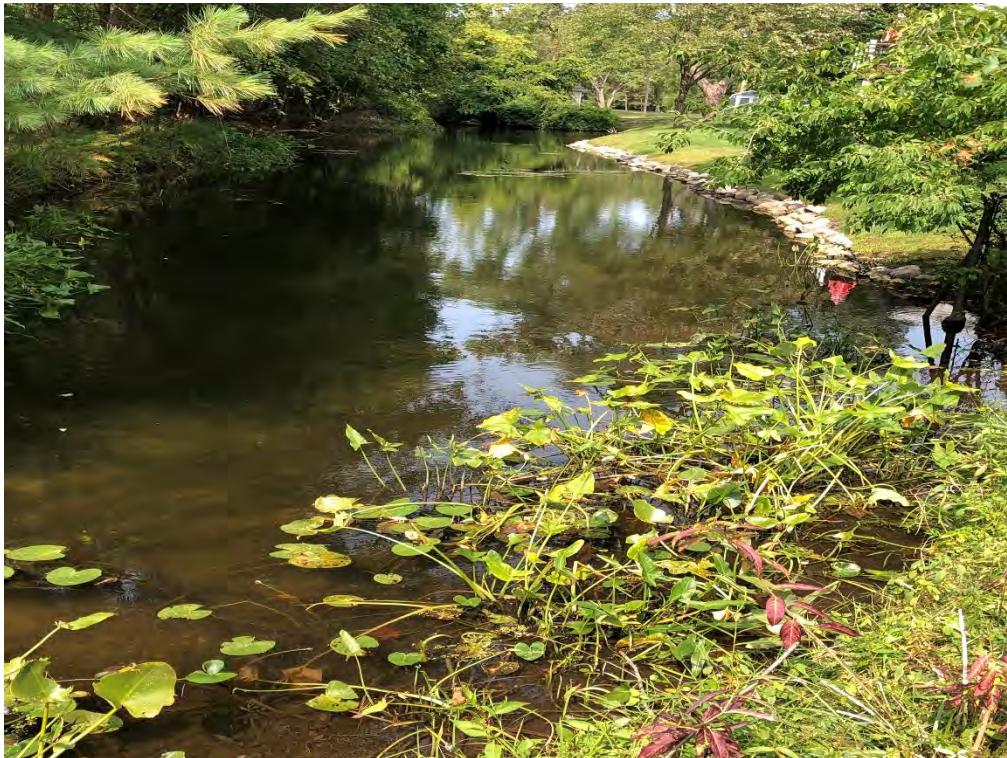
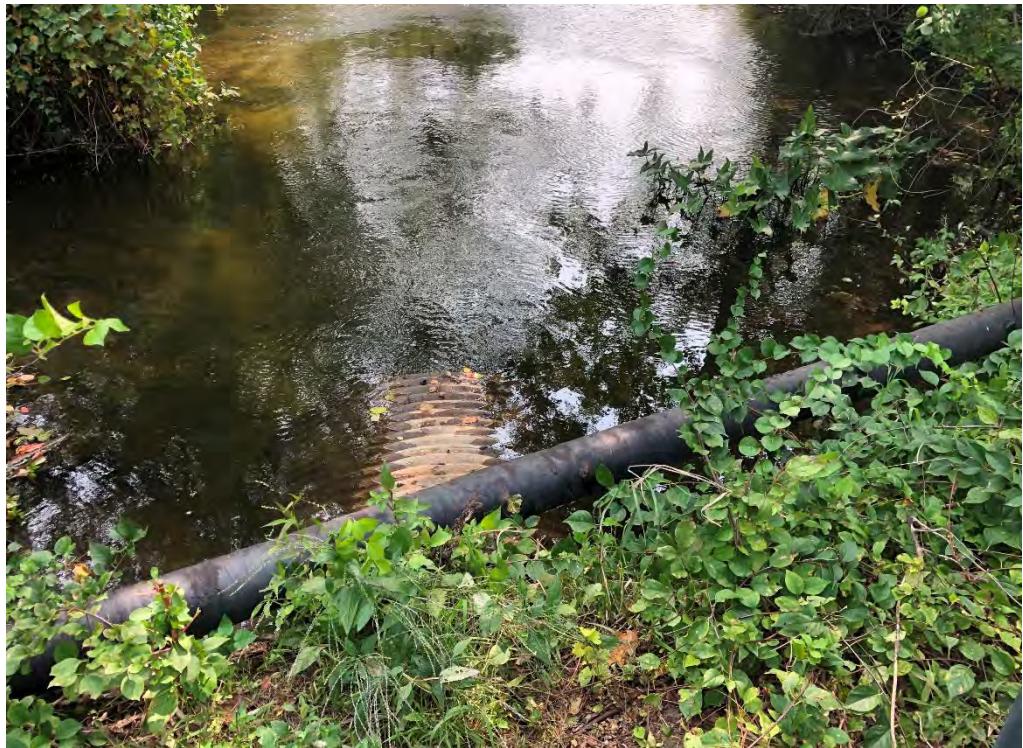
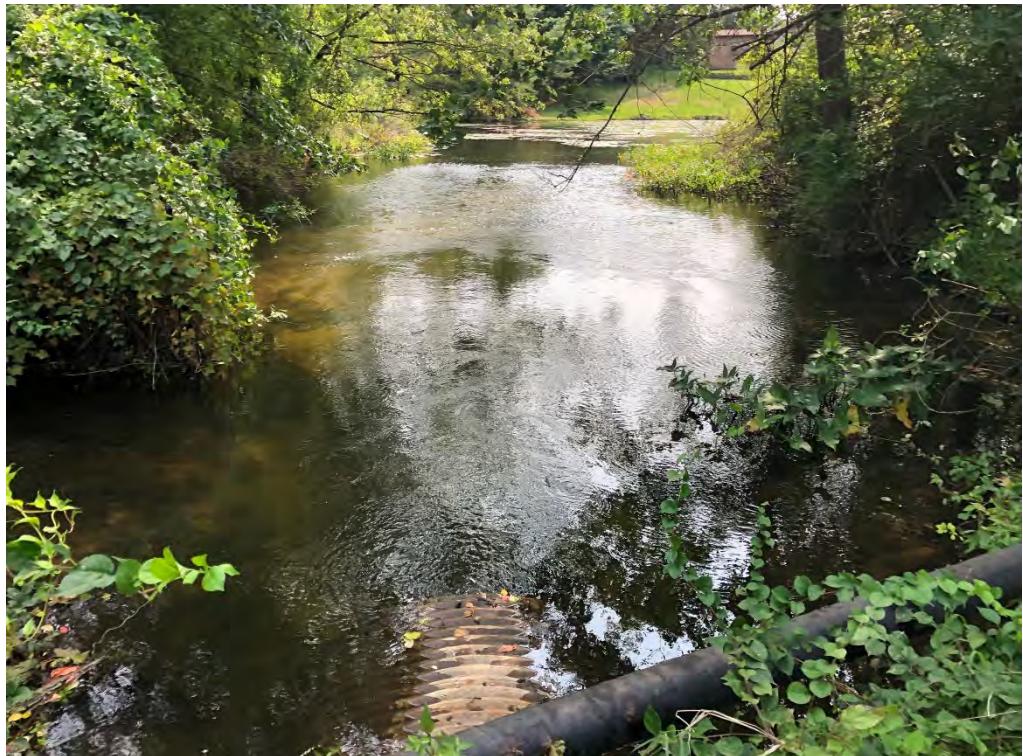
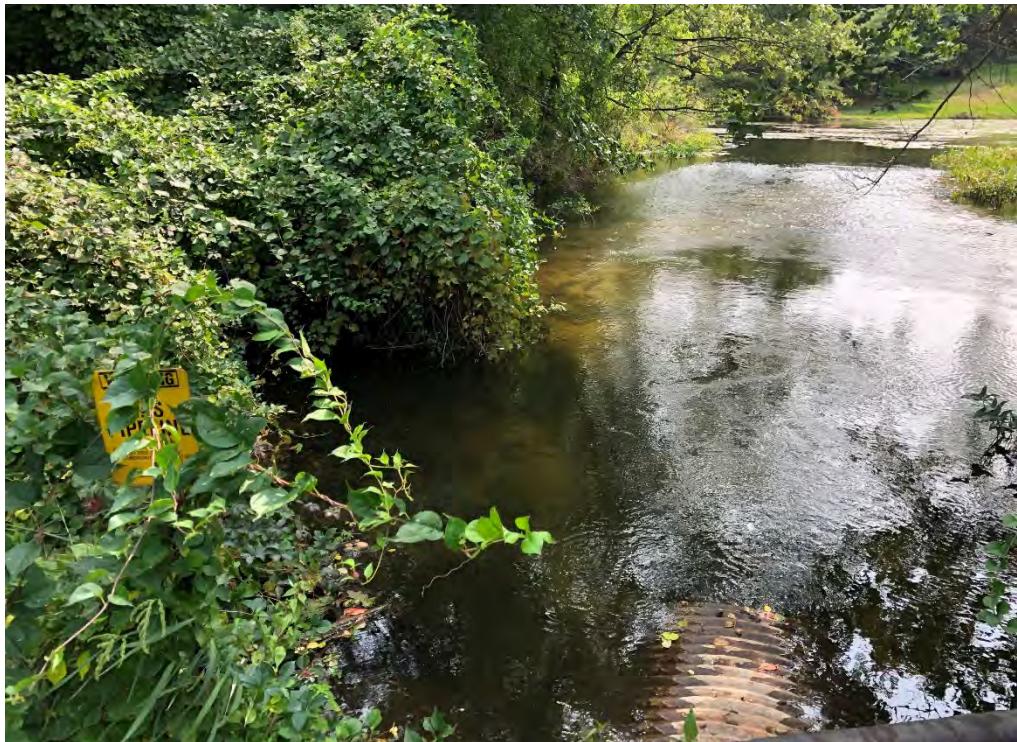
Photo 17. Angling Road Culvert: 9/15/2020

Photo 18. Angling Road Culvert: 9/15/2020

Photo 19. Angling Road Culvert: 9/15/2020

Photo 20. Angling Road Culvert: 9/15/2020

Photo 21. Angling Road Culvert: 9/15/2020
