Charter Township of Texas Flood Study

Eagle Lake Monitoring Results through October 4, 2022

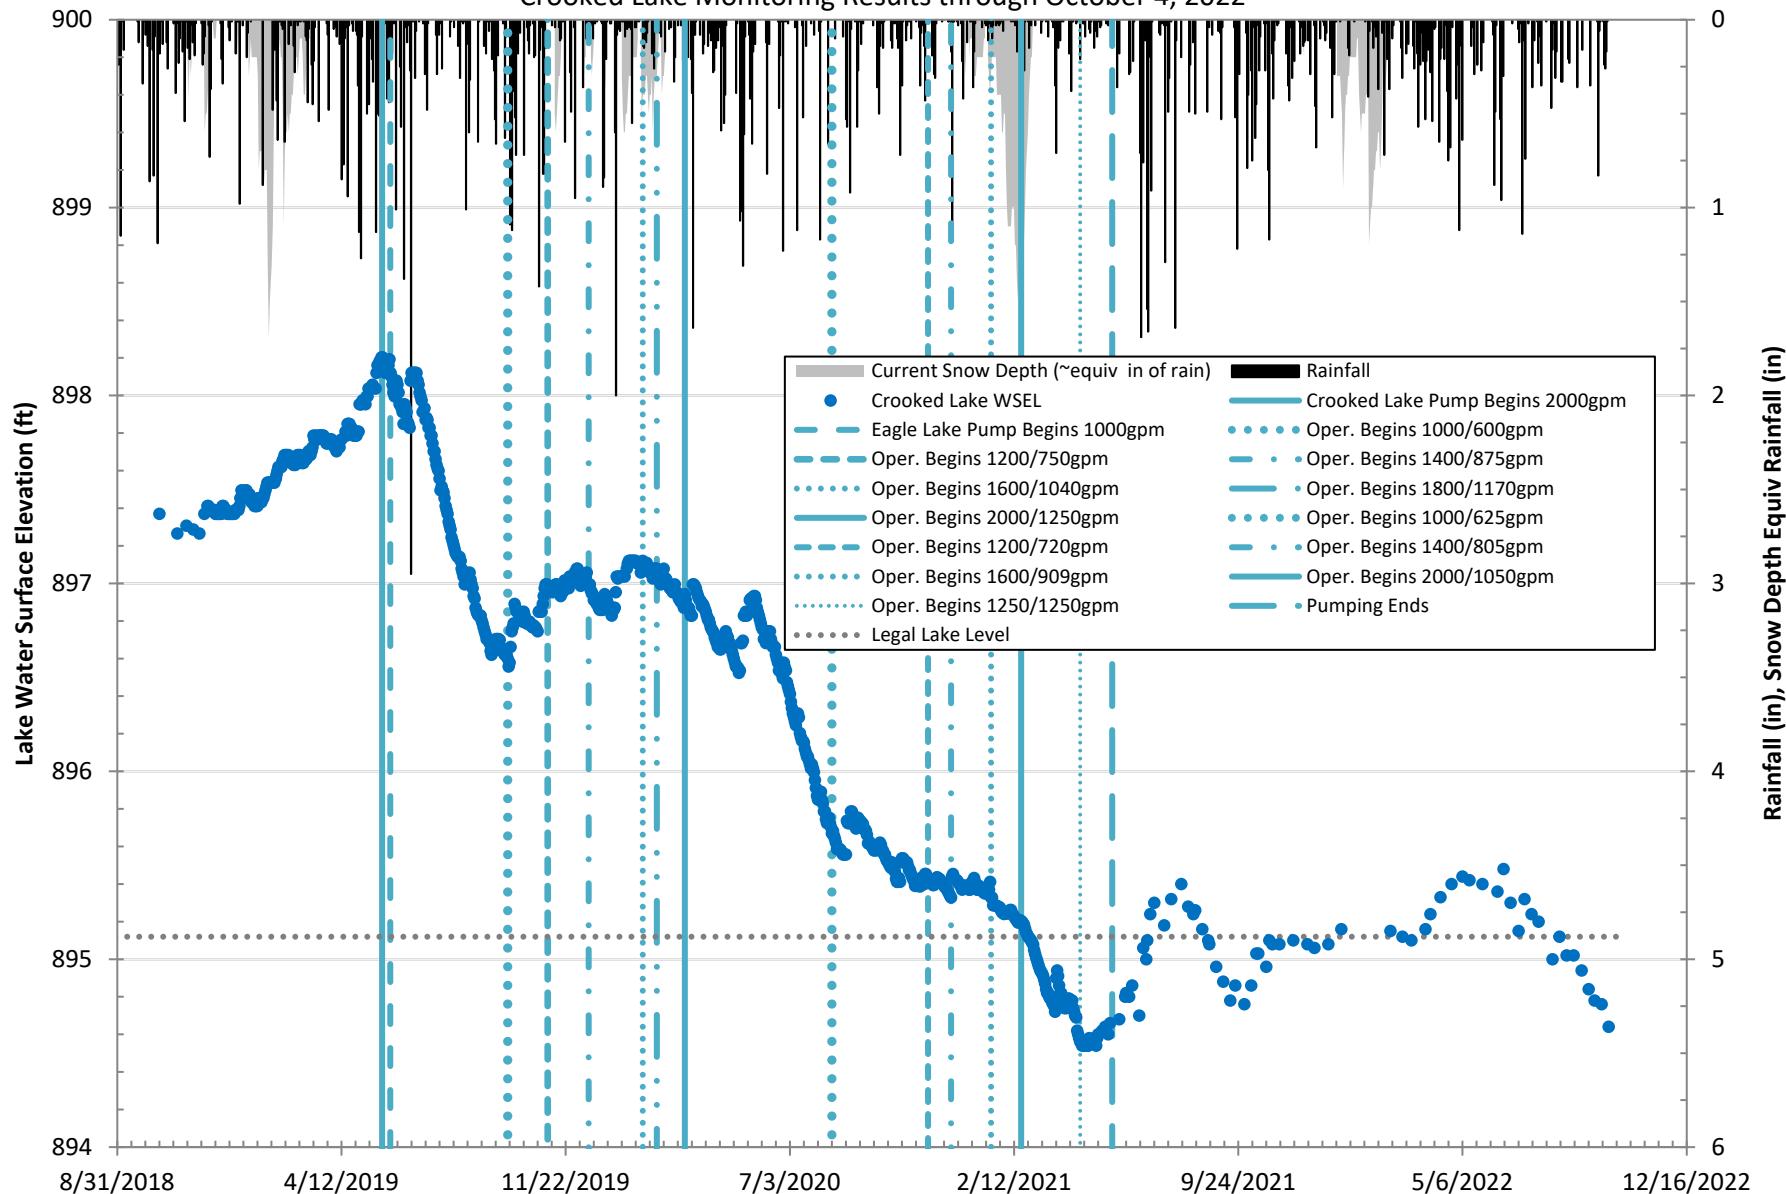
Crooked Lake Monitoring Results through October 4, 2022

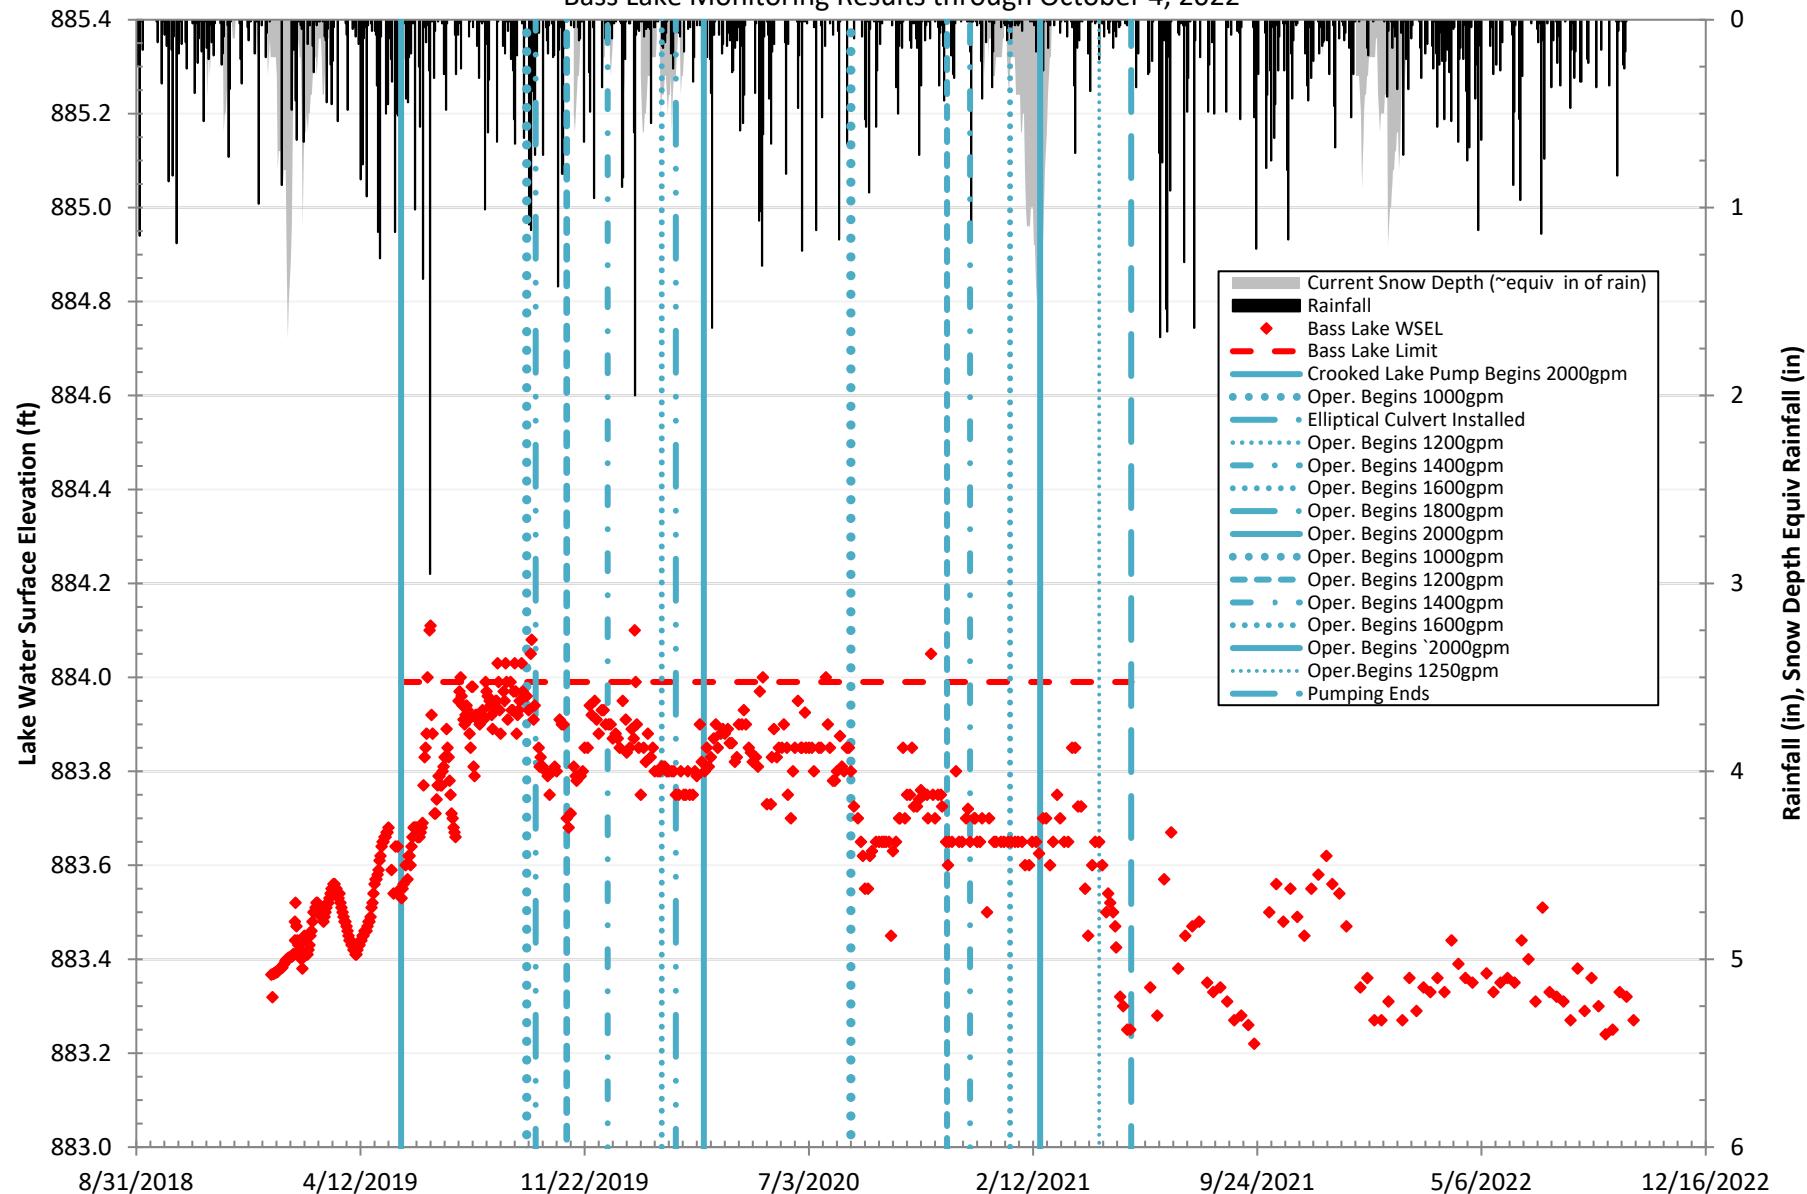
Bass Lake Monitoring Results through October 4, 2022

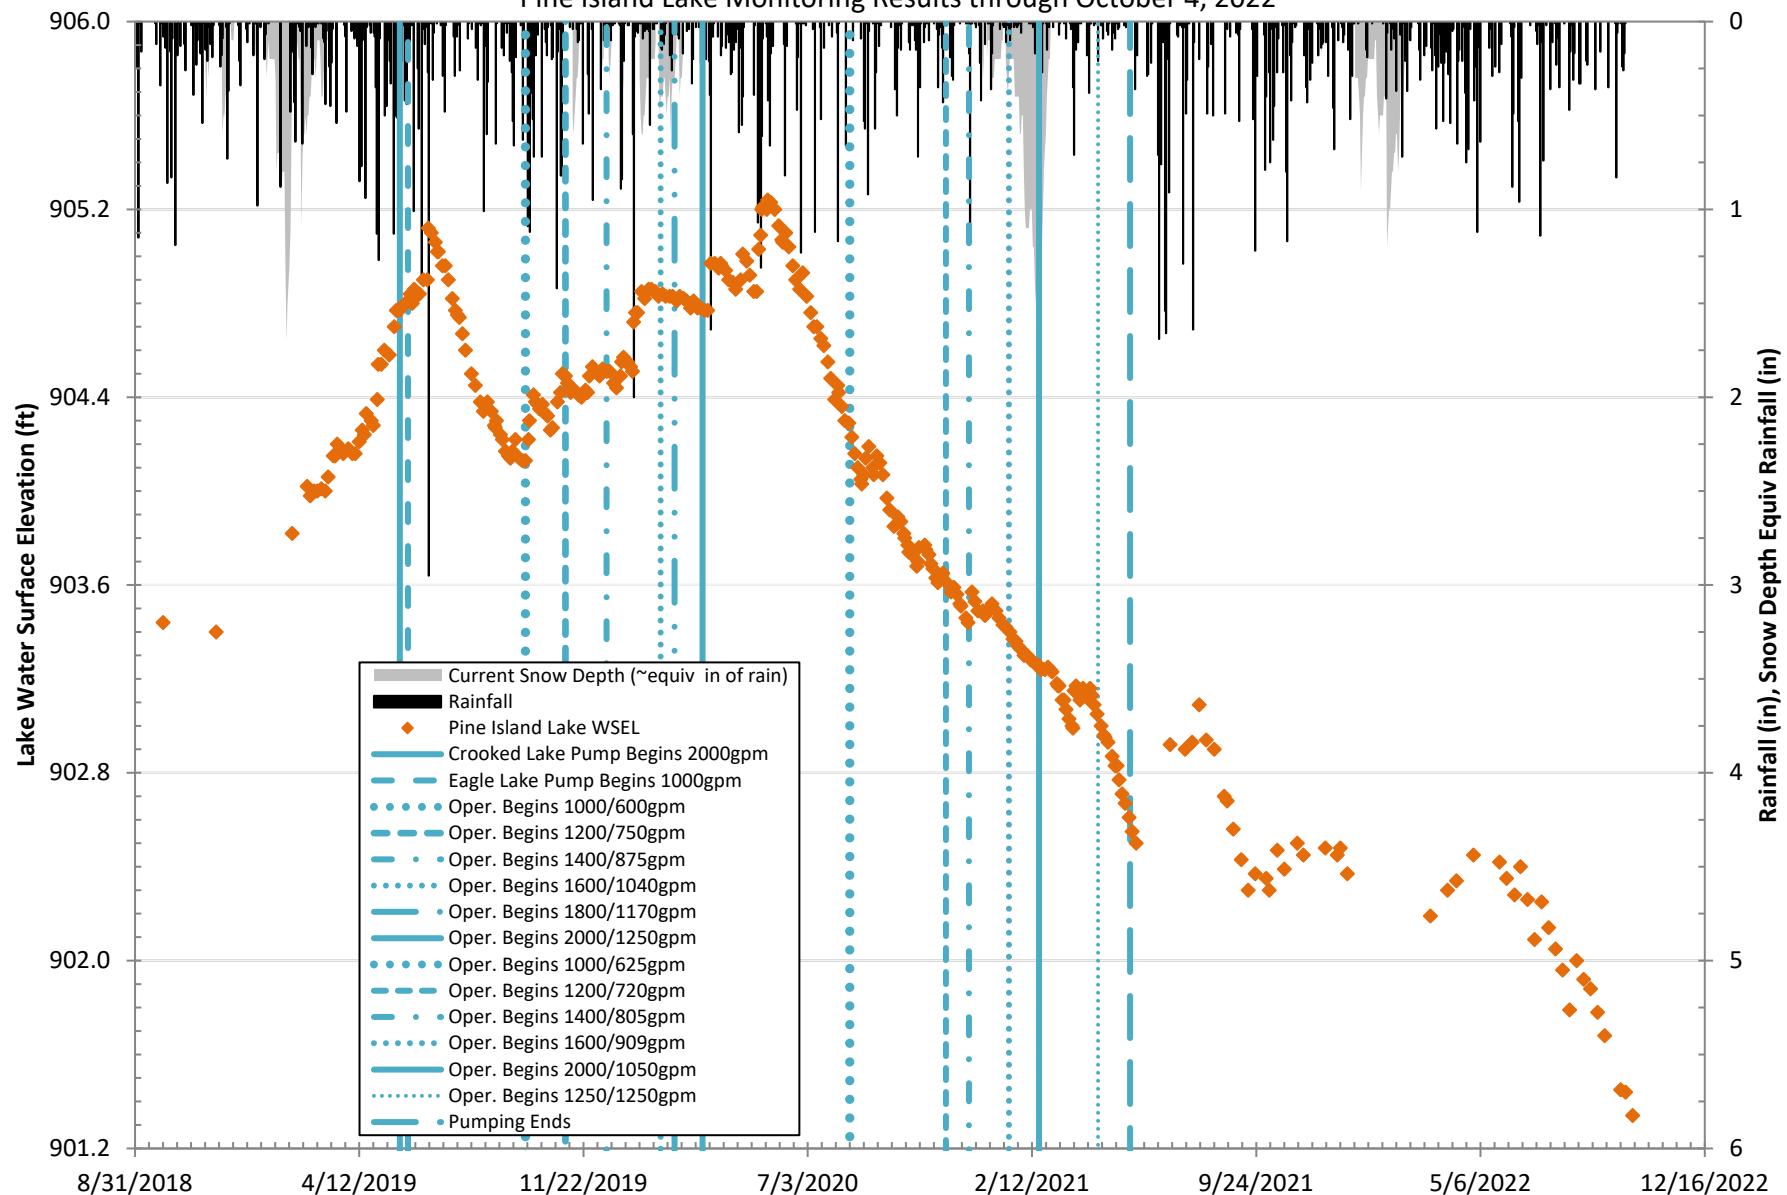
Pine Island Lake Monitoring Results through October 4, 2022

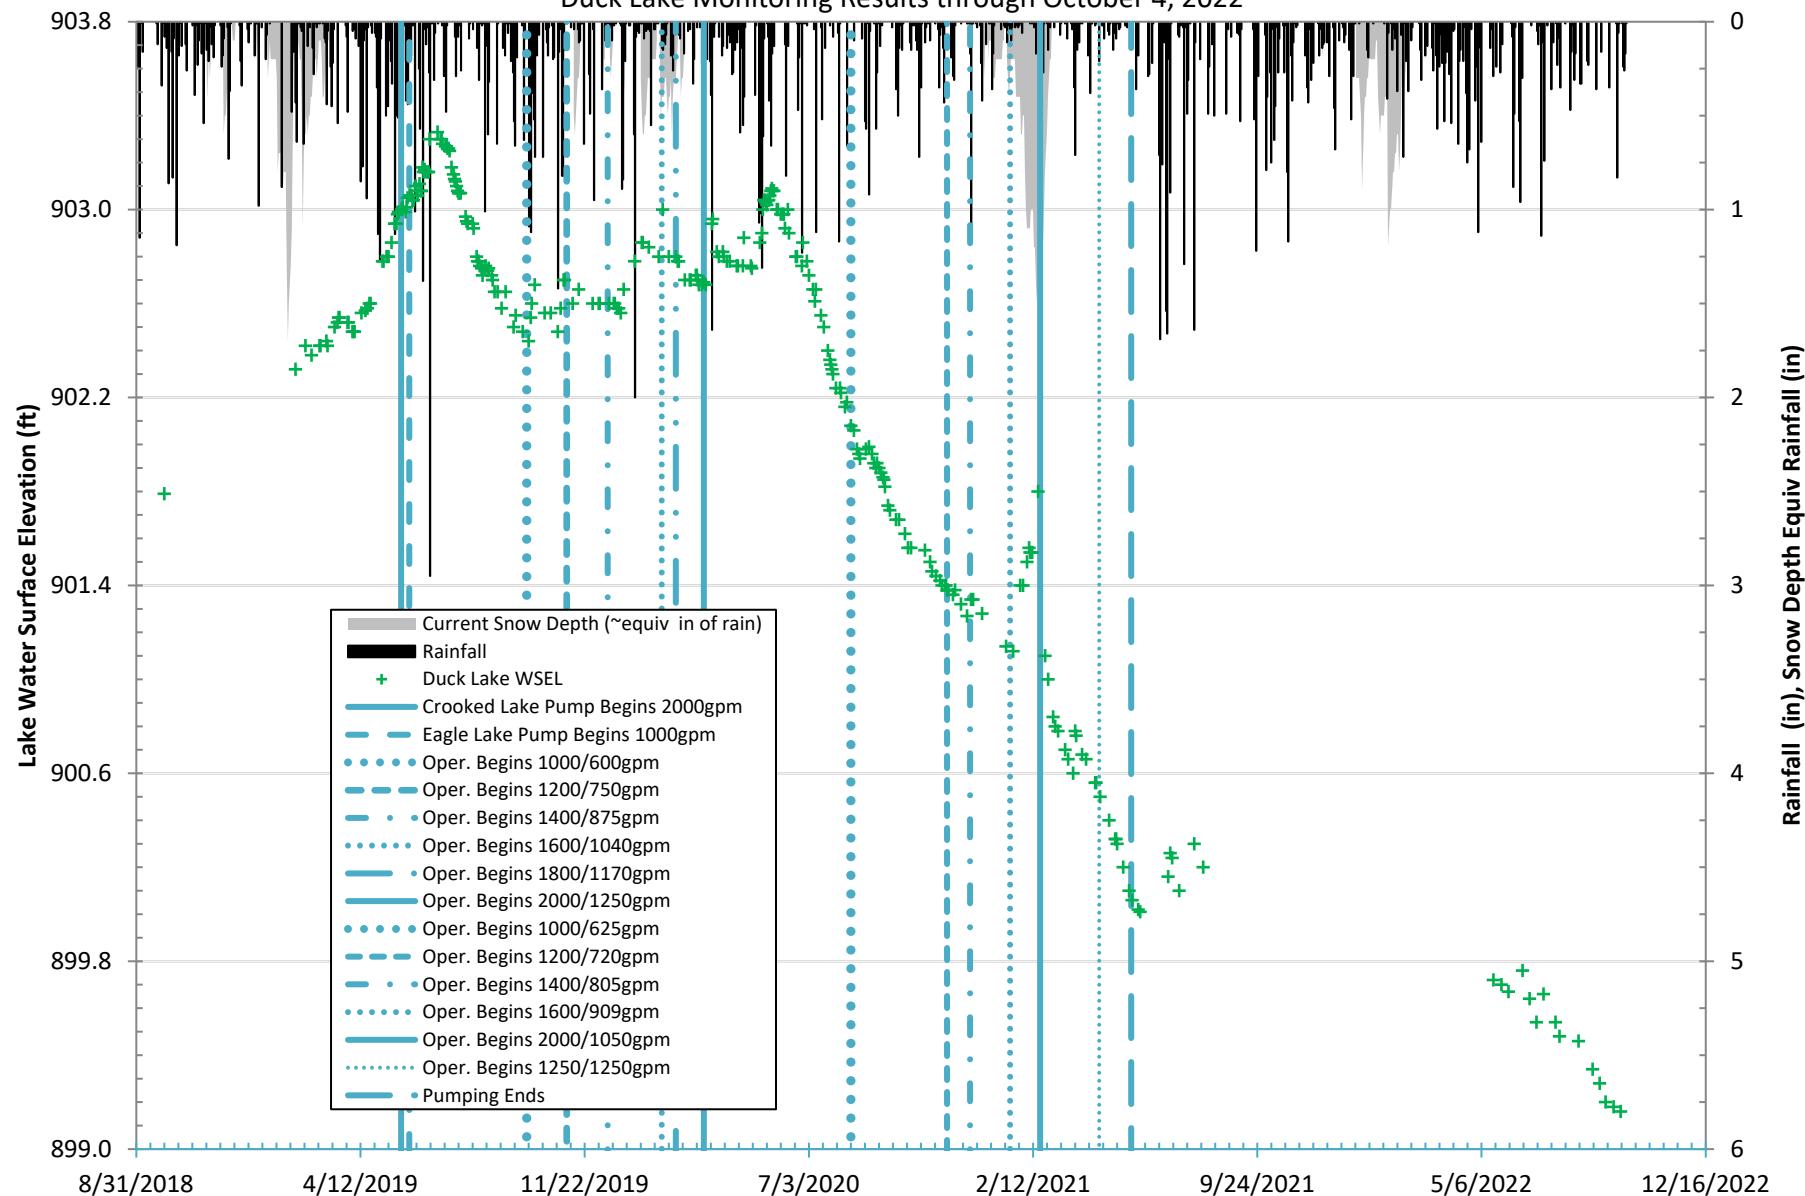
Duck Lake Monitoring Results through October 4, 2022

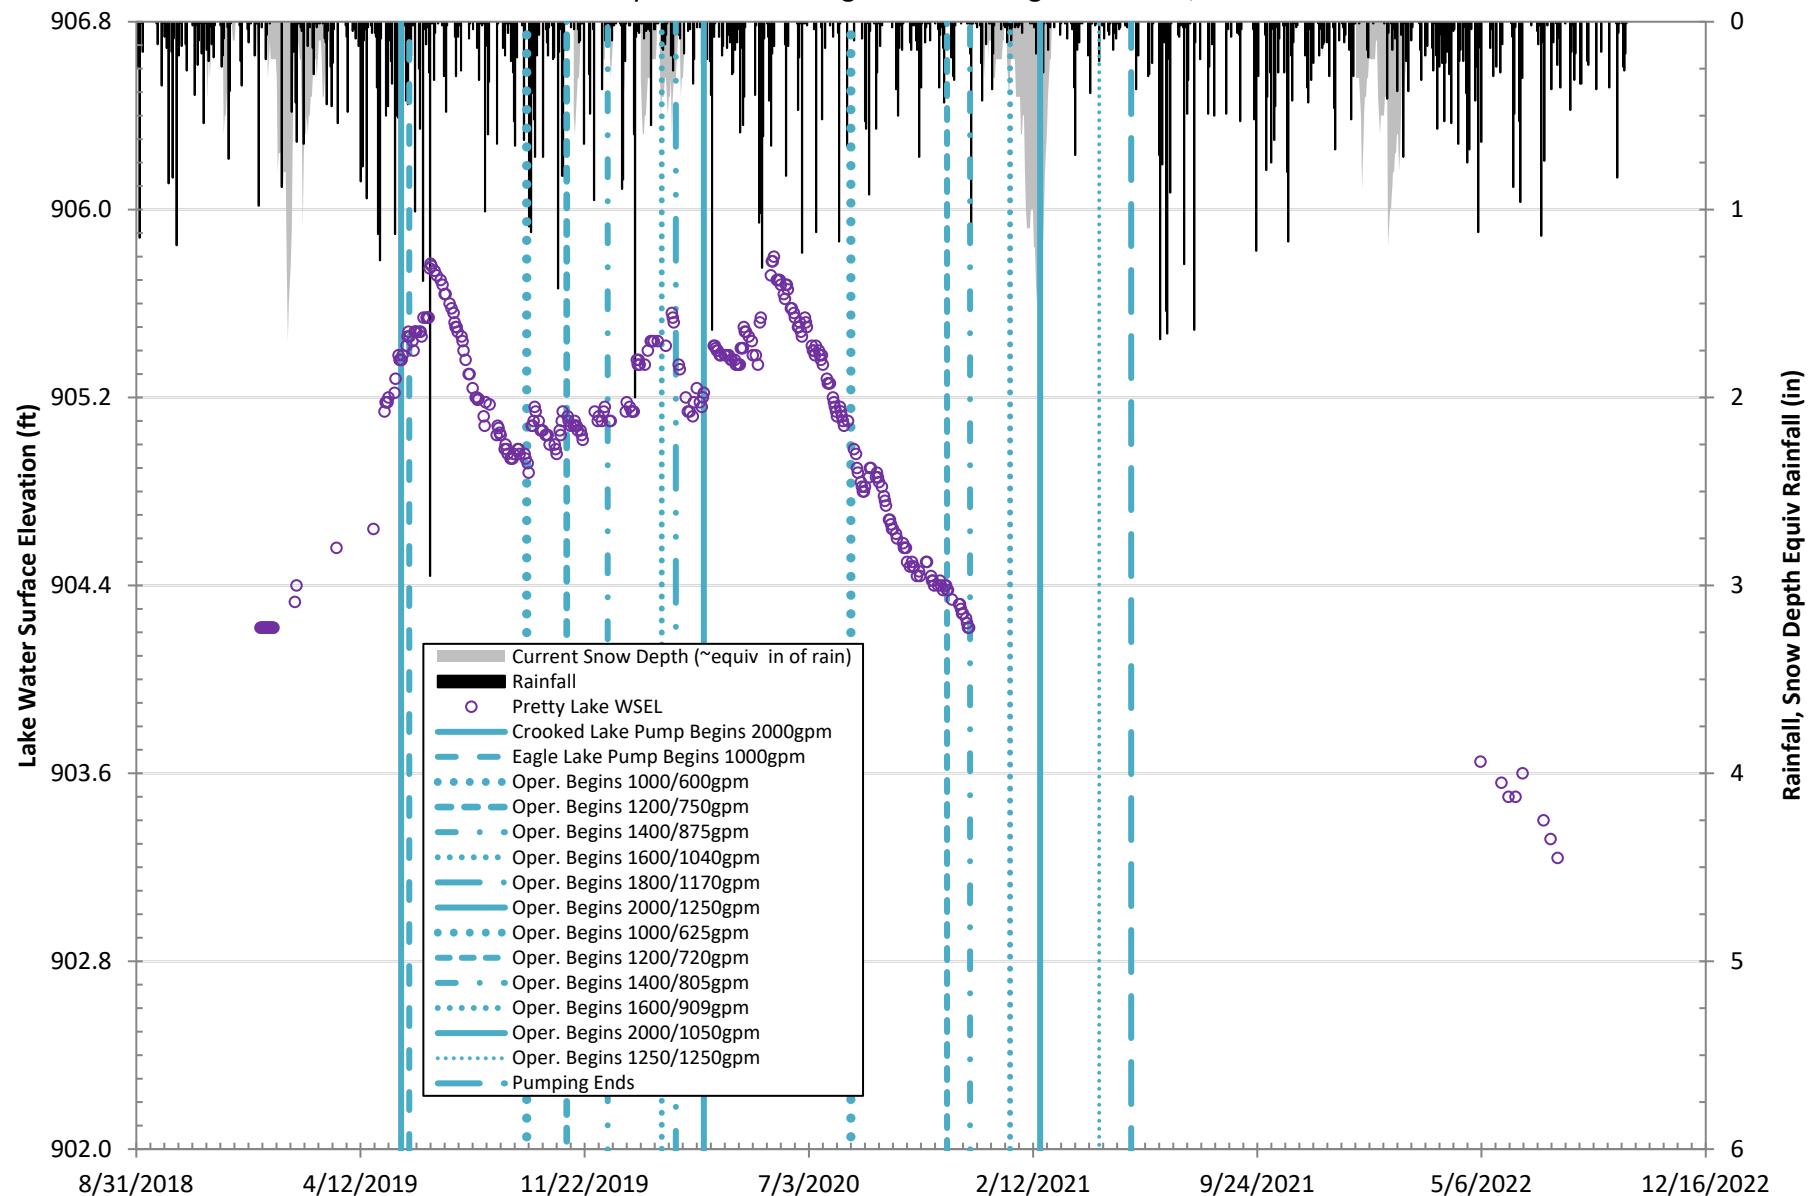
Pretty Lake Monitoring Results through October 4, 2022

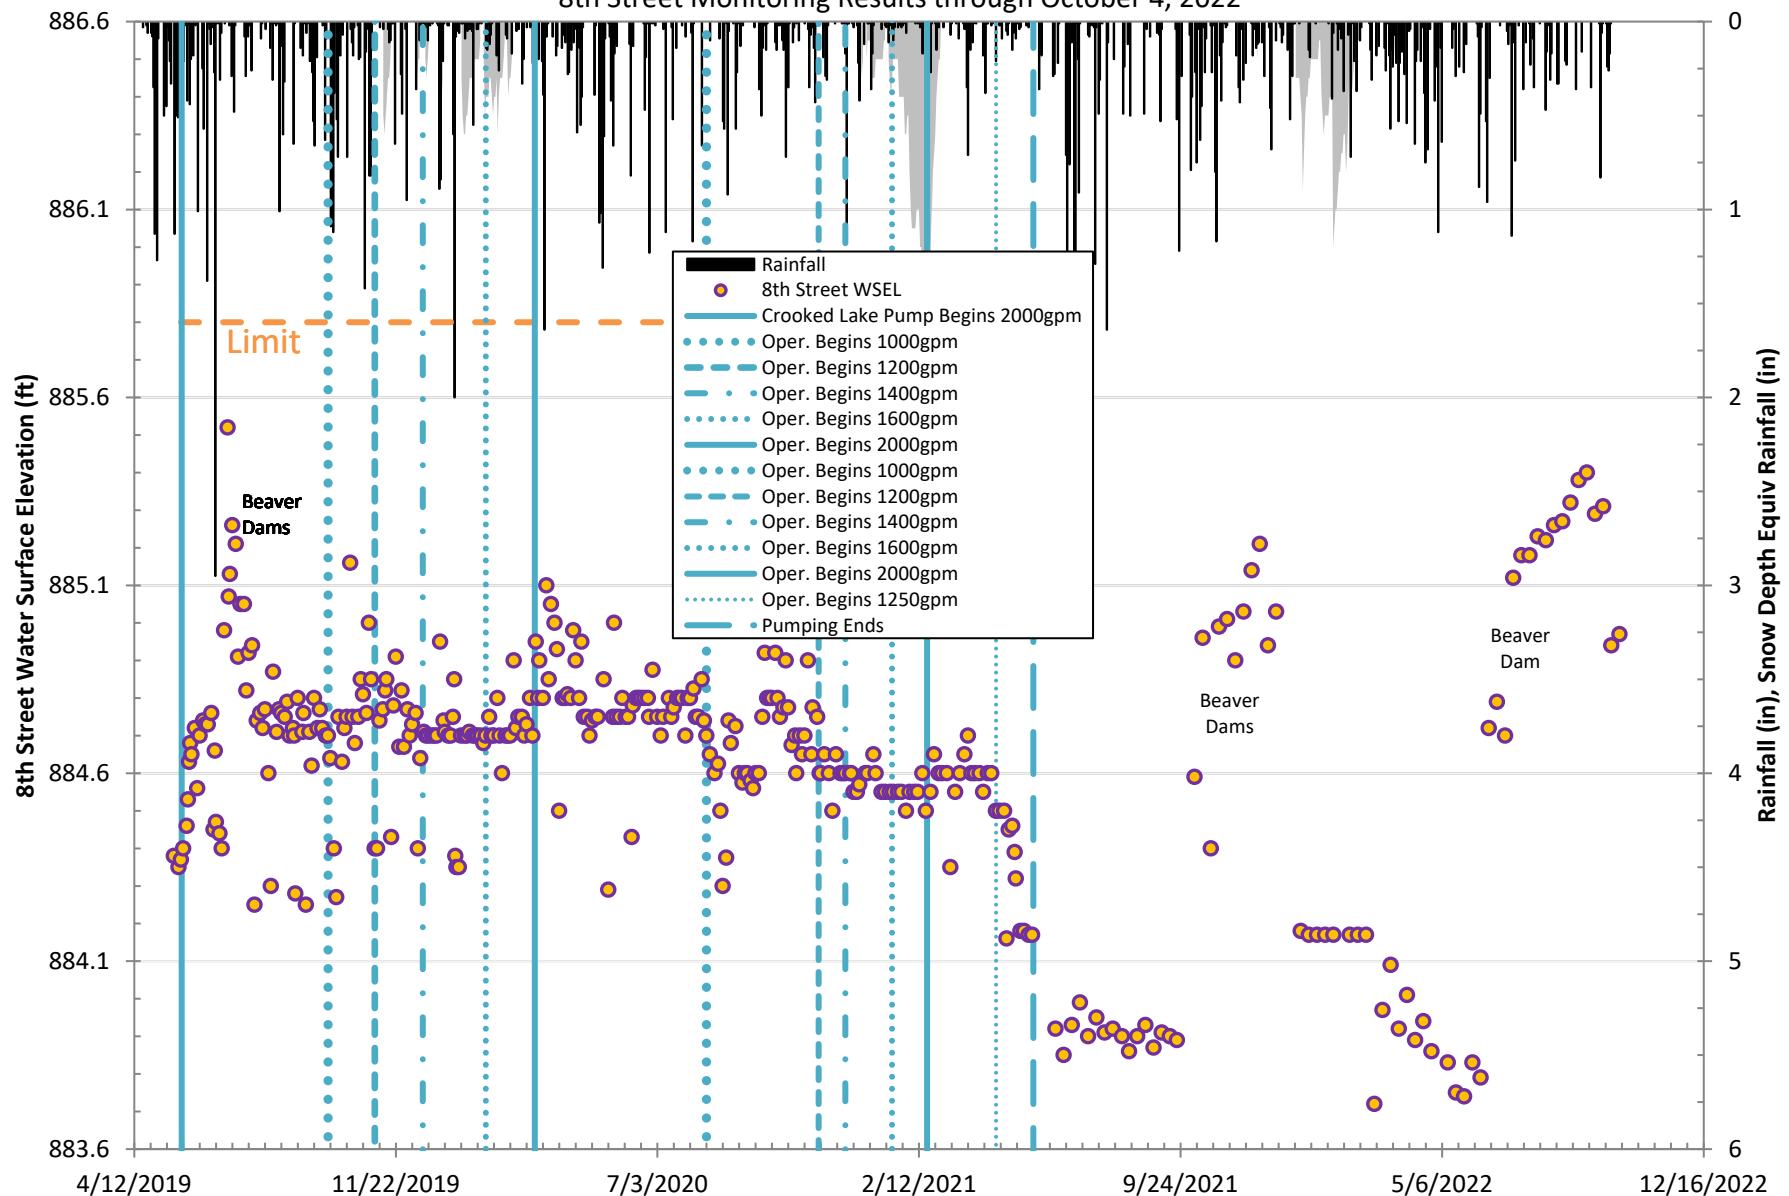
8th Street Monitoring Results through October 4, 2022

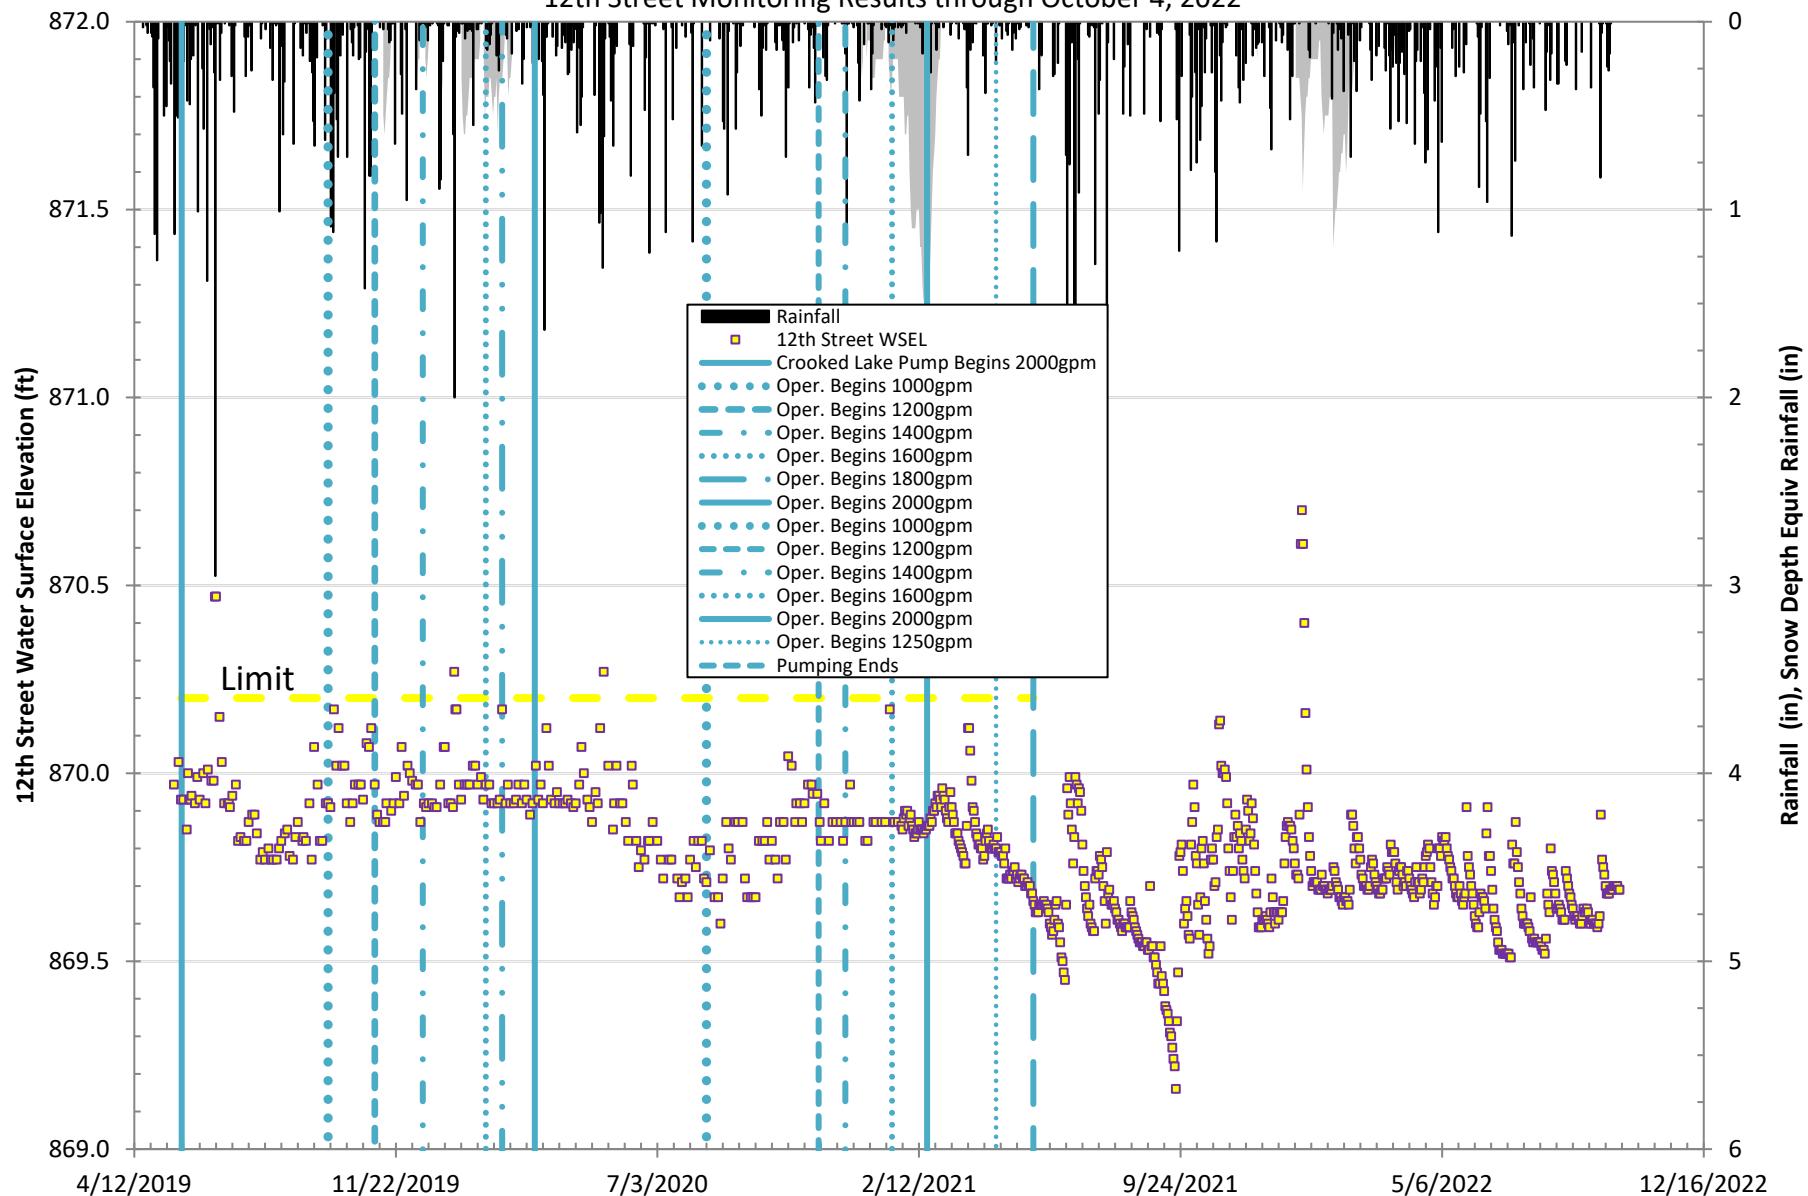
12th Street Monitoring Results through October 4, 2022

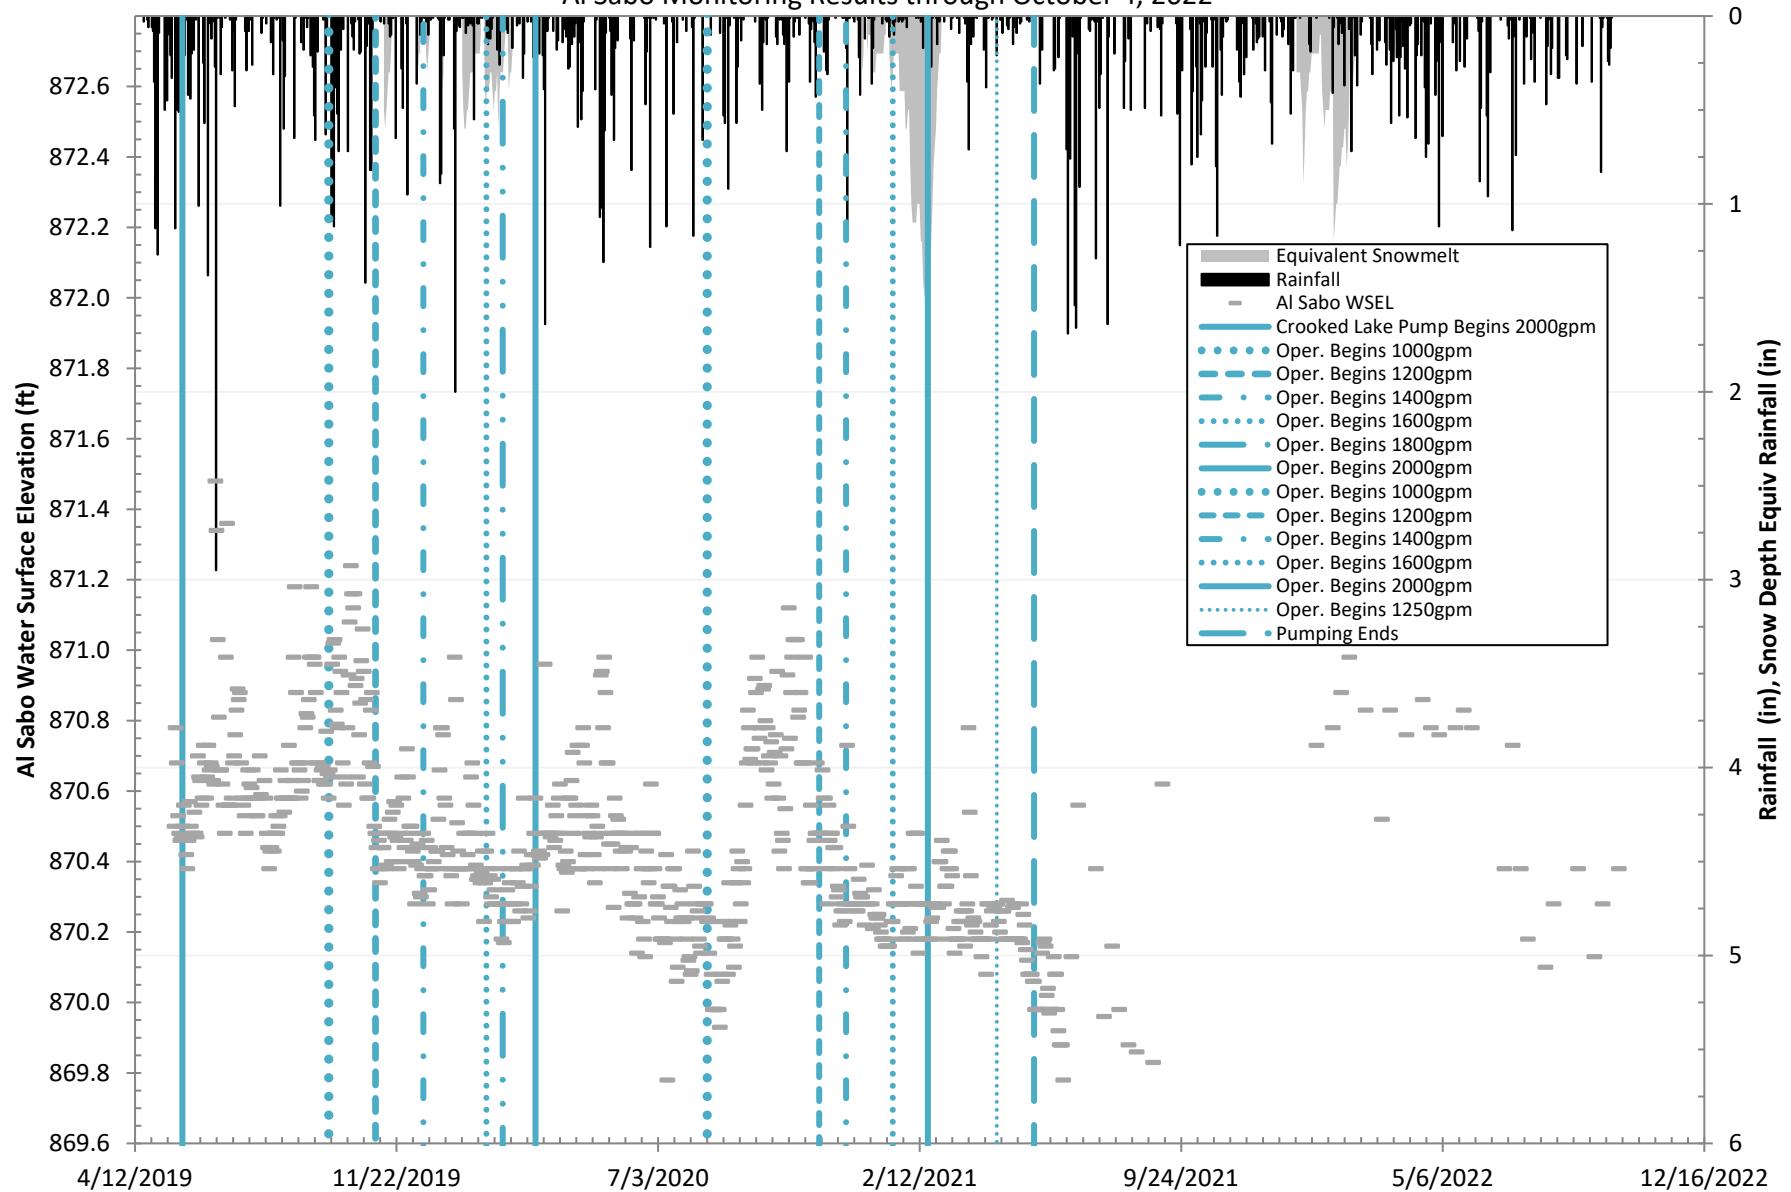
Al Sabo Monitoring Results through October 4, 2022

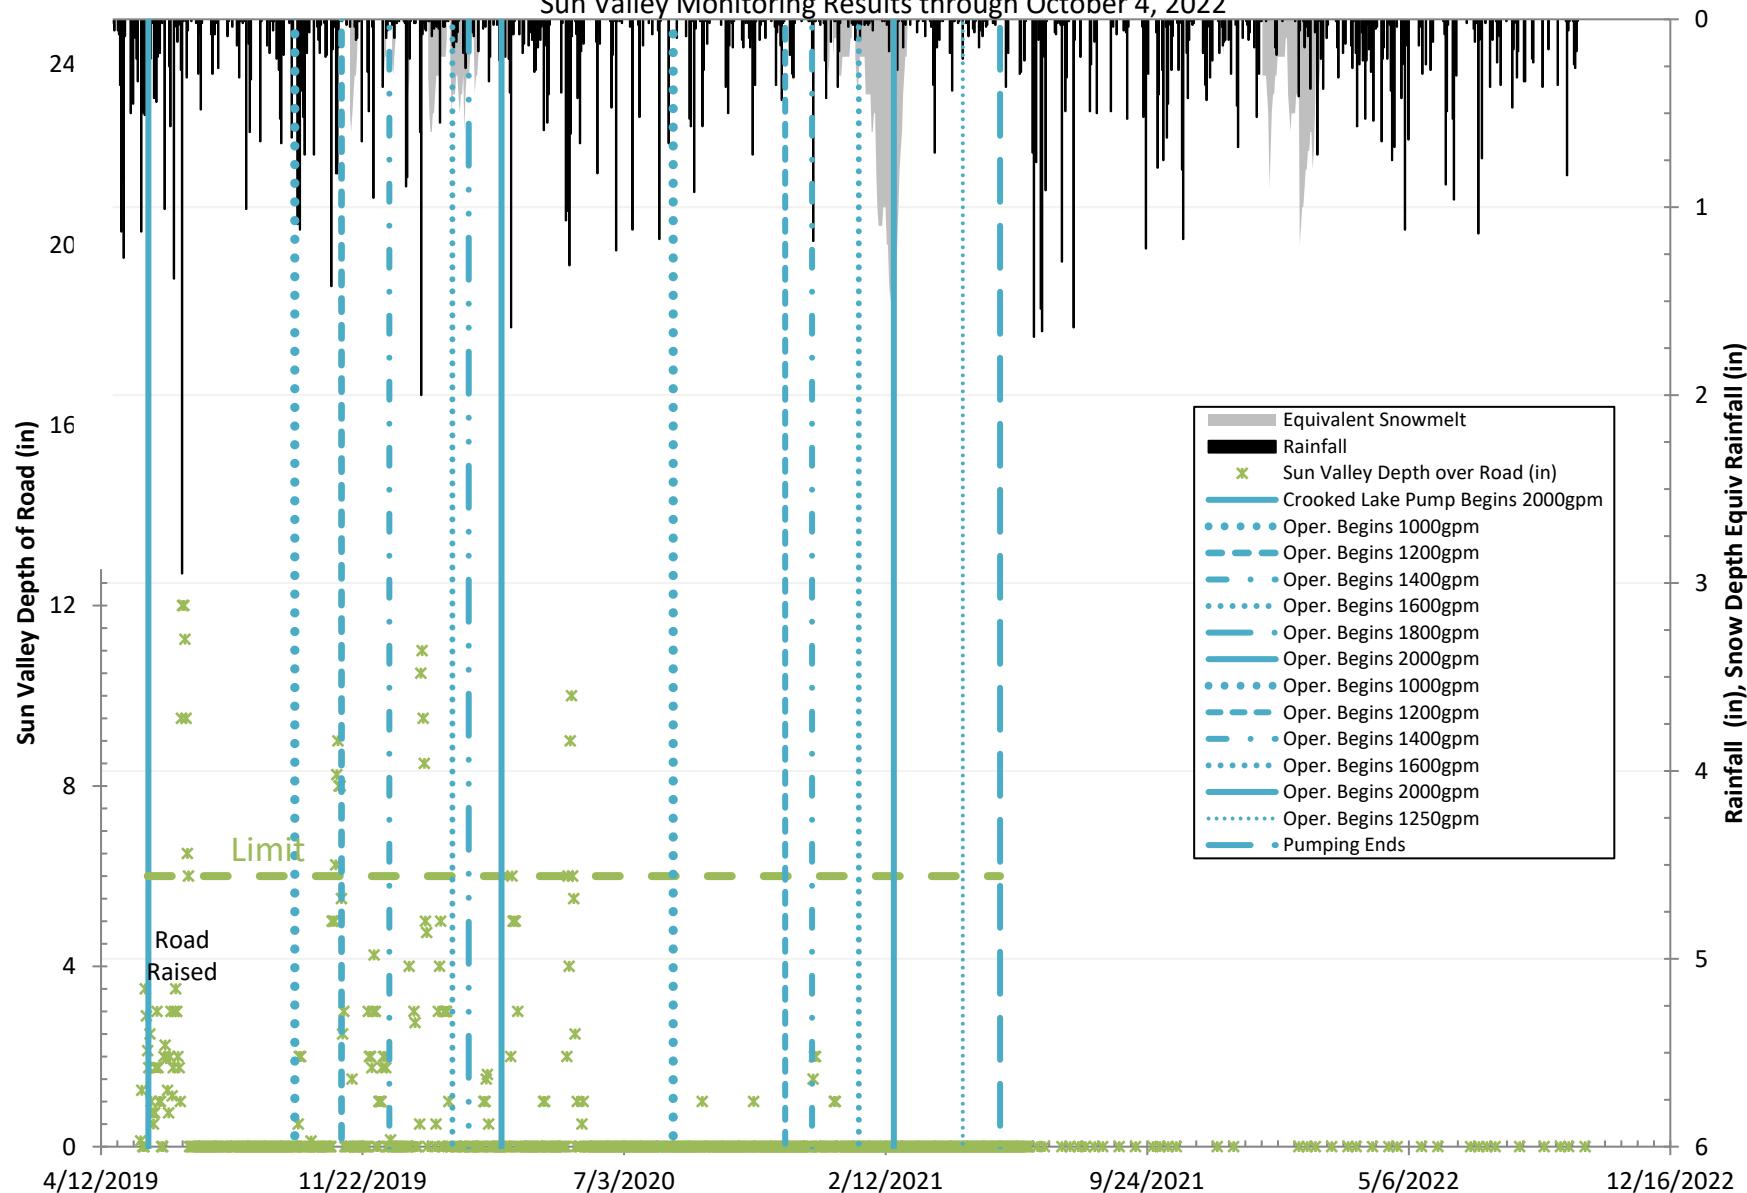
Sun Valley Monitoring Results through October 4, 2022

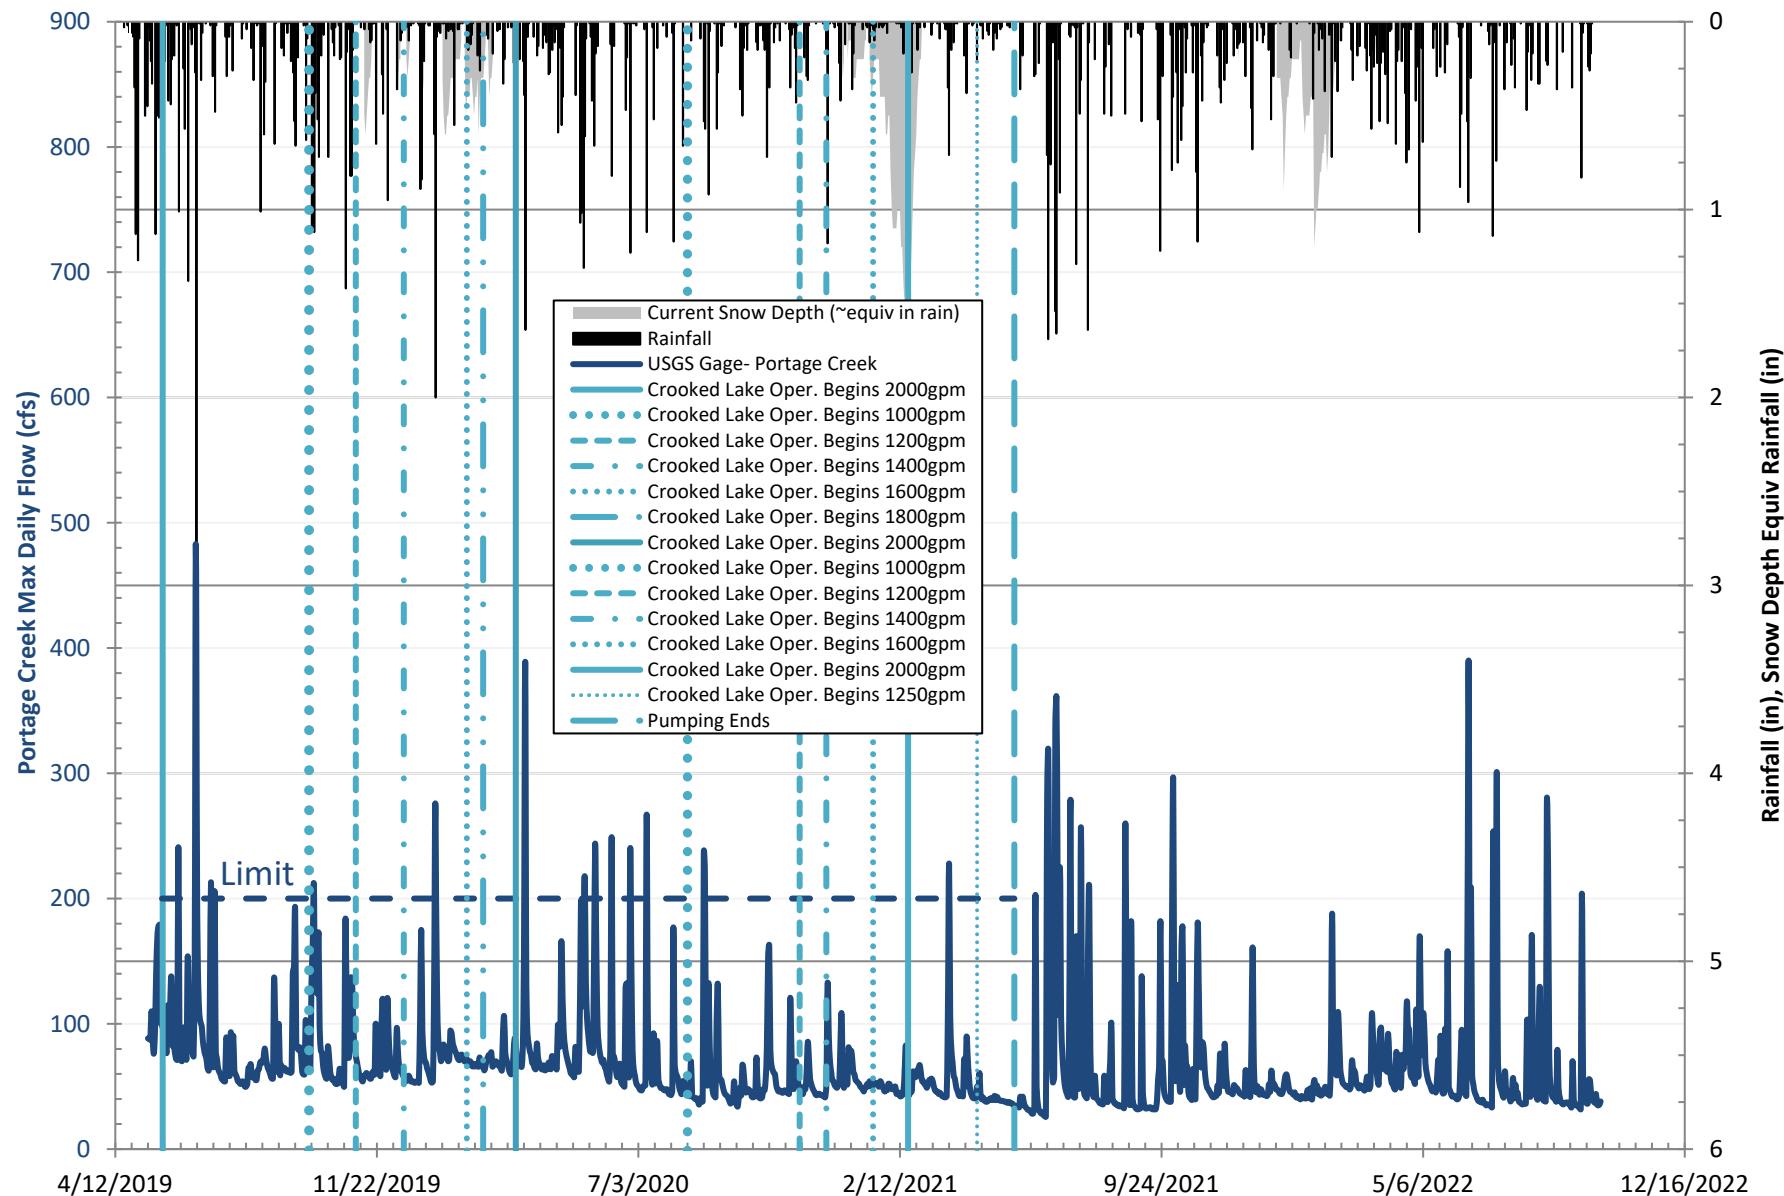
Charter Township of Texas Flood Study
 Figure
 USGS Portage Creek Monitoring Results through October 4, 2022
