Charter Township of Texas Flood Study

Eagle Lake Monitoring Results through October 4, 2022

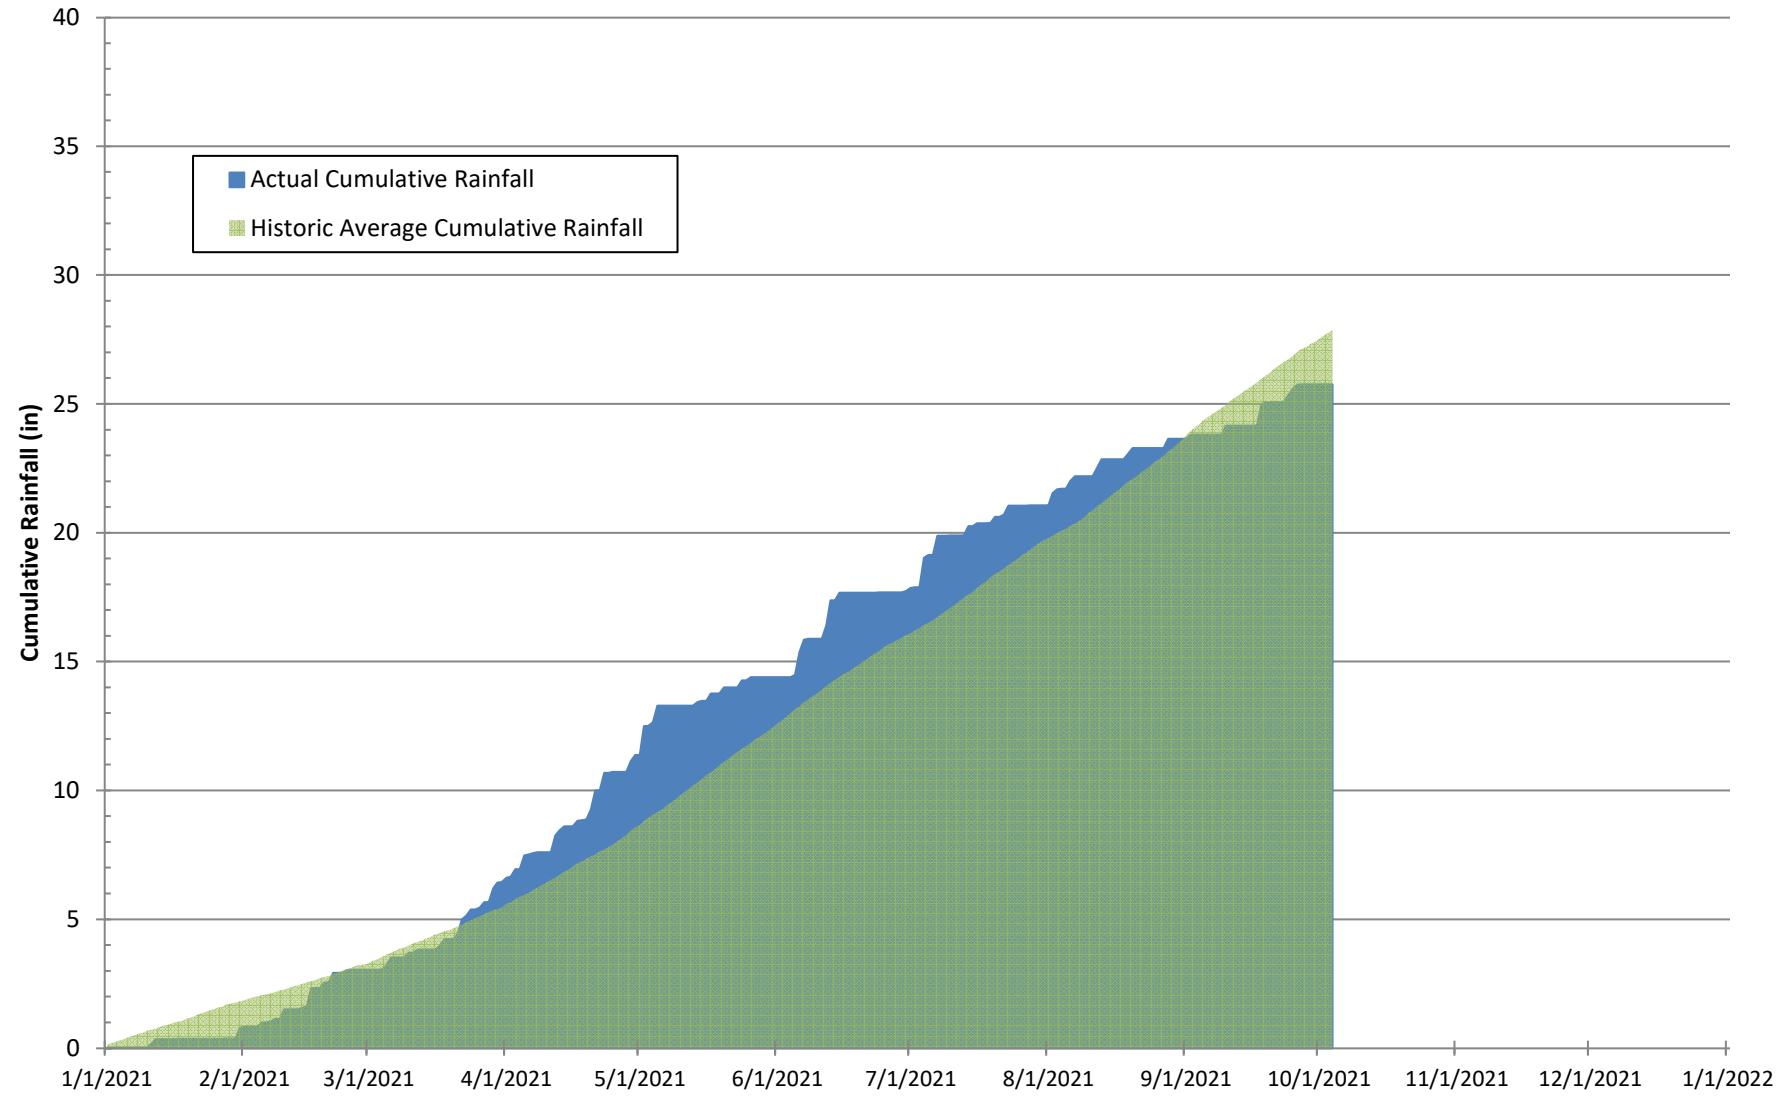
Average Rainfall vs Actual Rainfall - January 1, 2022 through October 4, 2022

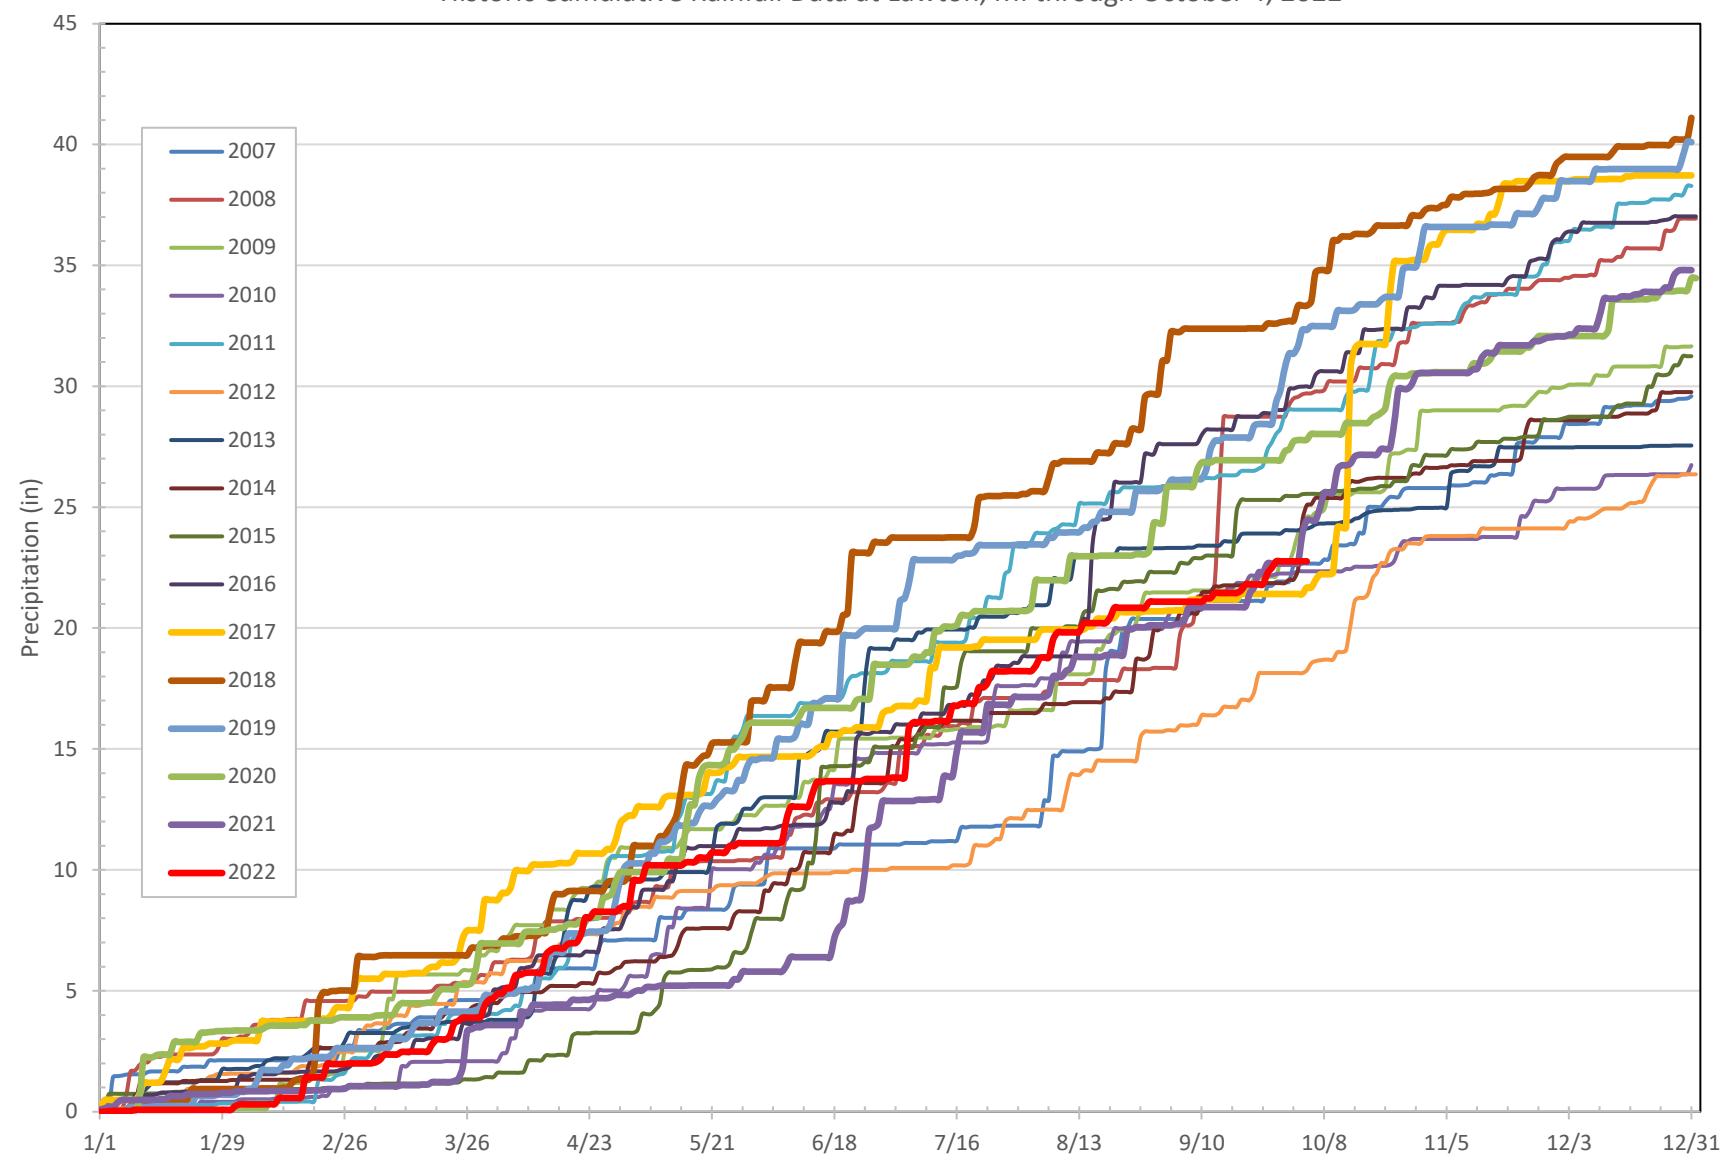
Charter Township of Texas Flood Study
Figure
Historic Cumulative Rainfall Data at Lawton, MI through October 4, 2022

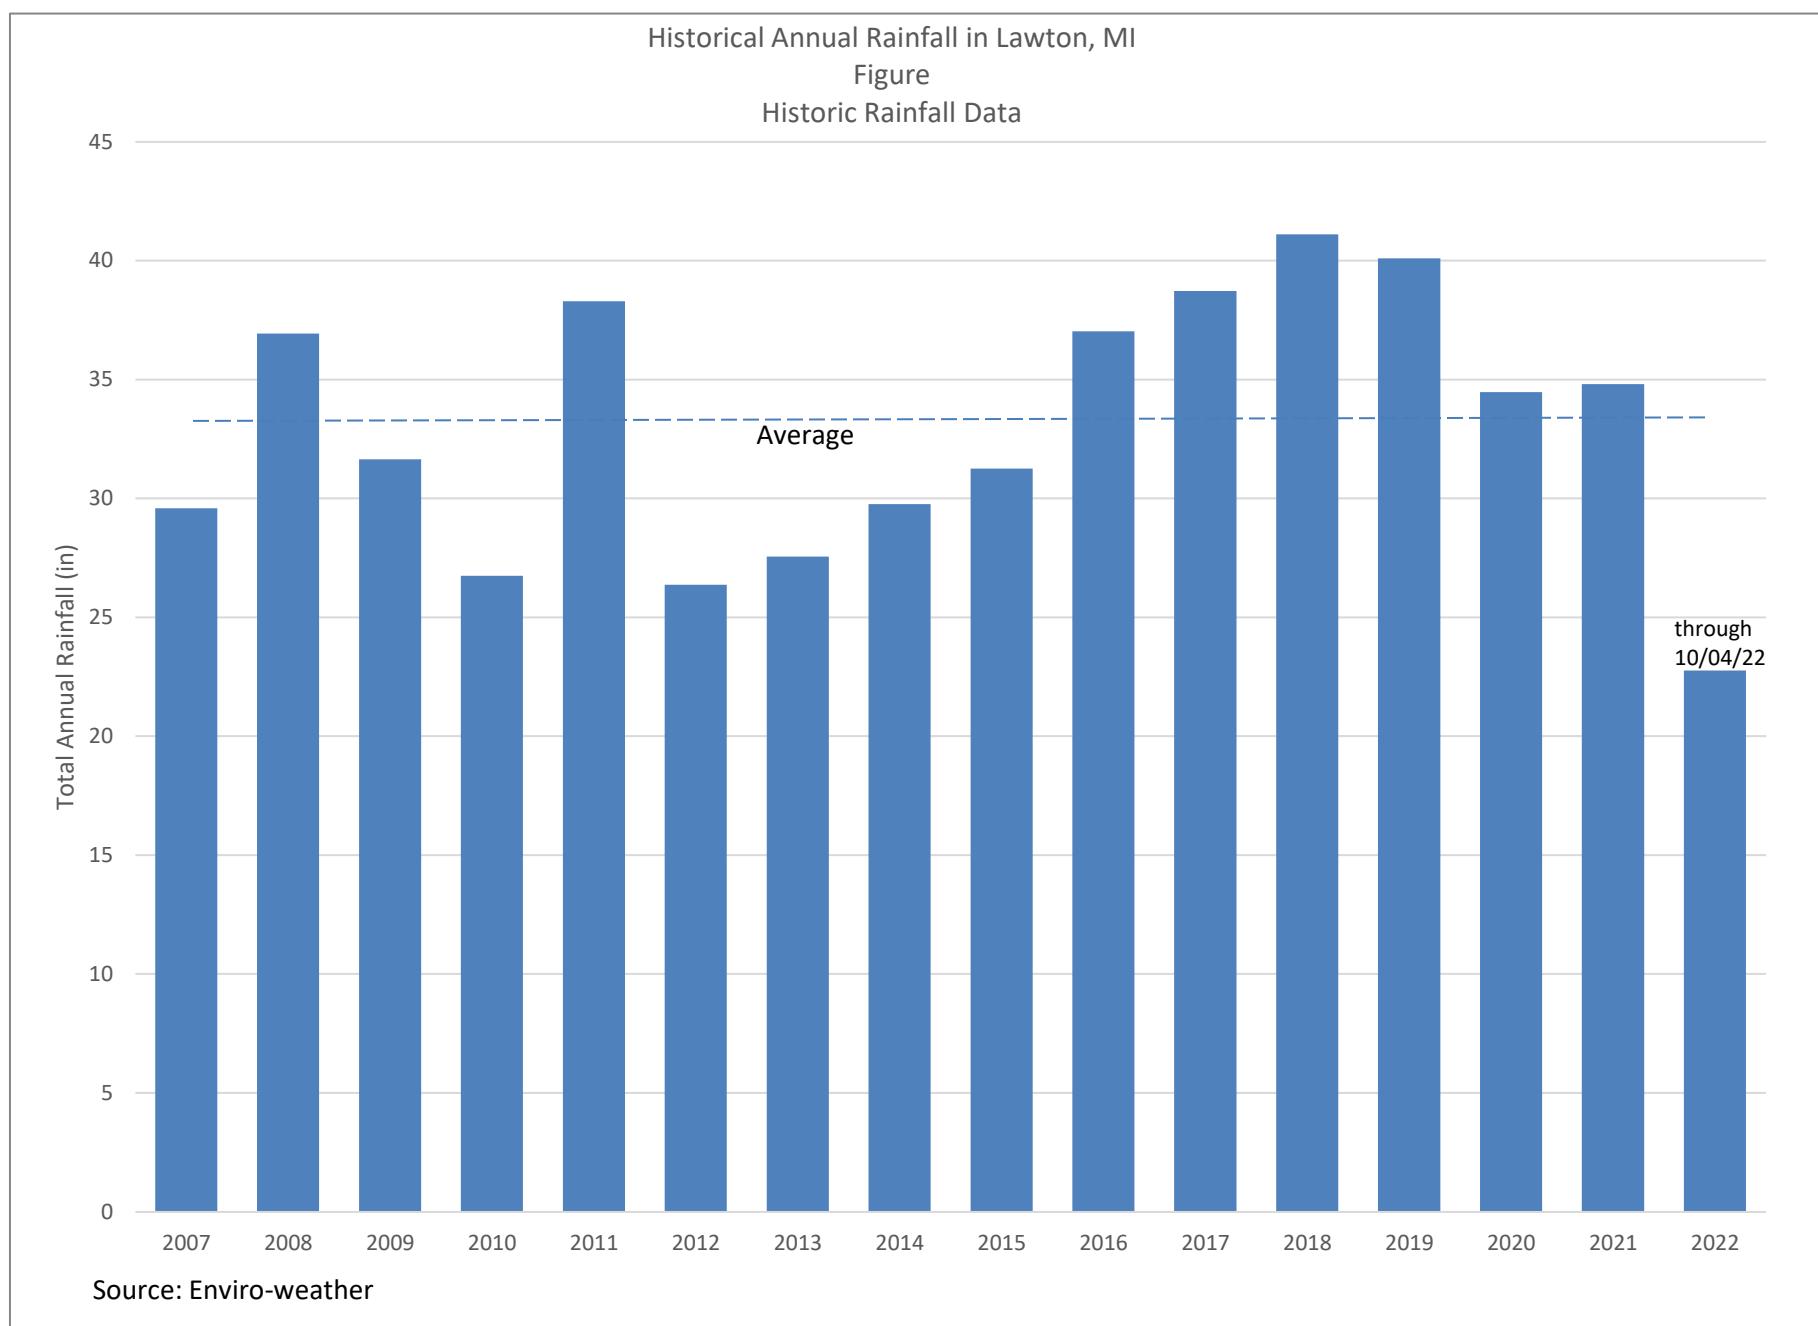
Historical Annual Rainfall in Lawton, MI
Figure
Historic Rainfall Data
