WIGHTMAN & ASSOCIATES, INC.

RE: Charter Township of Texas Assessment of Township Hall/Fire Station

A. Current Facility Conditions and Deficiencies

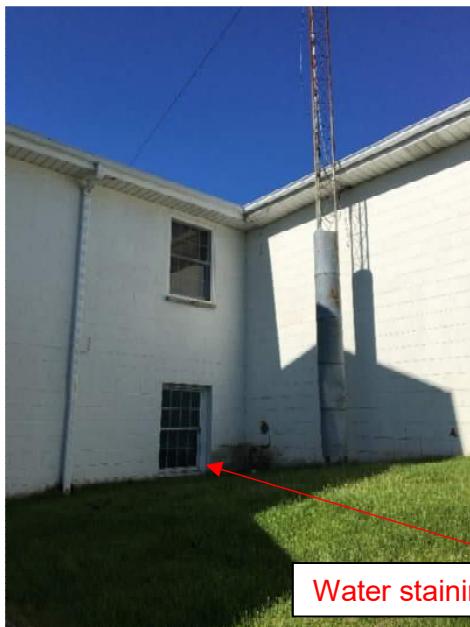
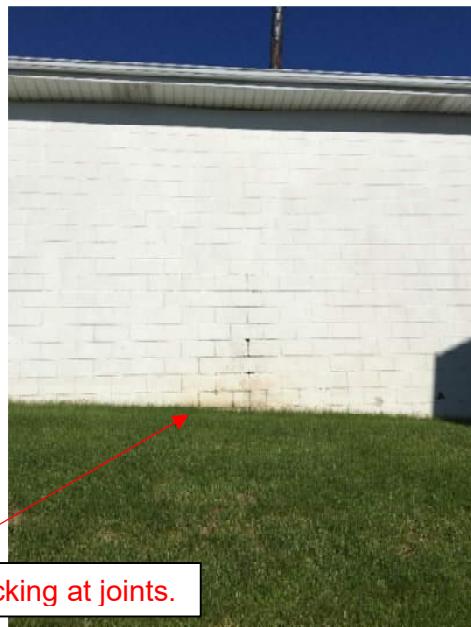
Image 1

- The base of the masonry wall outside the training room and apparatus bay shows signs of water damage. Reworking the downspouts and gutter system along this roof area and investigation along the grade line is recommended to repair and correct issues. **(Images 1 and 2)**

Water staining and cracking at joints.

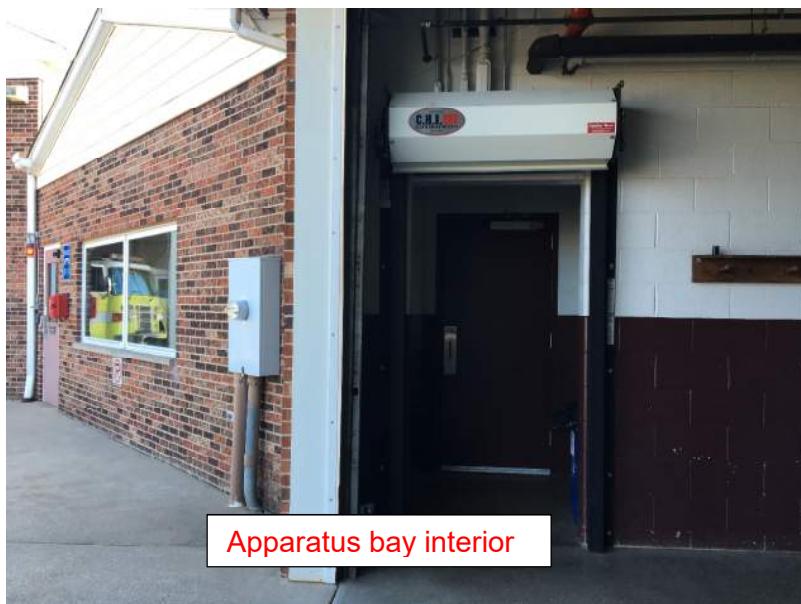
Image 3

- The apparatus bays are built of CMU with brick veneer and the roof structure is wood truss framing with asphalt shingles. (**Image 3**).
- The main construction of the existing building is wood frame construction with brick veneer and vinyl siding.

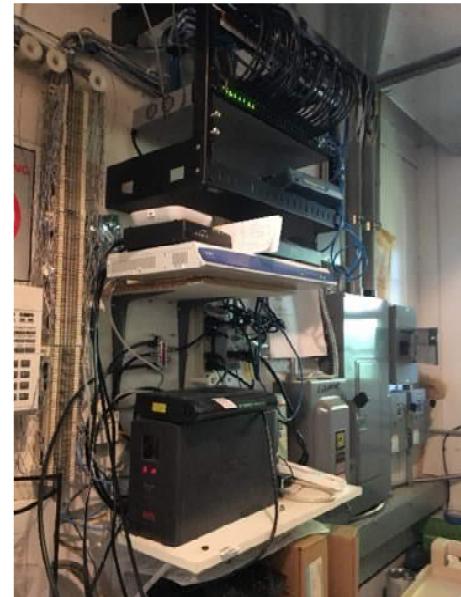
Image 4

- Server and computer systems support equipment should be housed in room(s) separate from mechanical and janitor equipment. Mechanical Room in the Township Hall staff corridor contains server equipment, electrical panels, mechanical system equipment and cleaning/janitorial supplies. **(Image 4)** This main staff corridor also provides access to the main office server which is in a storage closet. The door has been removed to provide improved air circulation. **(Image 5)**

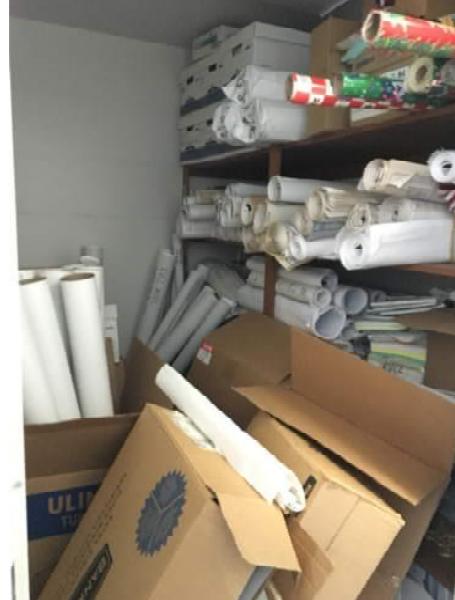
Image 6

- Drawing storage is maximized in a closet outside the Building Department area (**Image 6**) and overflow file storage is located in a public corridor. (**Image 7**)

- By efficiently designing the overall space, storage shall be provided throughout each department. This will provide efficient access to storage from staff work areas and better maintenance of stored materials.

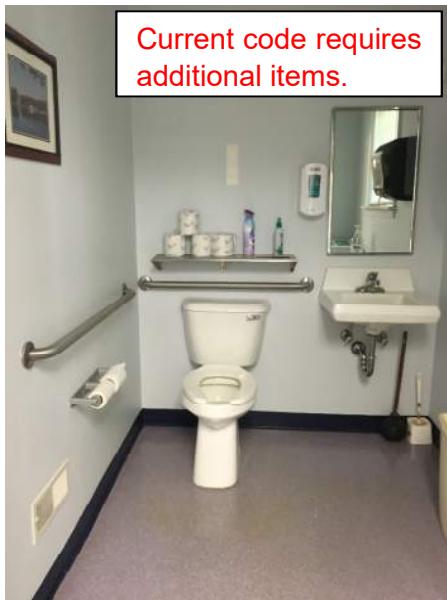
Image 8

- Minimum widths for accessible doors and passageways throughout the facility are inconsistent. All egress routes will need to be reviewed with planned building revisions and confirmed to be in conformance with ADA requirements.
- Proper numbers of plumbing fixtures and facilities for staff and public use will have to be calculated and assessed based on selected design concepts for future use.
- See **Images 8 and 9** for further restroom compliance issues. Only one unisex bathroom is provided in the building (staff area) and it does not meet accessibility requirements. (vertical grab bar and plumbing drain insulation are needed).

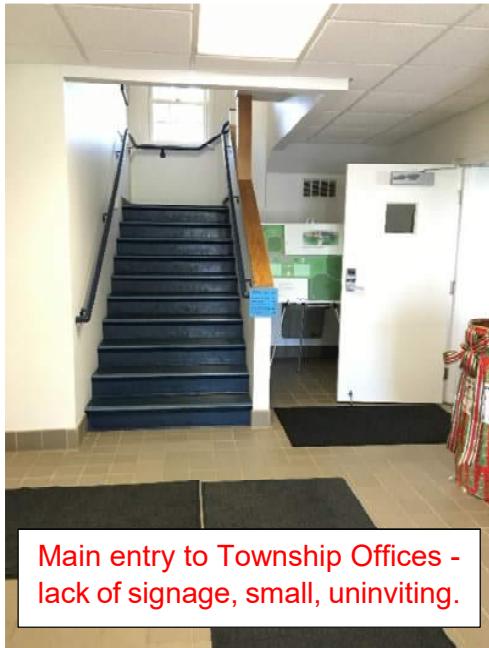
Image 10

- The Main Entrance and Lobby areas for the Township Offices (**Image 10**) and the Fire Station (**Image 11**) are outdated and unappealing to visitors. Lack of openness, proper wayfinding and dark, undefined spaces are not suited to current user-friendly design standards.

Main entry to Township Offices -
lack of signage, small, uninviting.

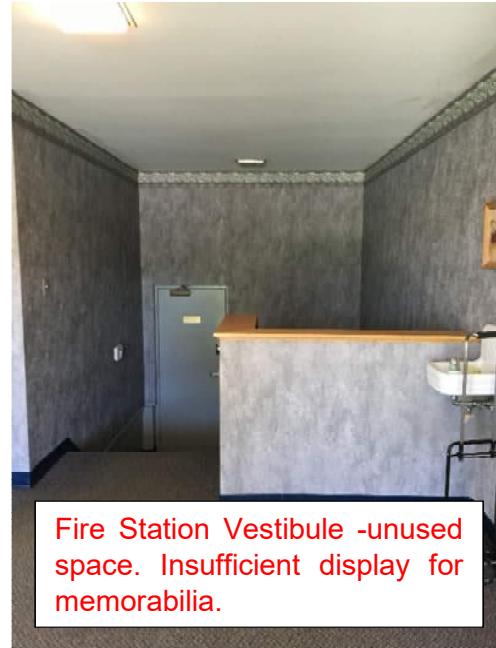
Fire Station Vestibule -unused
space. Insufficient display for
memorabilia.

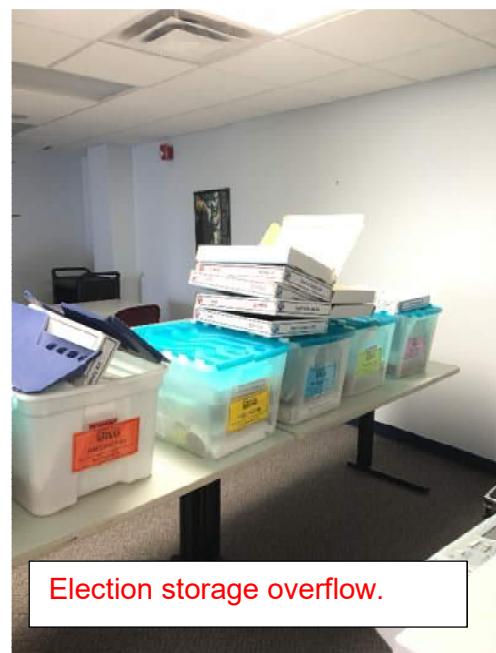
Image 12

Election storage overflow.

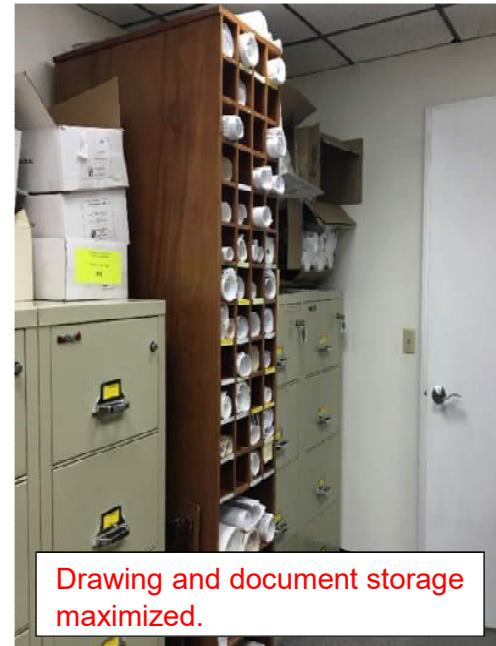
Image 15

- The Staff work stations and department spaces (Fire Department and Township offices) are outdated and don't meet the current design standards for efficiency and productivity that are common in workplace research and design.
- The main Board Room deficiencies in acoustics can be modified to increase the functional experience, however the lack of sufficient user amenities and poor orientation of the space do not allow for the future flexibility and expansion needs of the Township.
- The mechanical systems have many add-ons do not meet the comfort needs of the users and the energy efficiency standards that are common in current construction. Storage of records and documents, and computer equipment needs are also not met with the current insufficient temperature and air-quality controls.

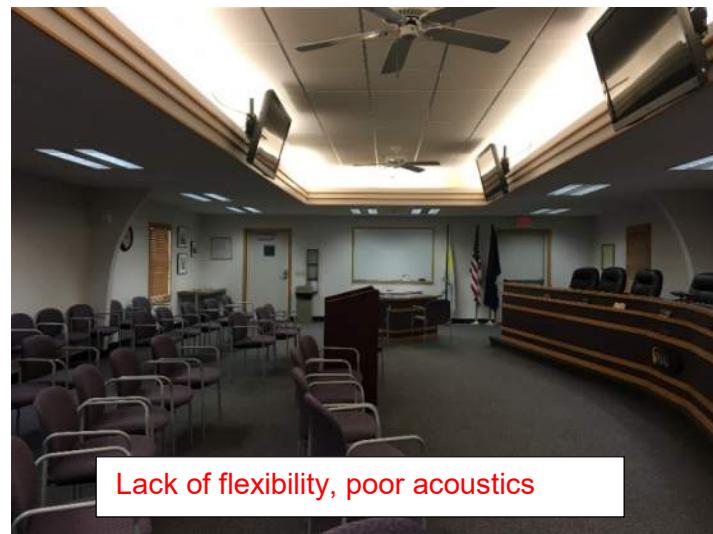
Image 21

- Provide a variety of meeting room sizes to accommodate a variety of functions. Meeting rooms shall maintain acoustical separation to provide needed privacy for each space.
- The current Board Room is oriented in a manner that does not allow proper viewing of monitors (too close to audience and too high for comfortable angle of view). Acoustics are poor and the geometry of the ceiling effectively traps sound and creates difficulty in communication.

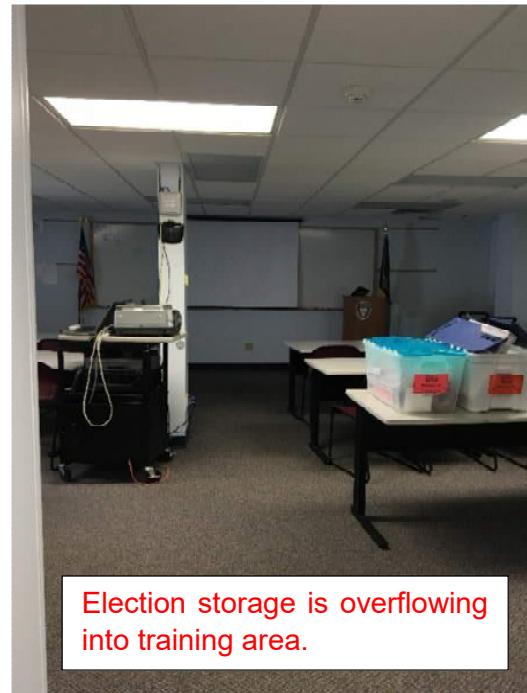
Image 22

- The Training room is on the lower level between the Township staff offices and the Fire Department. The square footage provided is adequate for current needs, but the technology is out of date, and the configuration of the room (with a center column) makes flexibility difficult. The storage and function of election materials and equipment currently overflows into this room, also cutting down on the usability of the space.

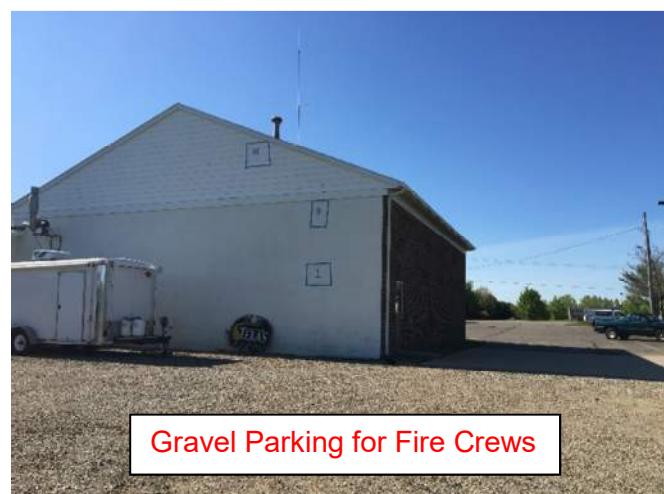
Image 24

- Parking for the public and Township Offices staff is located at the back of the building with the main driveway off West Q Avenue. 42 spaces (including 3 ADA spaces) are provided in this lot. One of the ADA spaces is shared with the public for use at the Farmer's Market facility to the east. Asphalt paving is in need of resurfacing; however, the striping is well-maintained. (**Image 23**) One (1) additional ADA parking space is located at the southwest corner of the building and is accessed from the driveway accessing Fire Station facilities. Nine (9) parking spaces are placed along the western edge of the west lot at the Fire Department side of the building. Additional Fire Department staff parking is provided in a gravel area to north of the north Apparatus Bay. (**Image 24**).

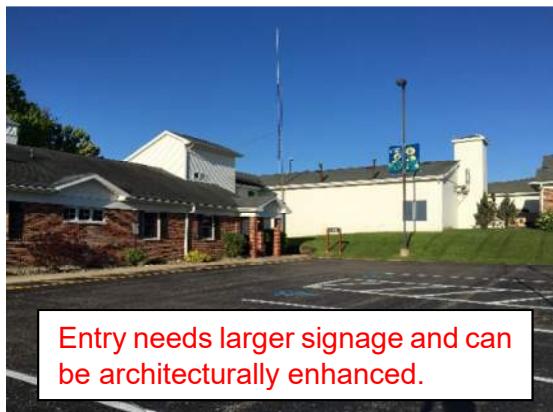
Image 25

- A new entrance to the Fire Department should be added to the east side of the building with direct connection to the north parking lot and a clear relationship/connection with the Township offices entrance.

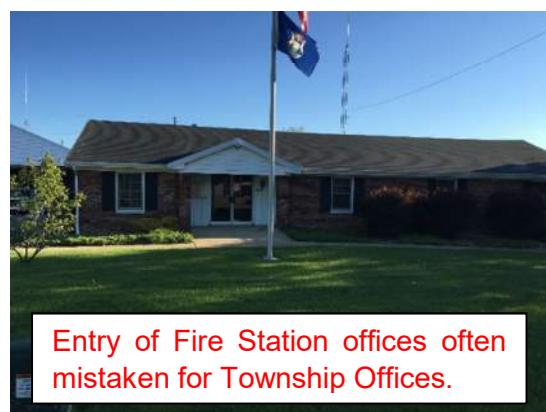
Image 26

- Signage designating the Township Hall, the Fire Department and the associated main entries should be provided along Q Avenue for access and community awareness.

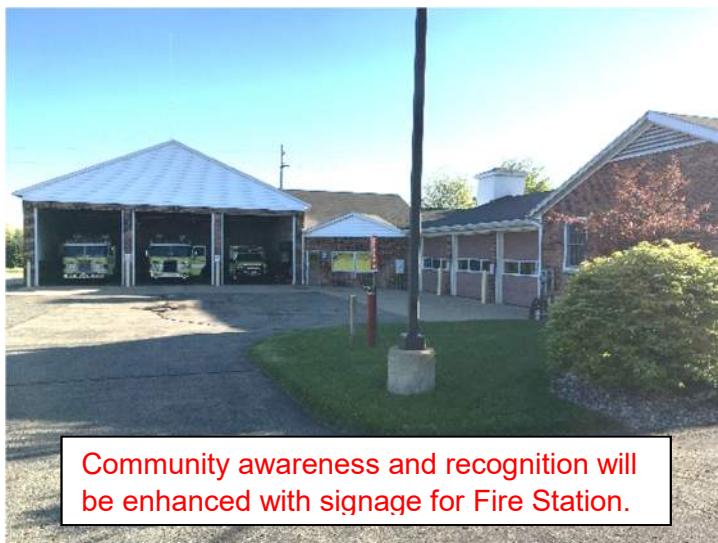
Image 27

Community awareness and recognition will be enhanced with signage for Fire Station.
