Charter Township of Texas Flood Study

Eagle Lake Monitoring Results through September 18, 2025

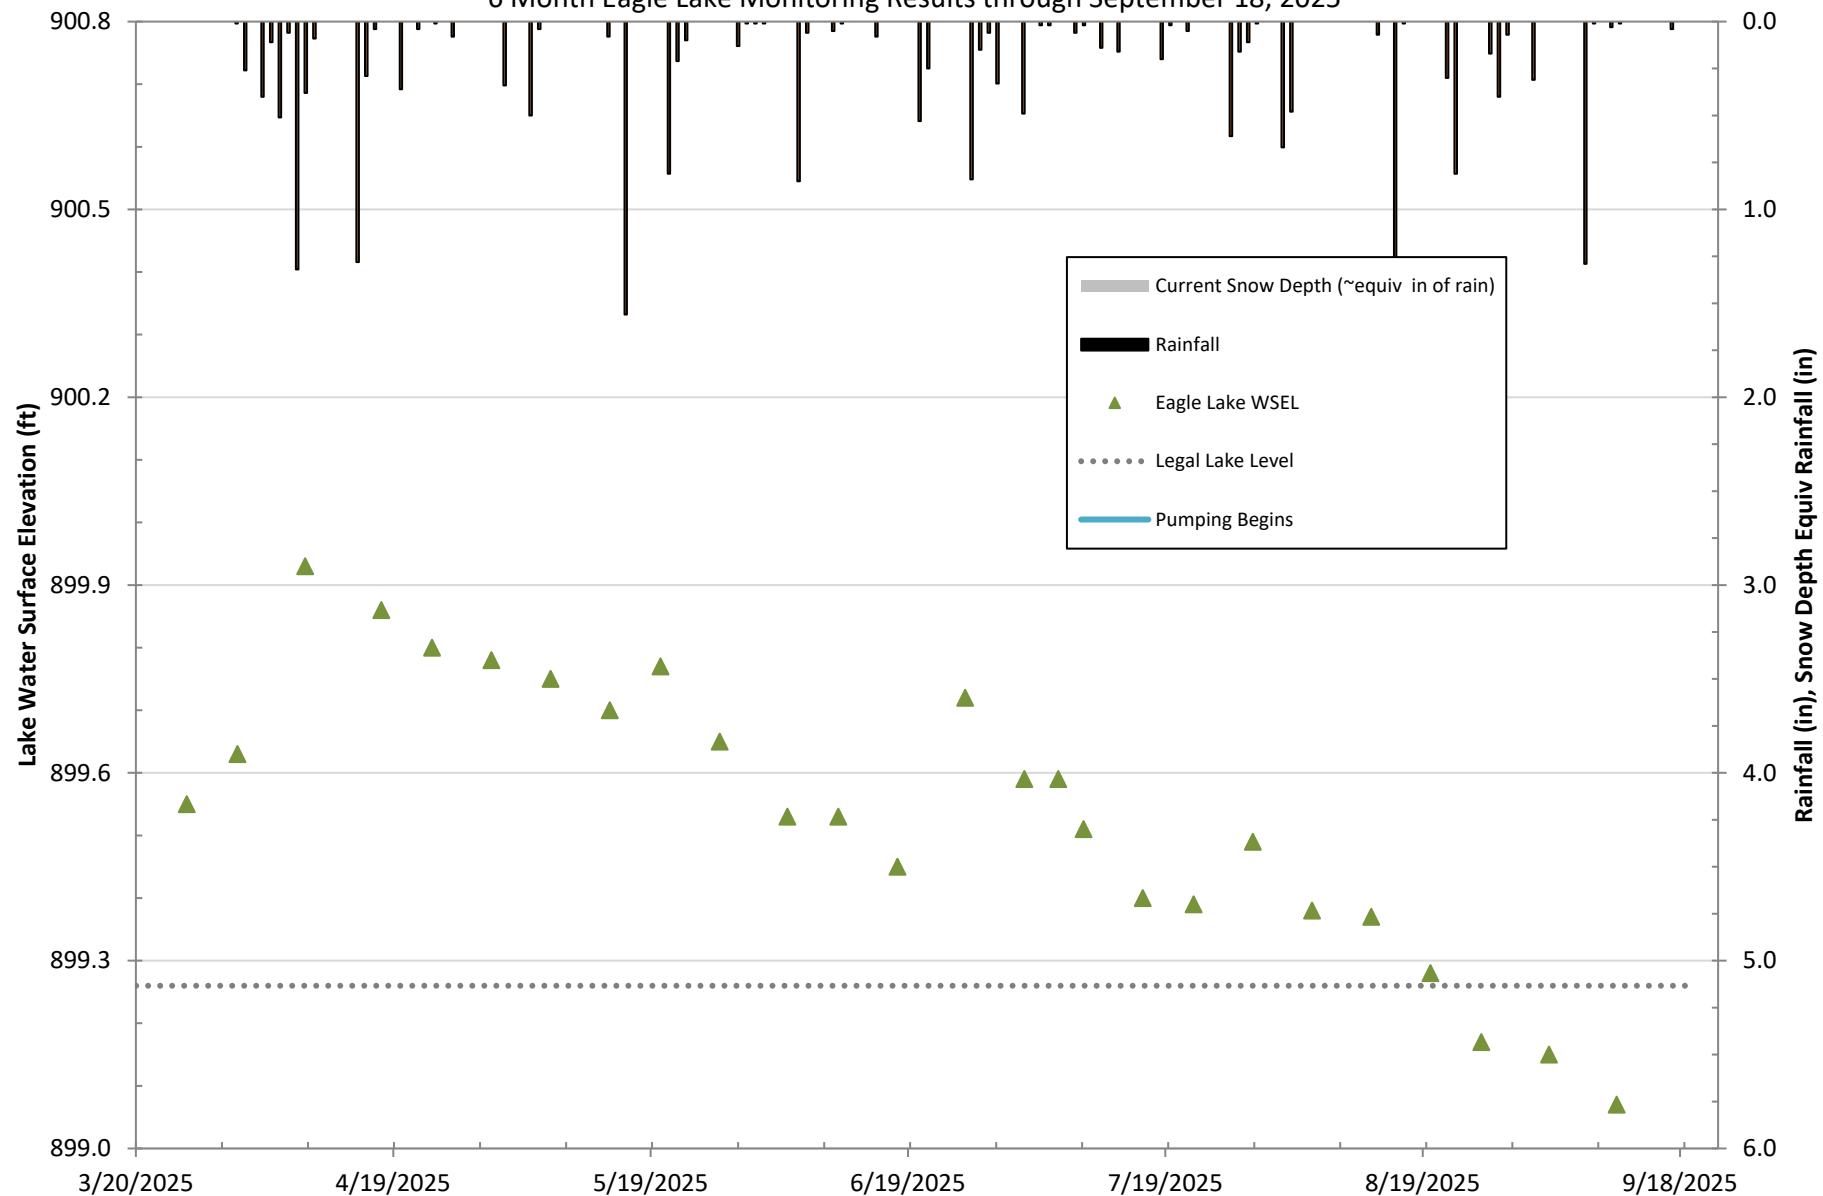
Figure

6 Month Eagle Lake Monitoring Results through September 18, 2025

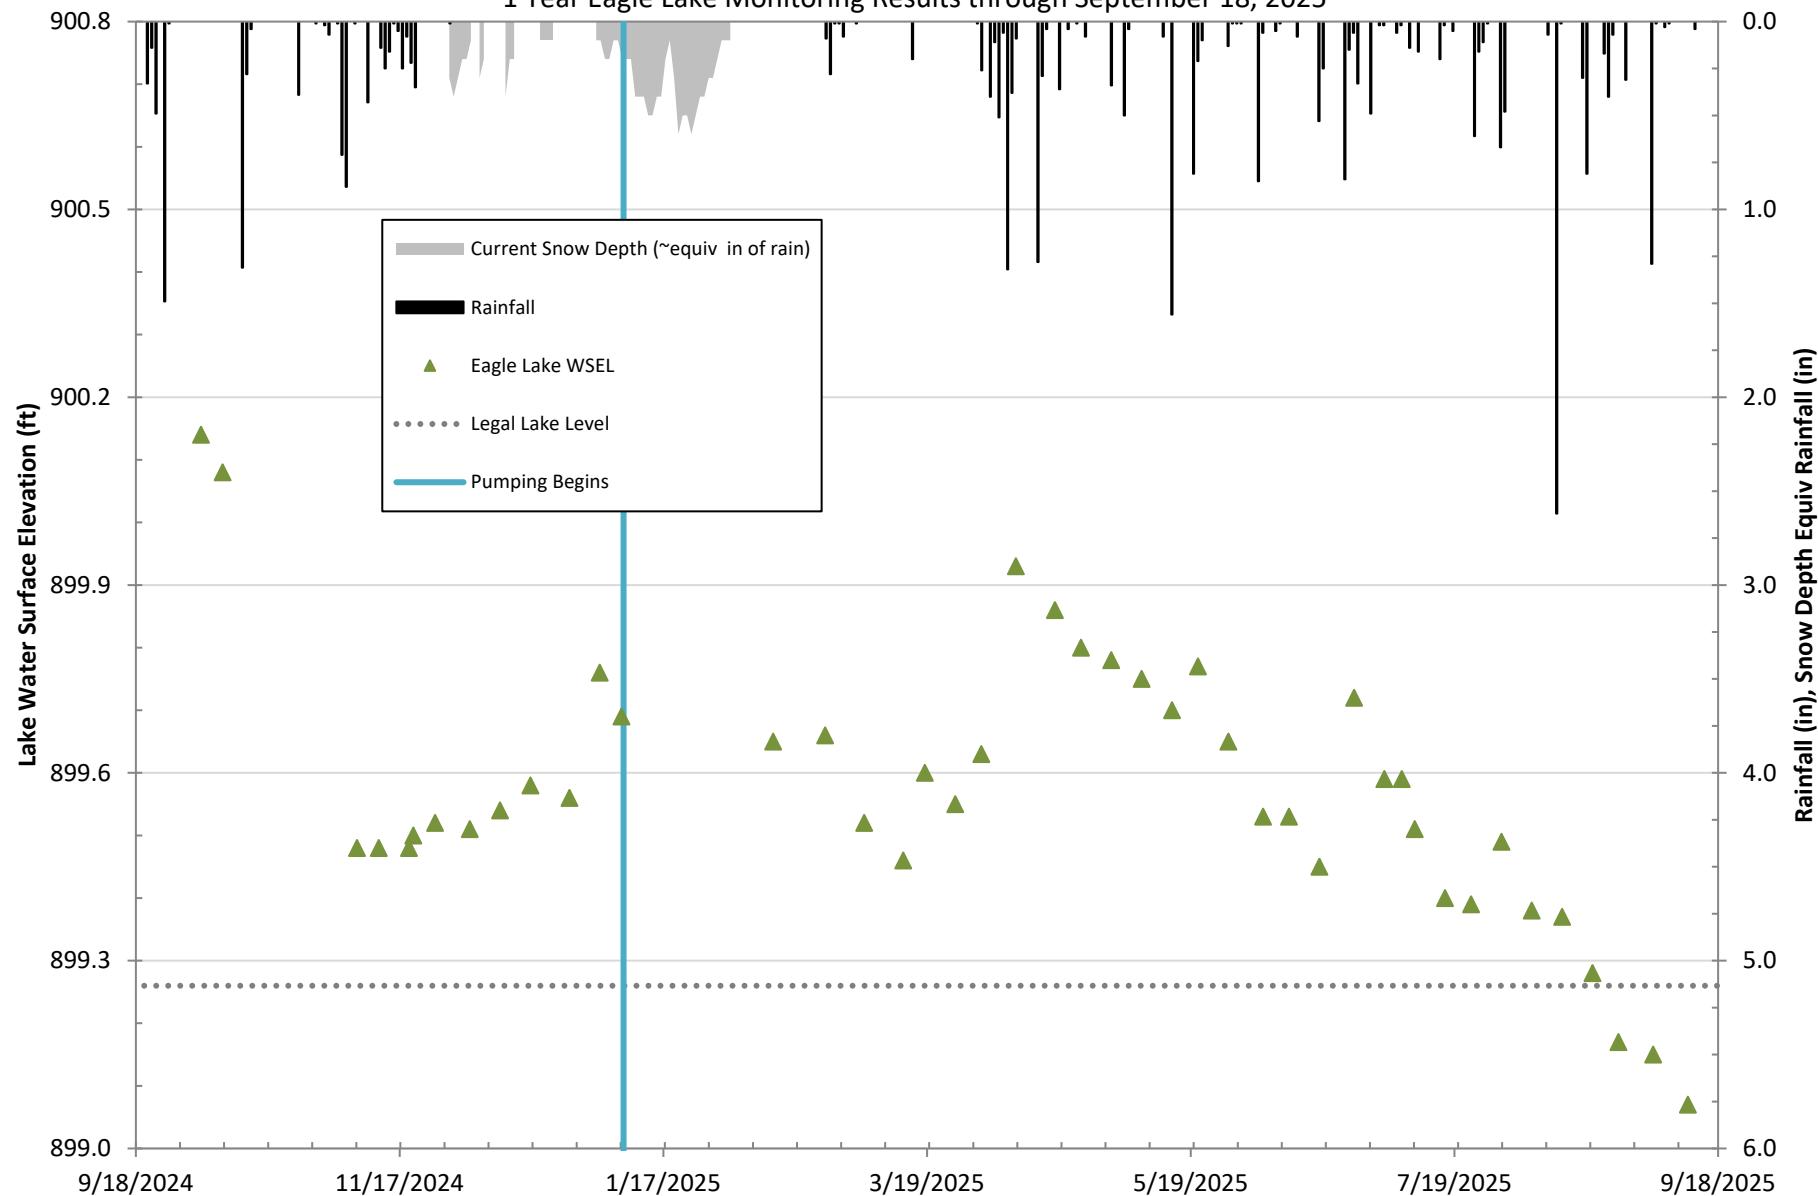
Figure

1 Year Eagle Lake Monitoring Results through September 18, 2025

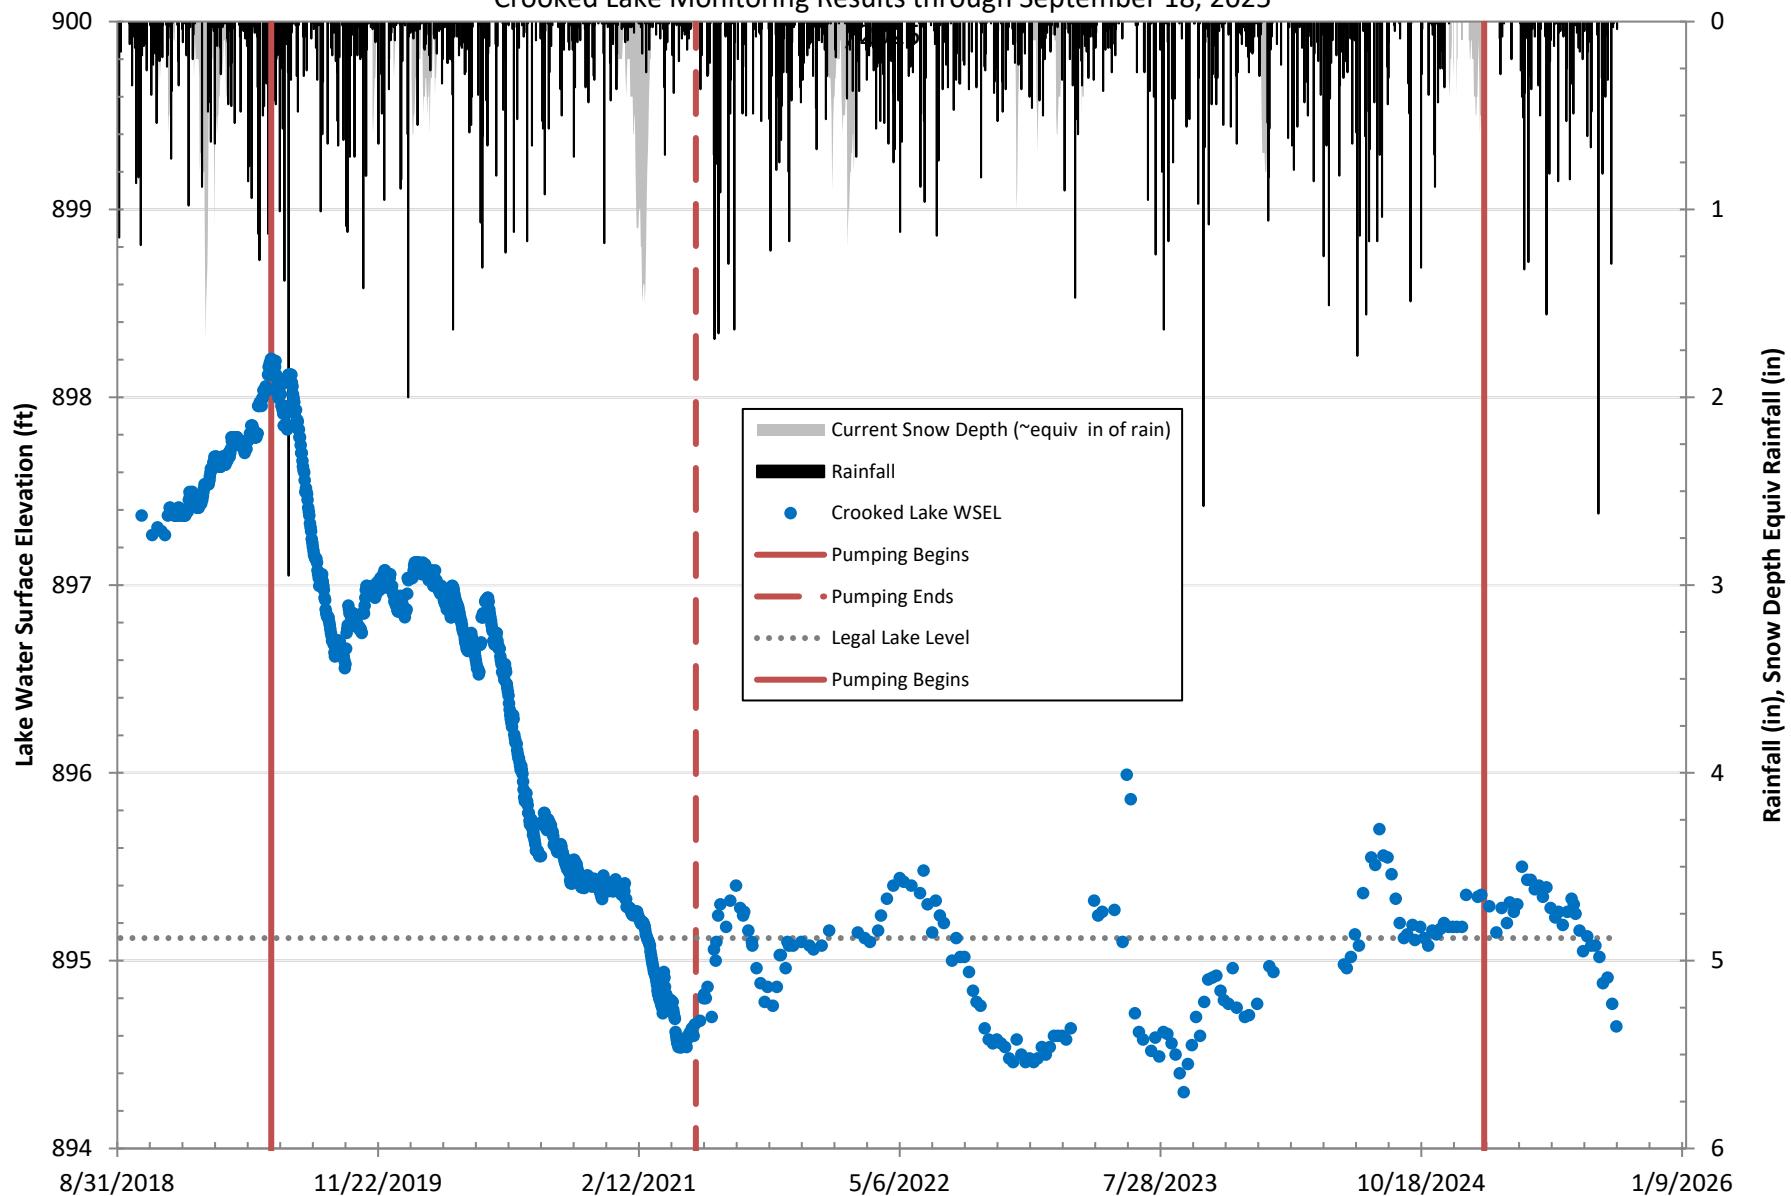
Figure

Crooked Lake Monitoring Results through September 18, 2025

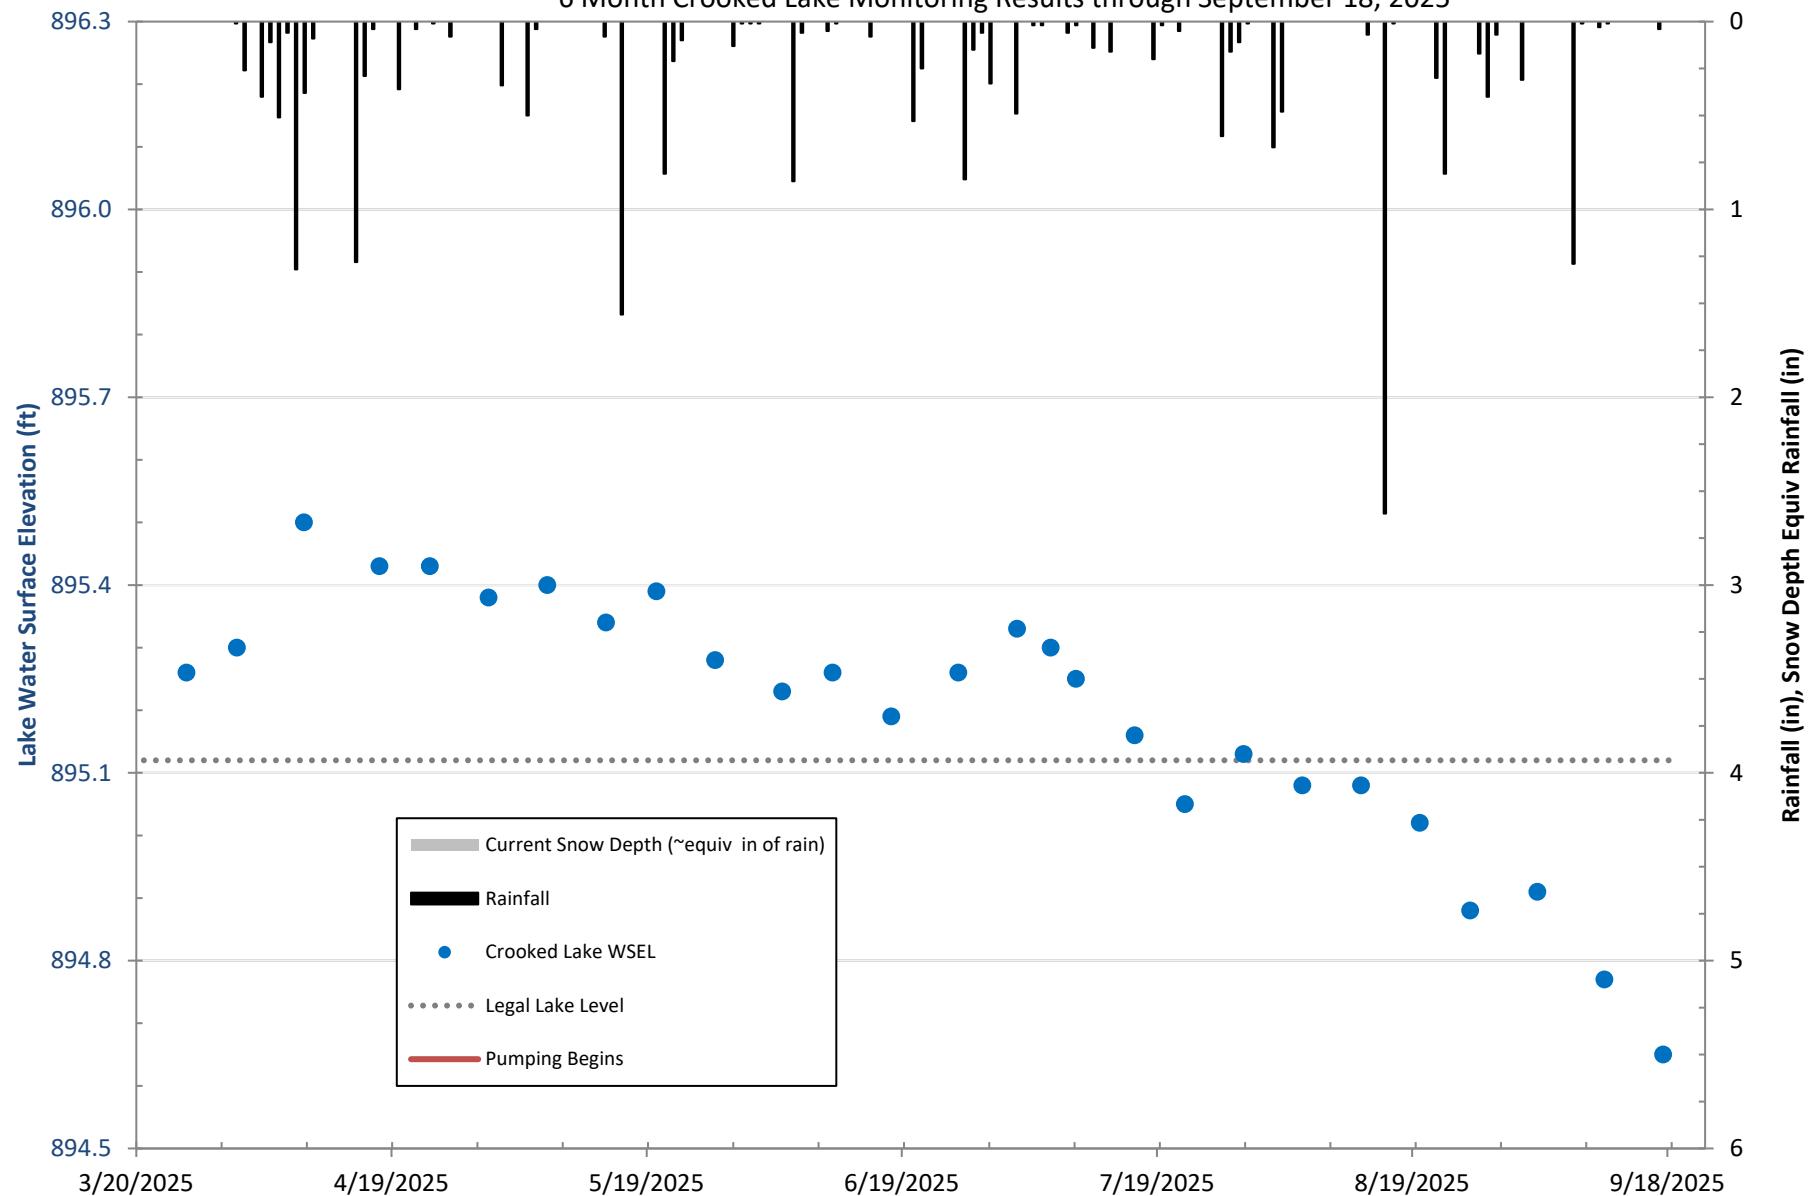
Figure

6 Month Crooked Lake Monitoring Results through September 18, 2025

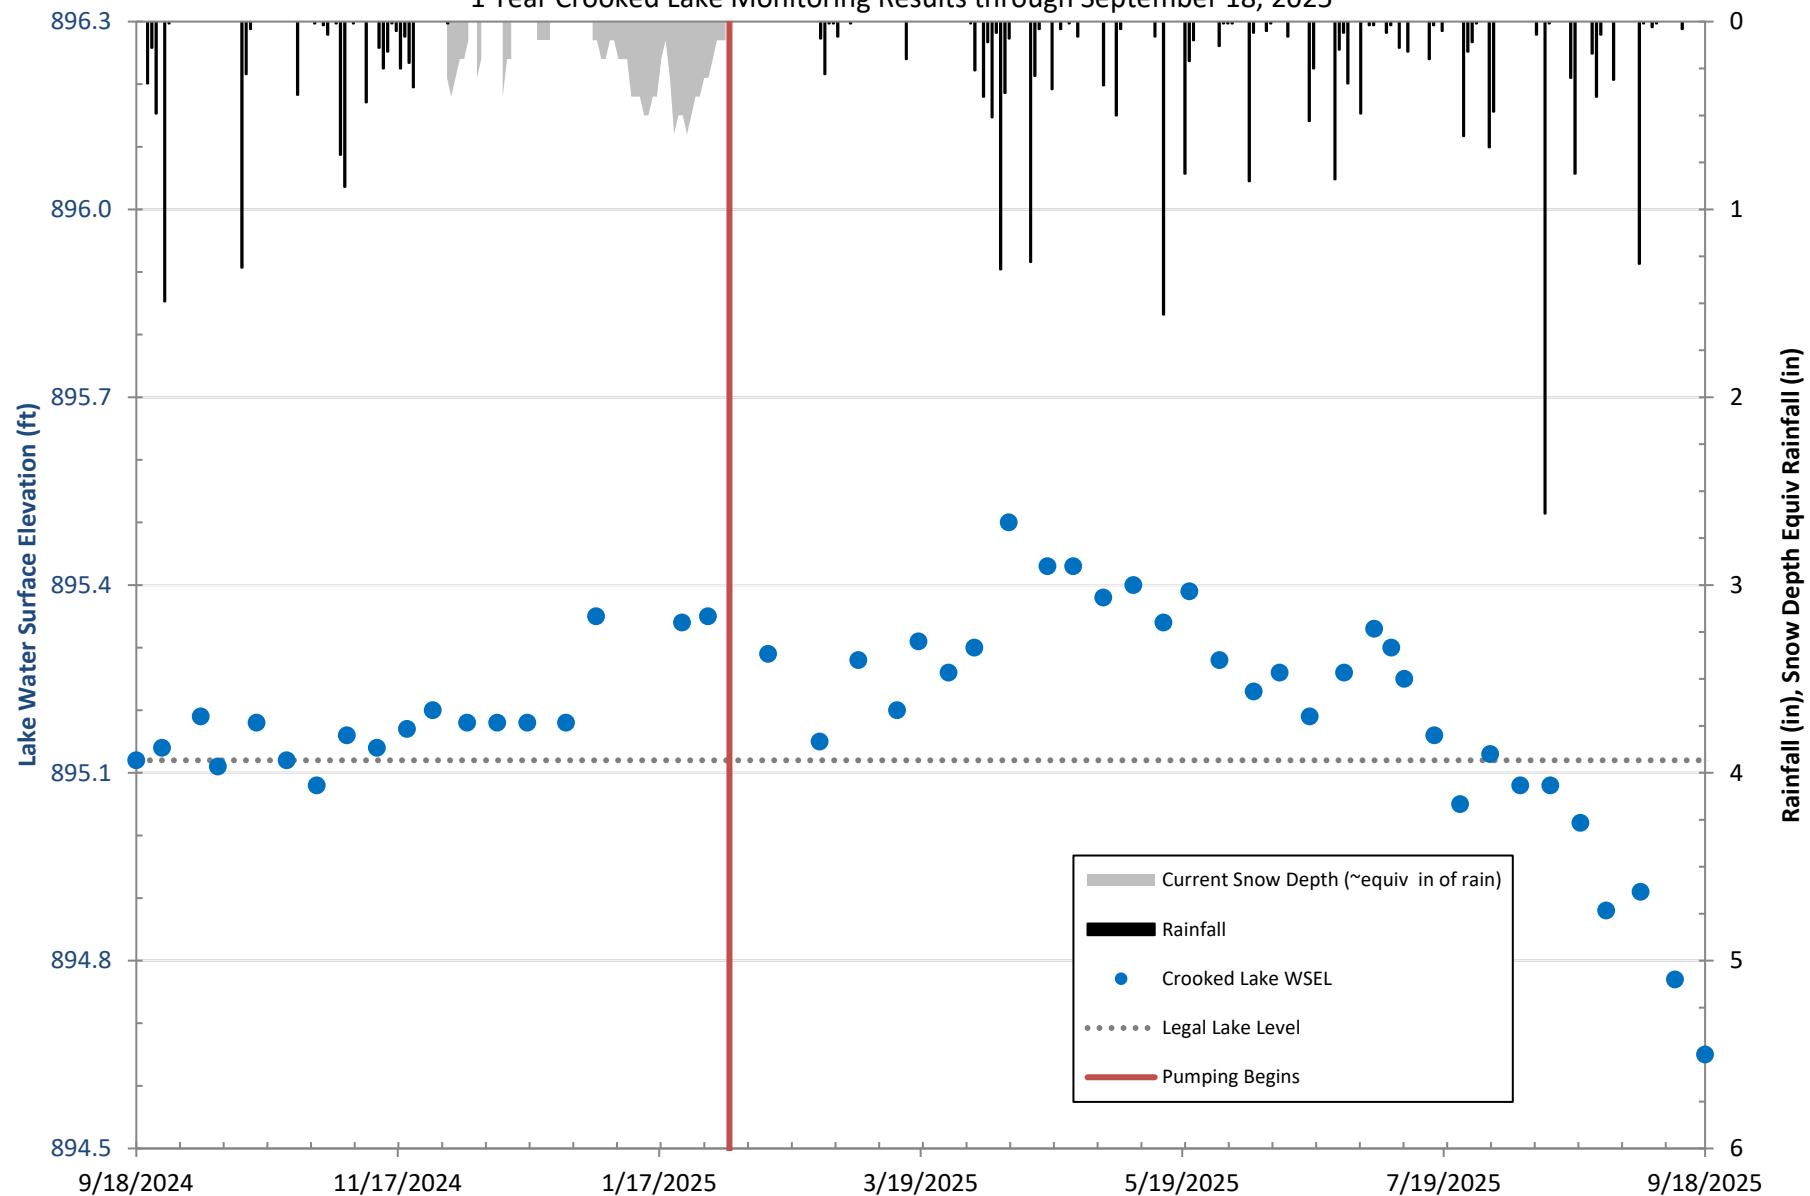
Figure

1 Year Crooked Lake Monitoring Results through September 18, 2025

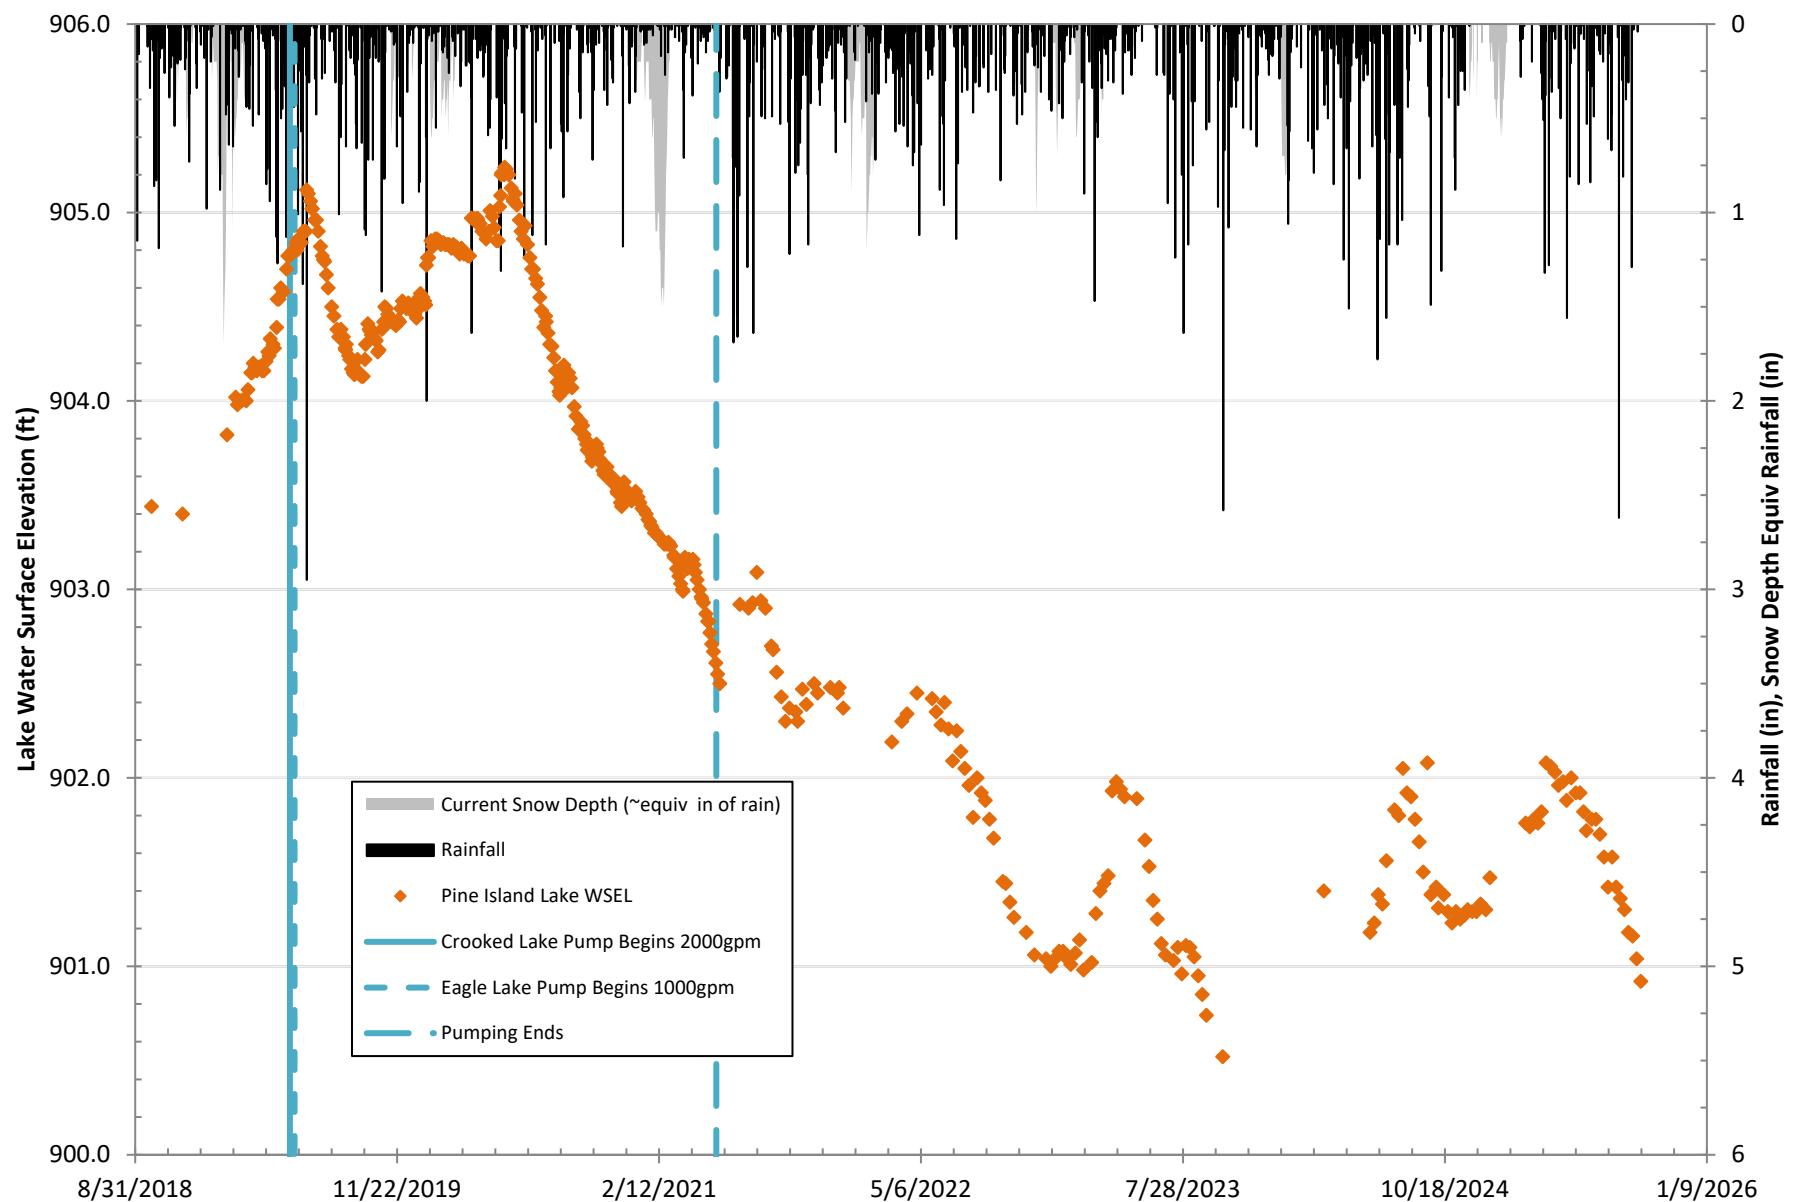
Charter Township of Texas Flood Study
Figure
Pine Island Lake Monitoring Results through September 18, 2025

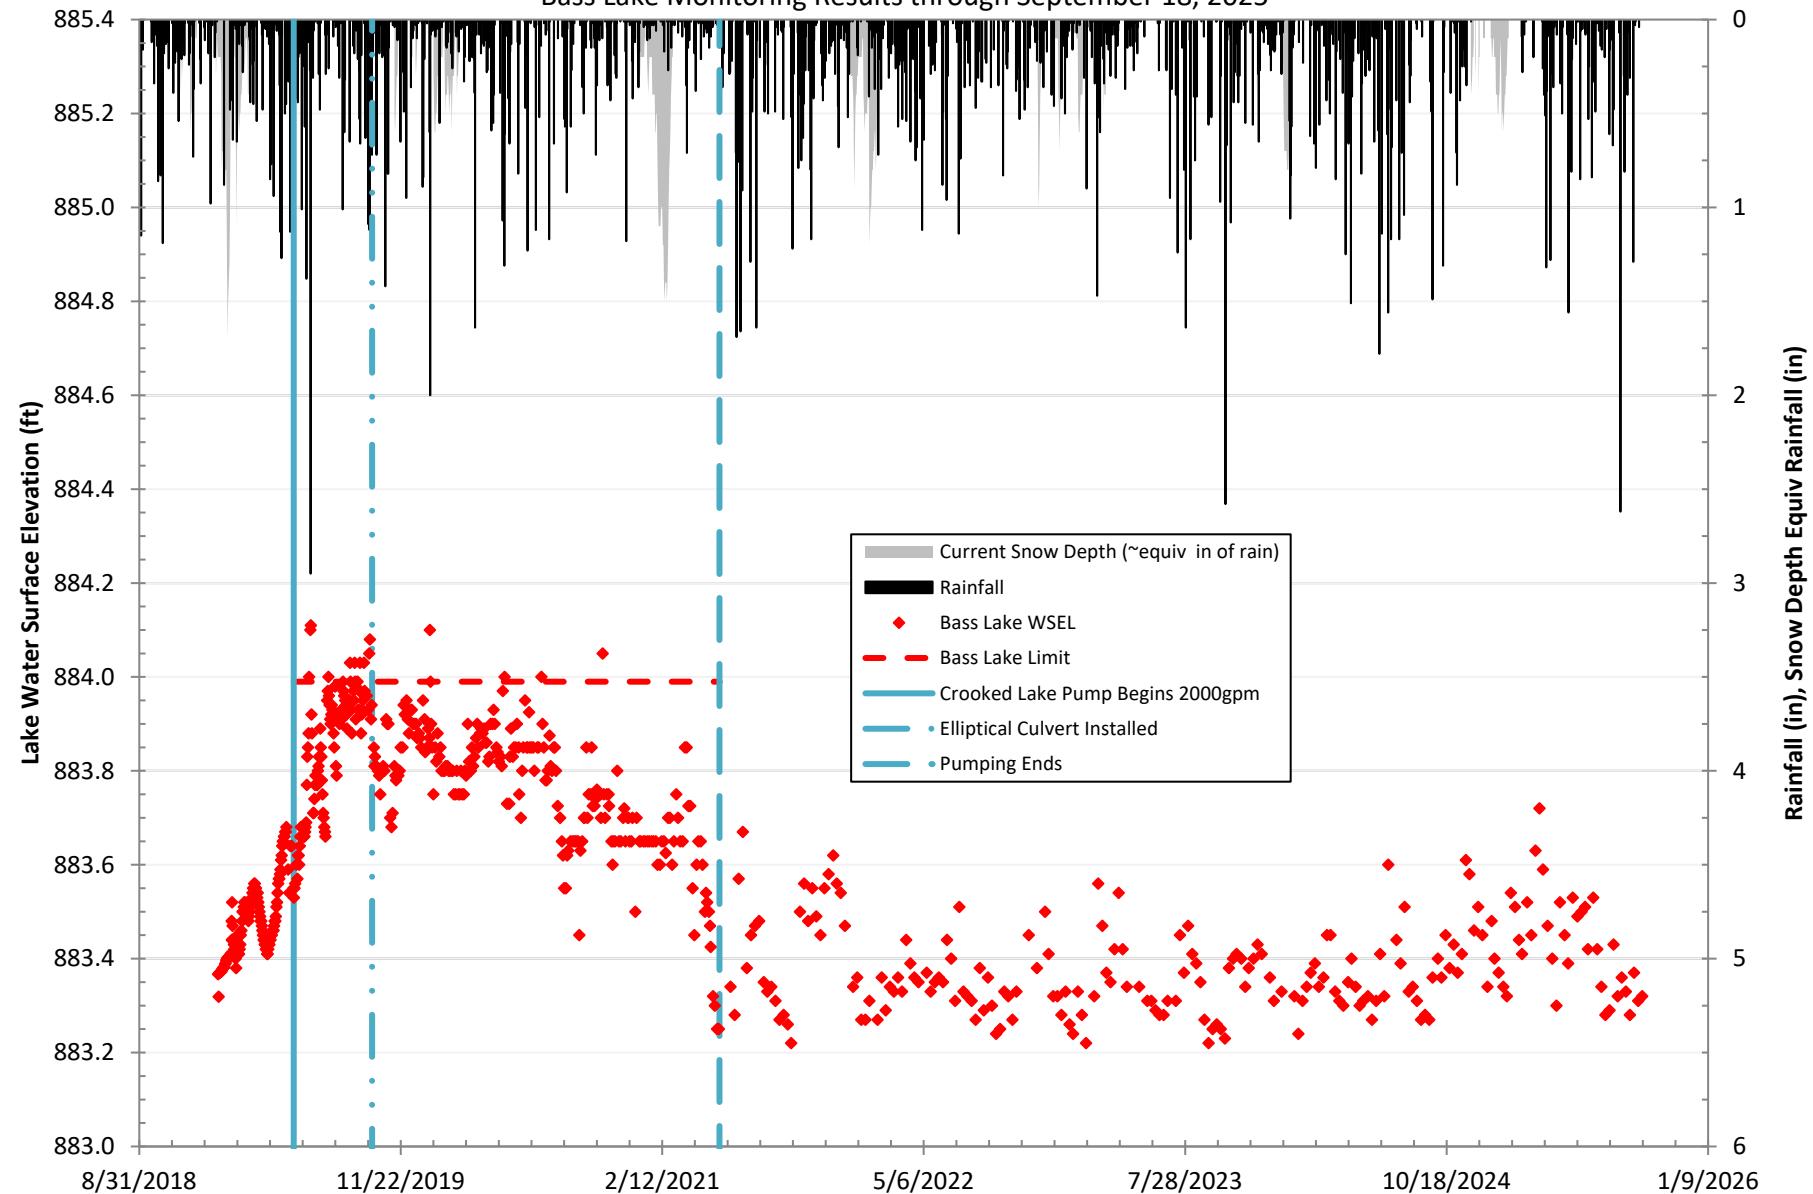
Figure

Bass Lake Monitoring Results through September 18, 2025

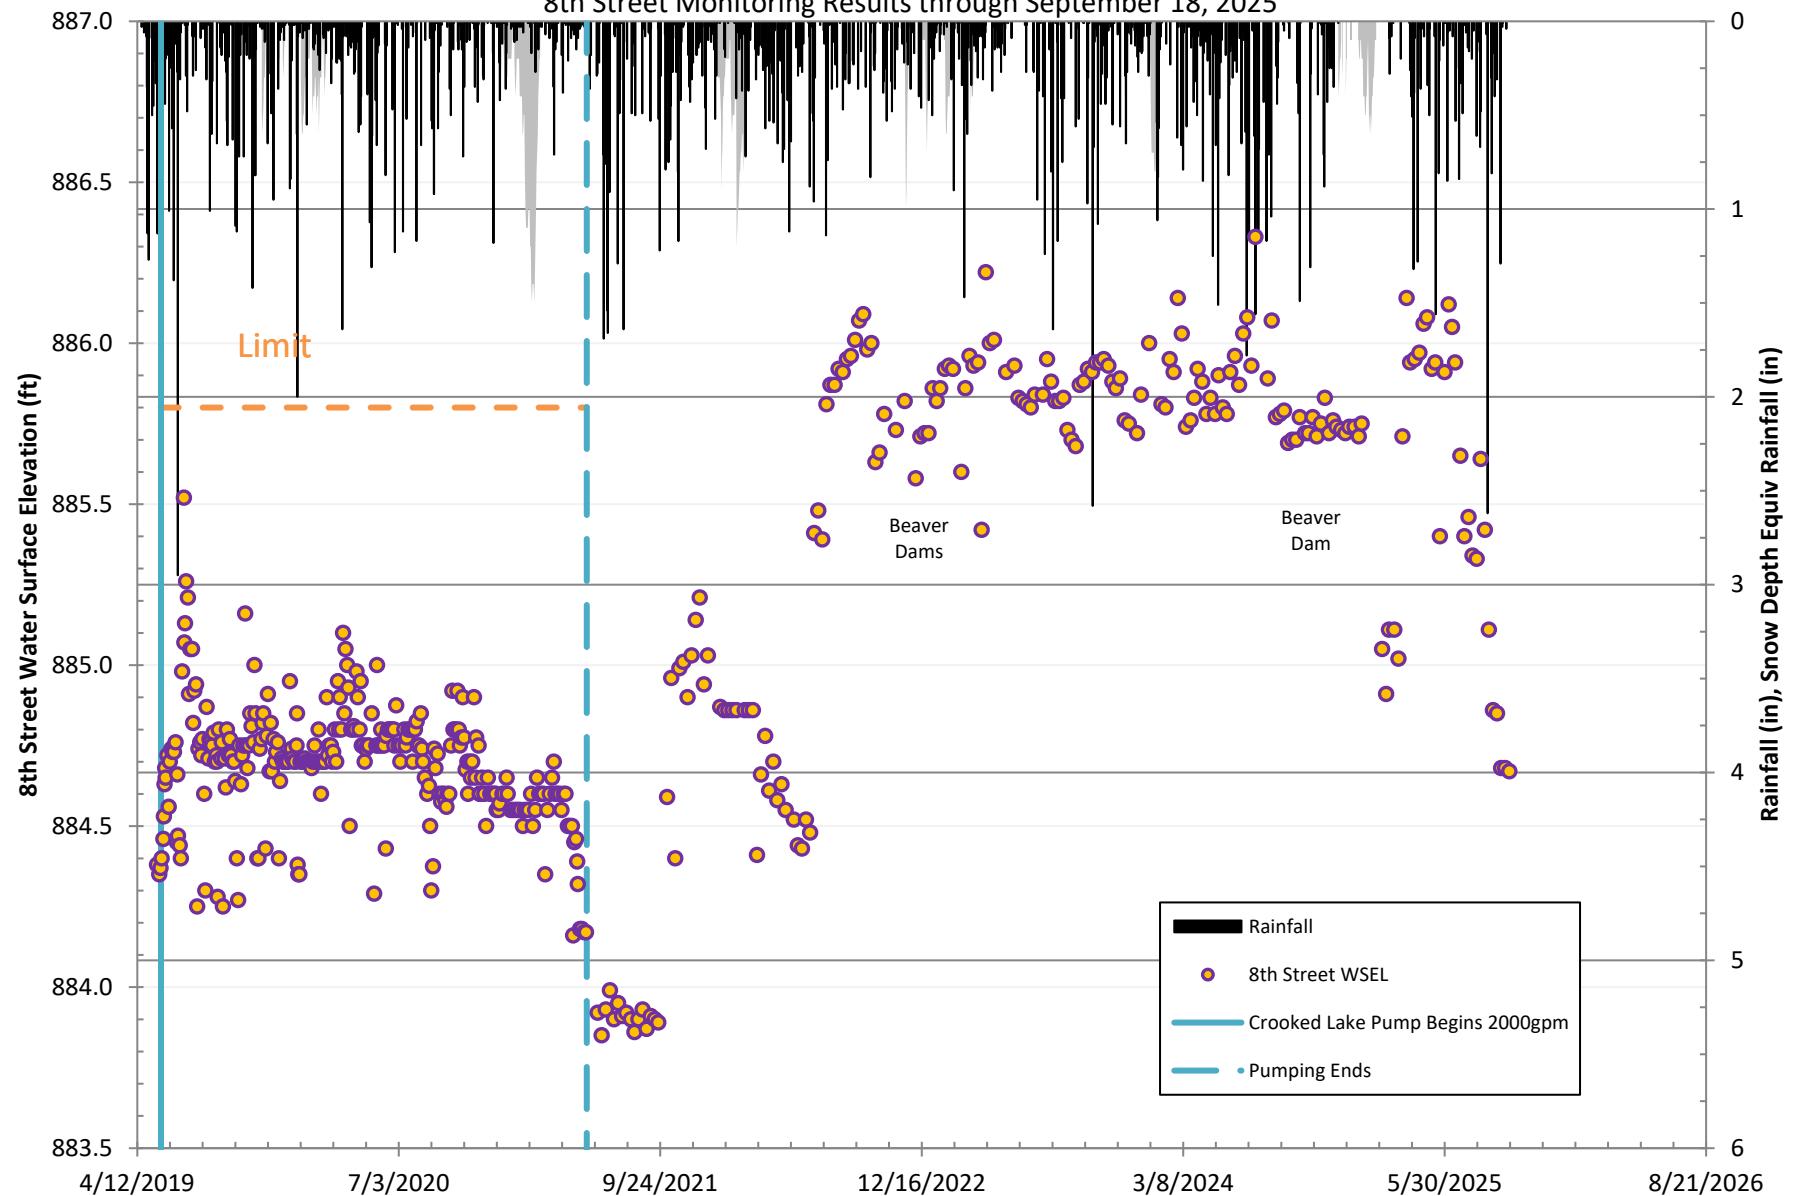
Figure

8th Street Monitoring Results through September 18, 2025

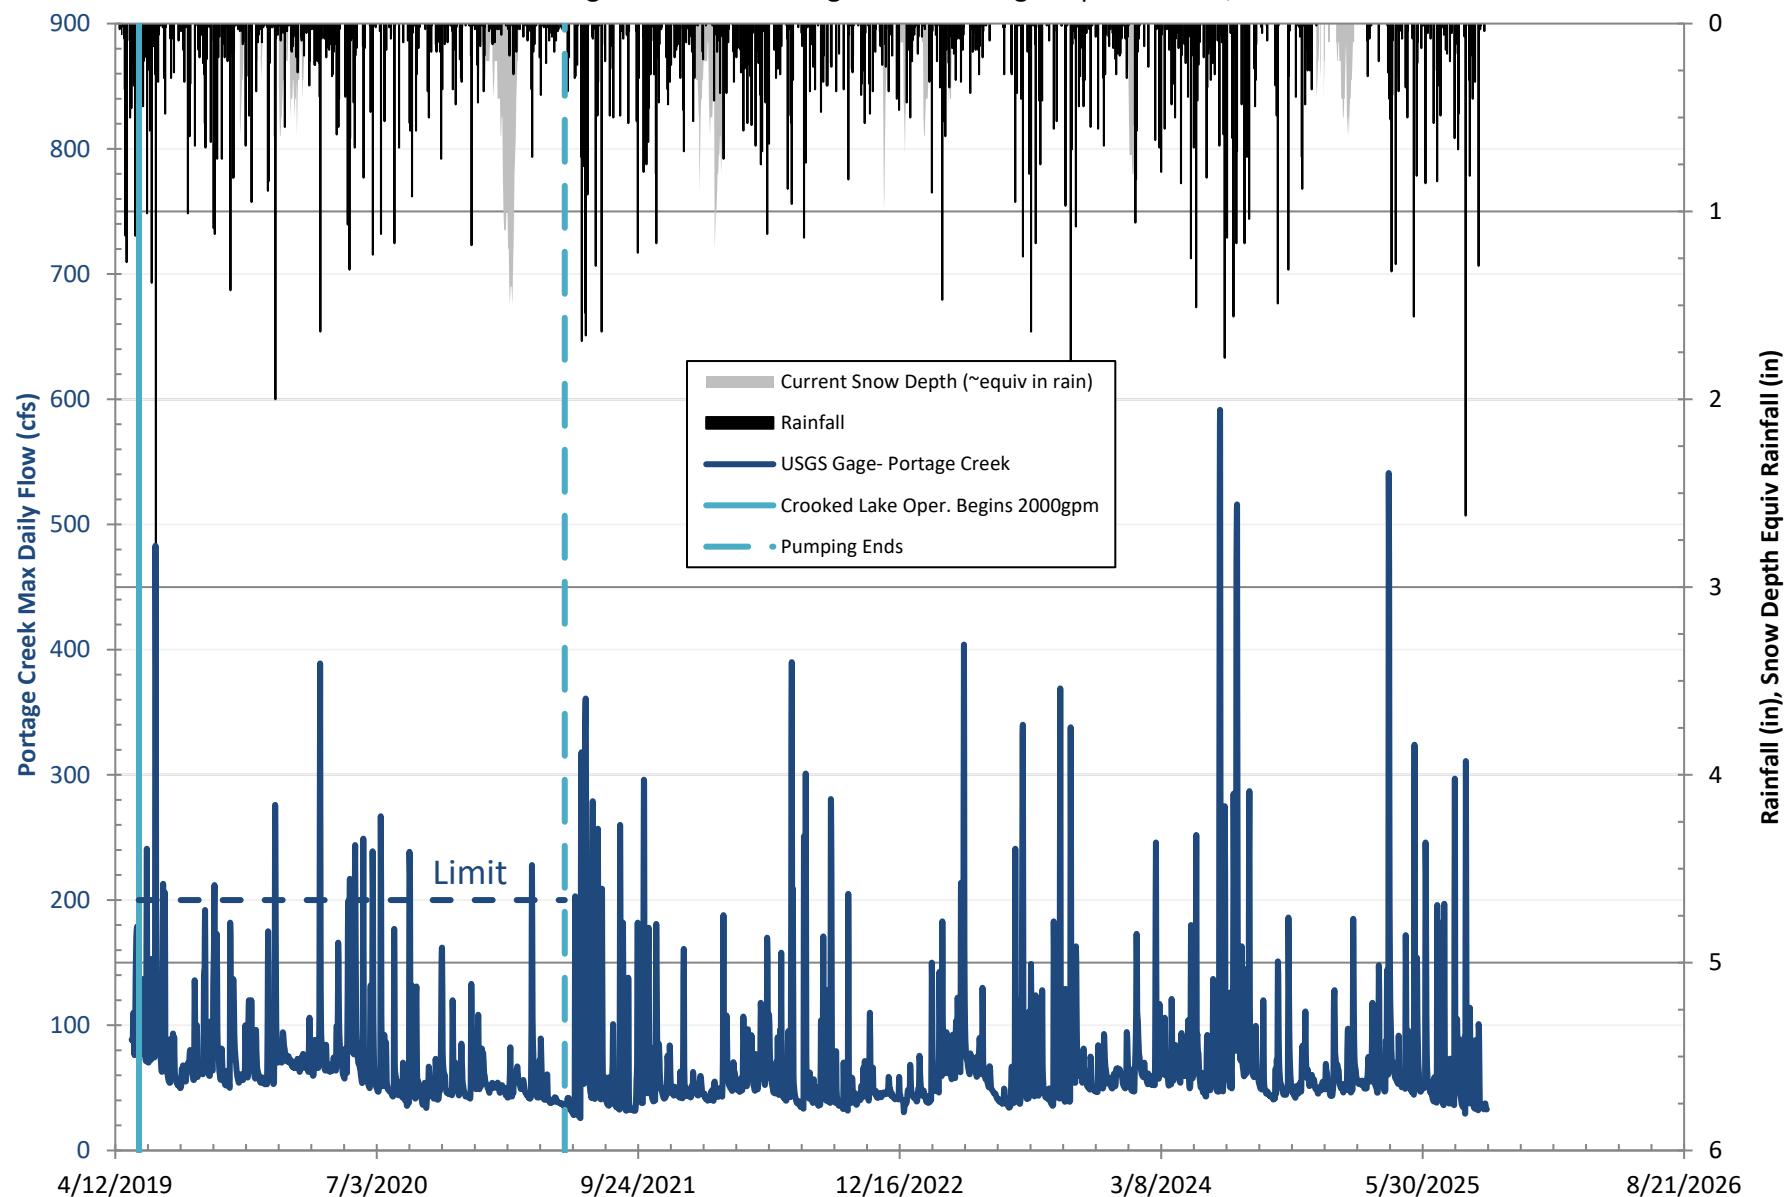
Charter Township of Texas Flood Study
Figure
USGS Portage Creek Monitoring Results through September 18, 2025

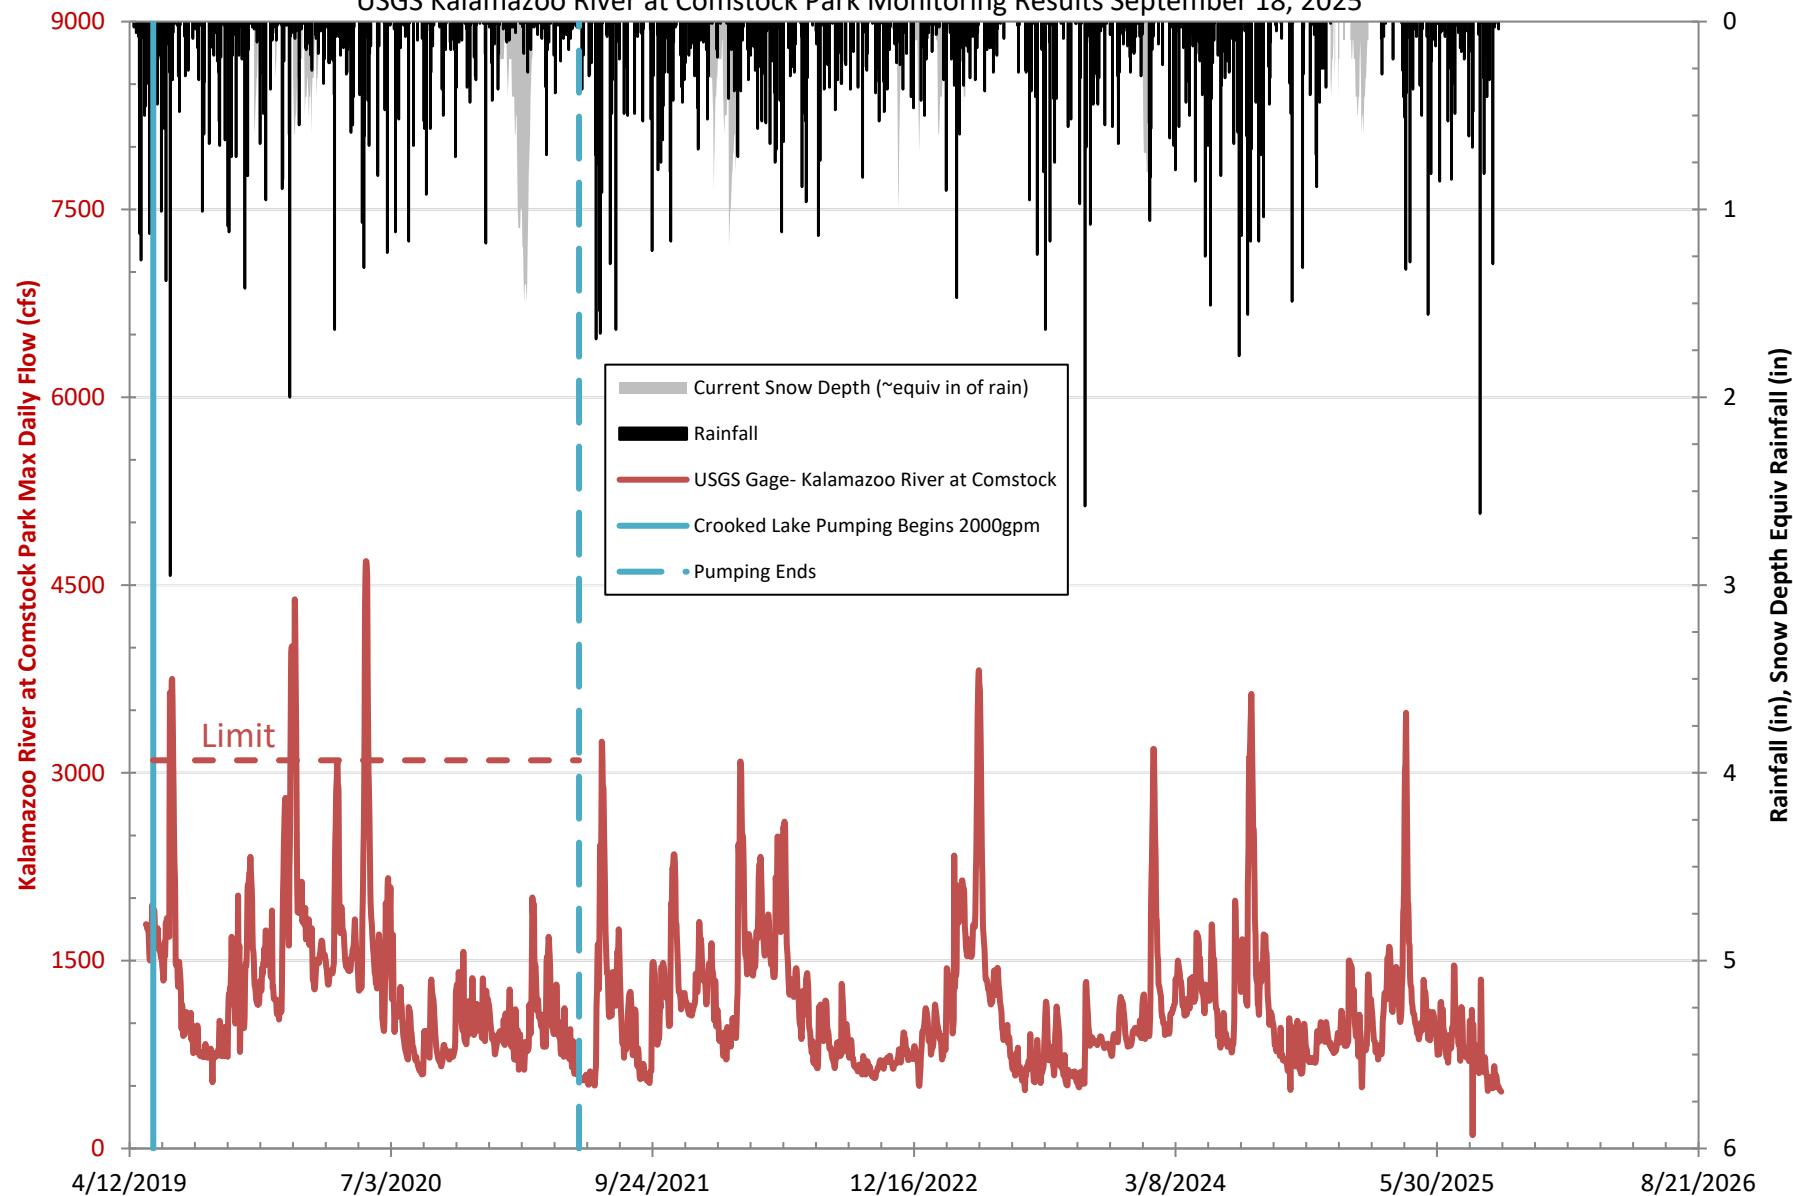
Figure

USGS Kalamazoo River at Comstock Park Monitoring Results September 18, 2025
