Charter Township of Texas Flood Study

Eagle Lake Monitoring Results through September 18, 2025

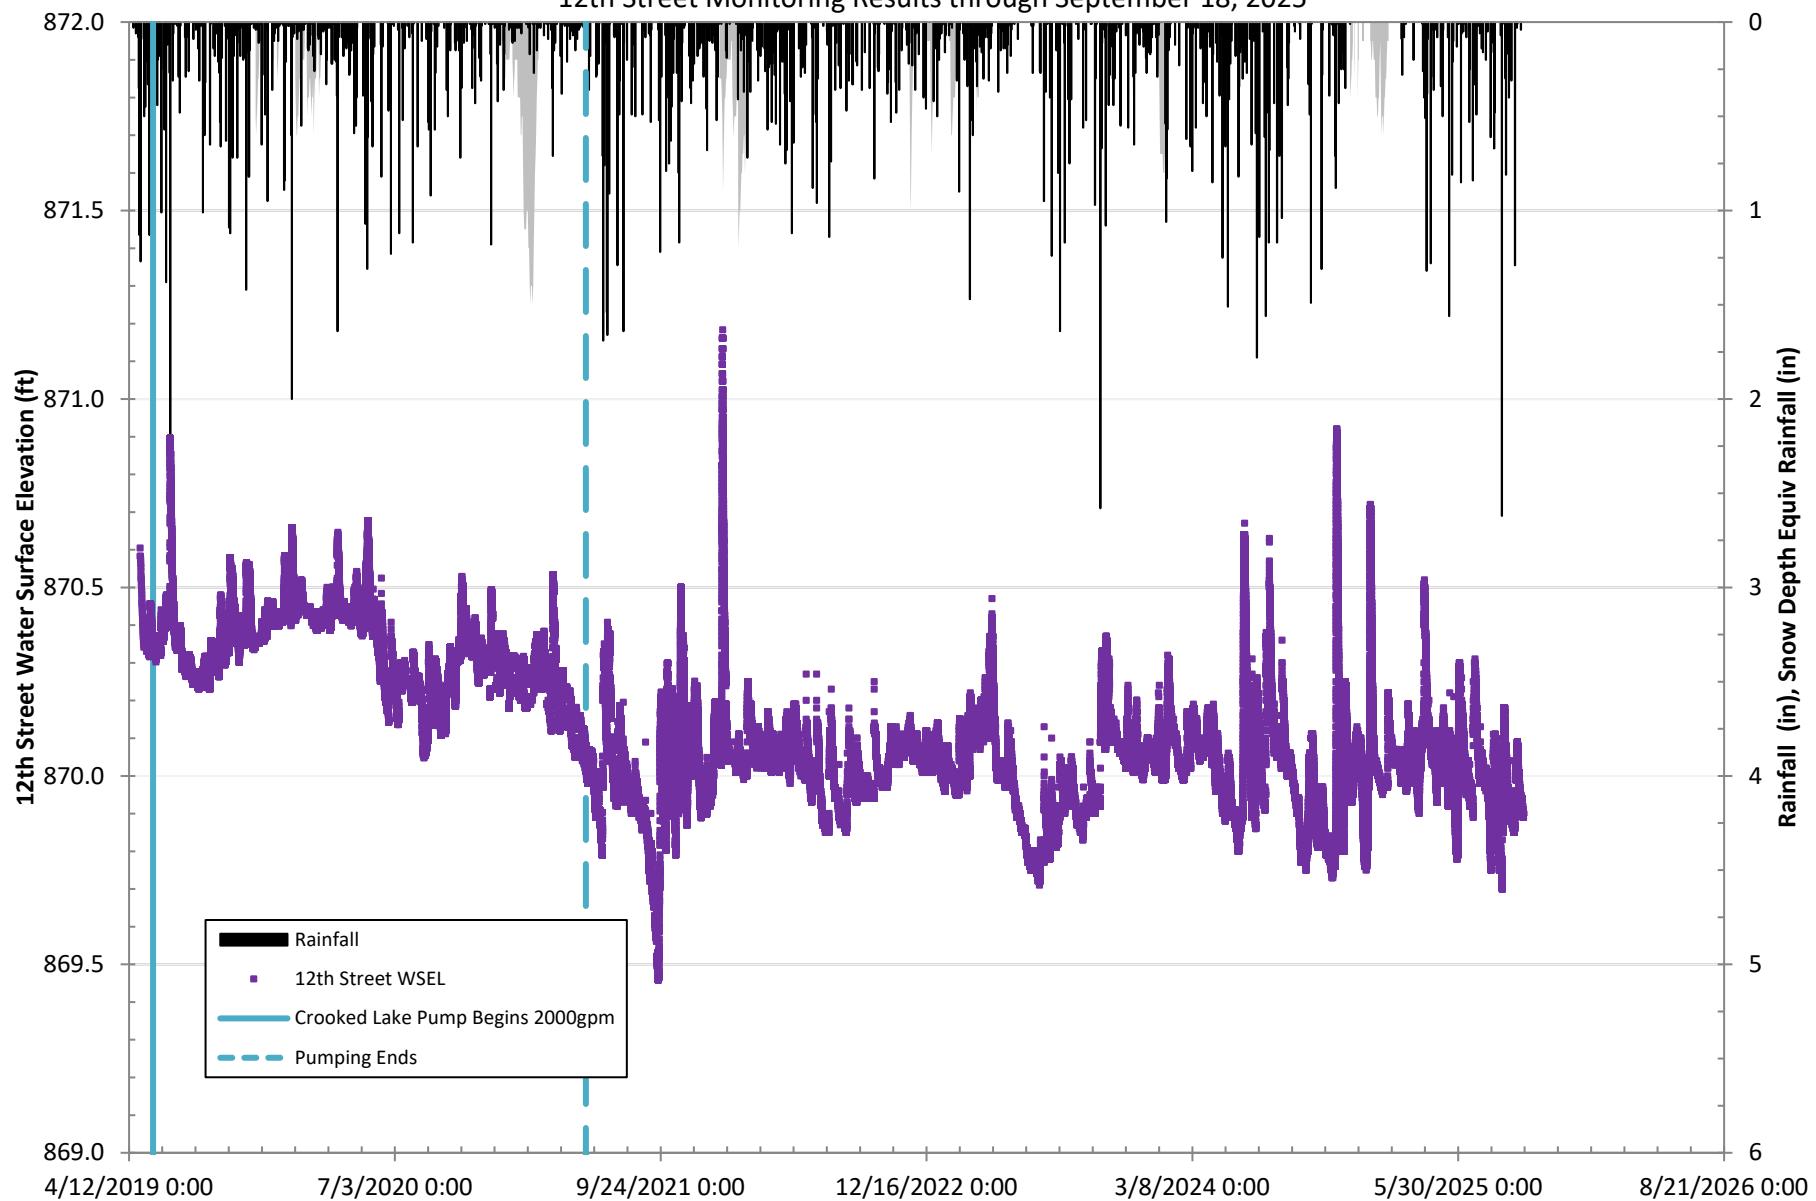
Figure

12th Street Monitoring Results through September 18, 2025

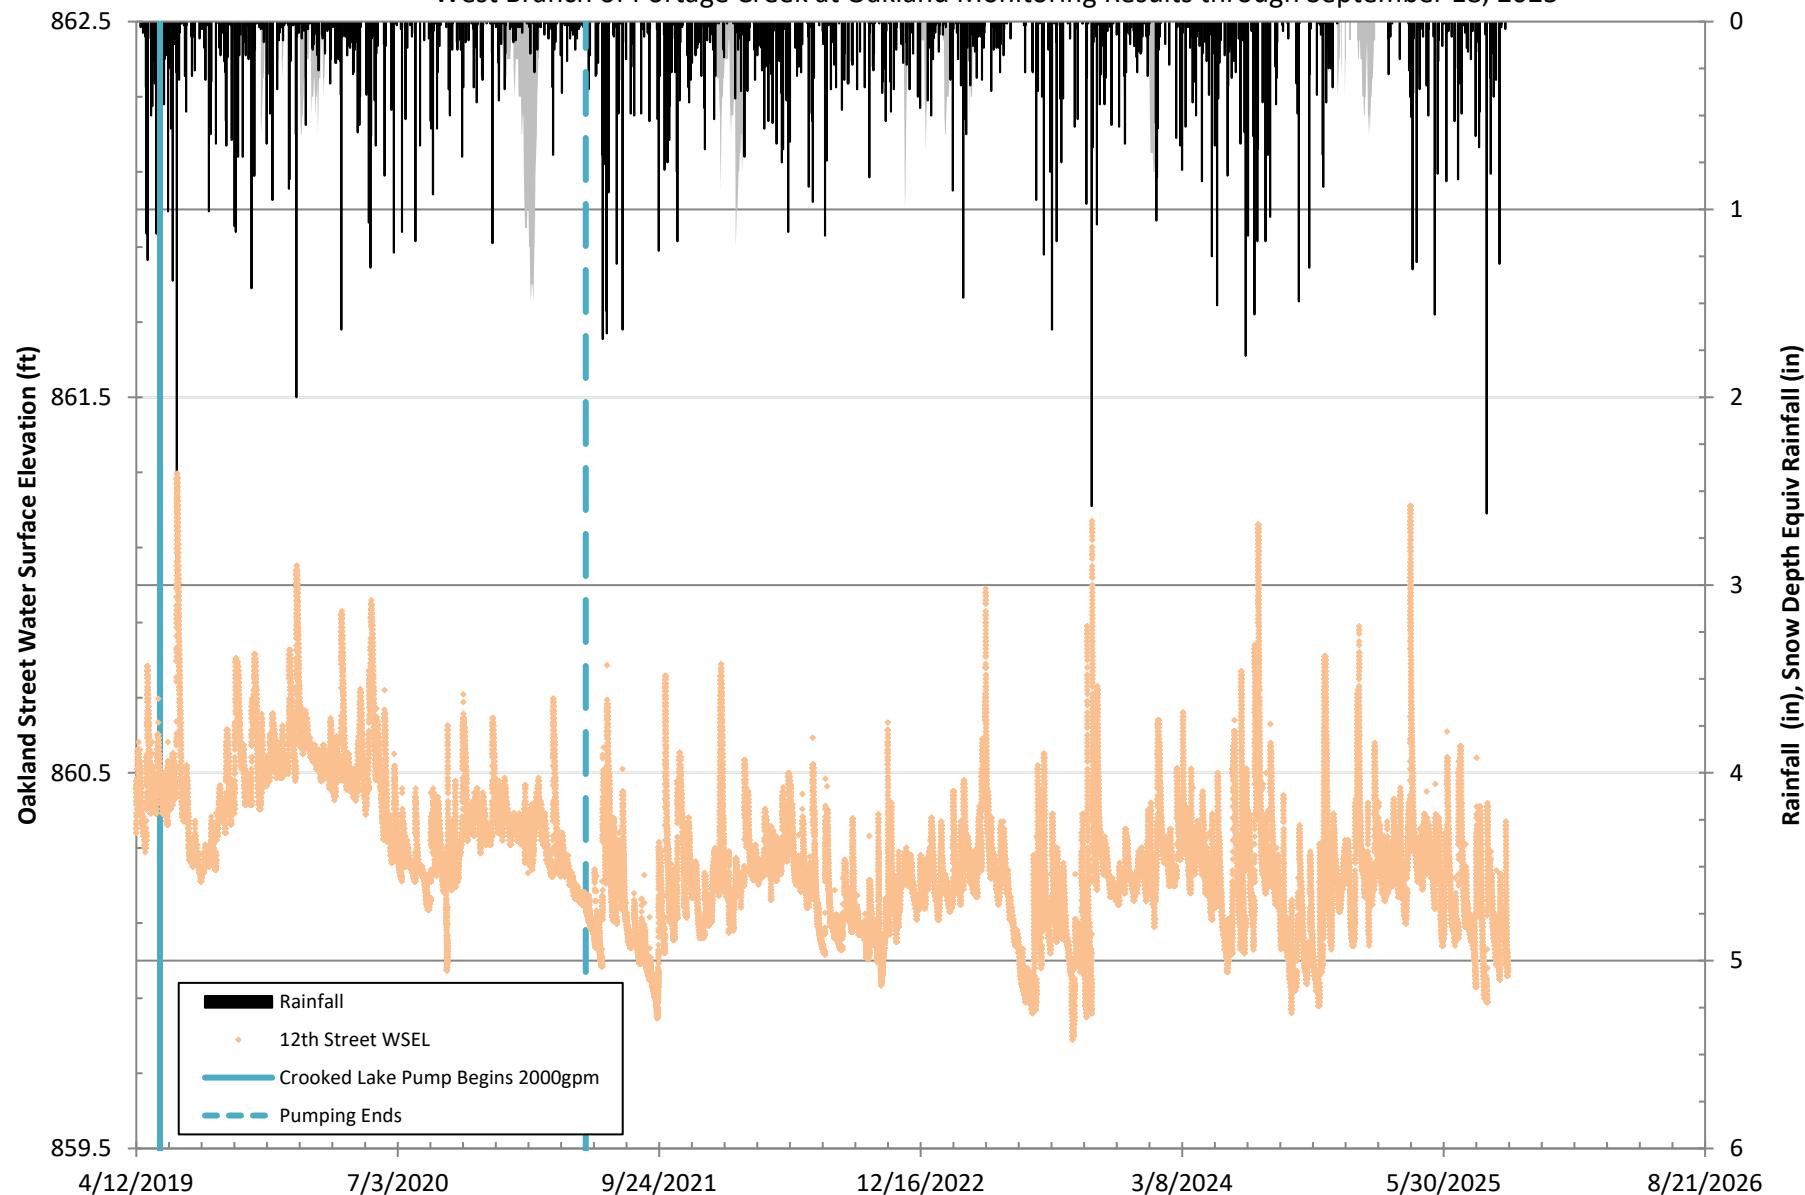
Figure

West Branch of Portage Creek at Oakland Monitoring Results through September 18, 2025

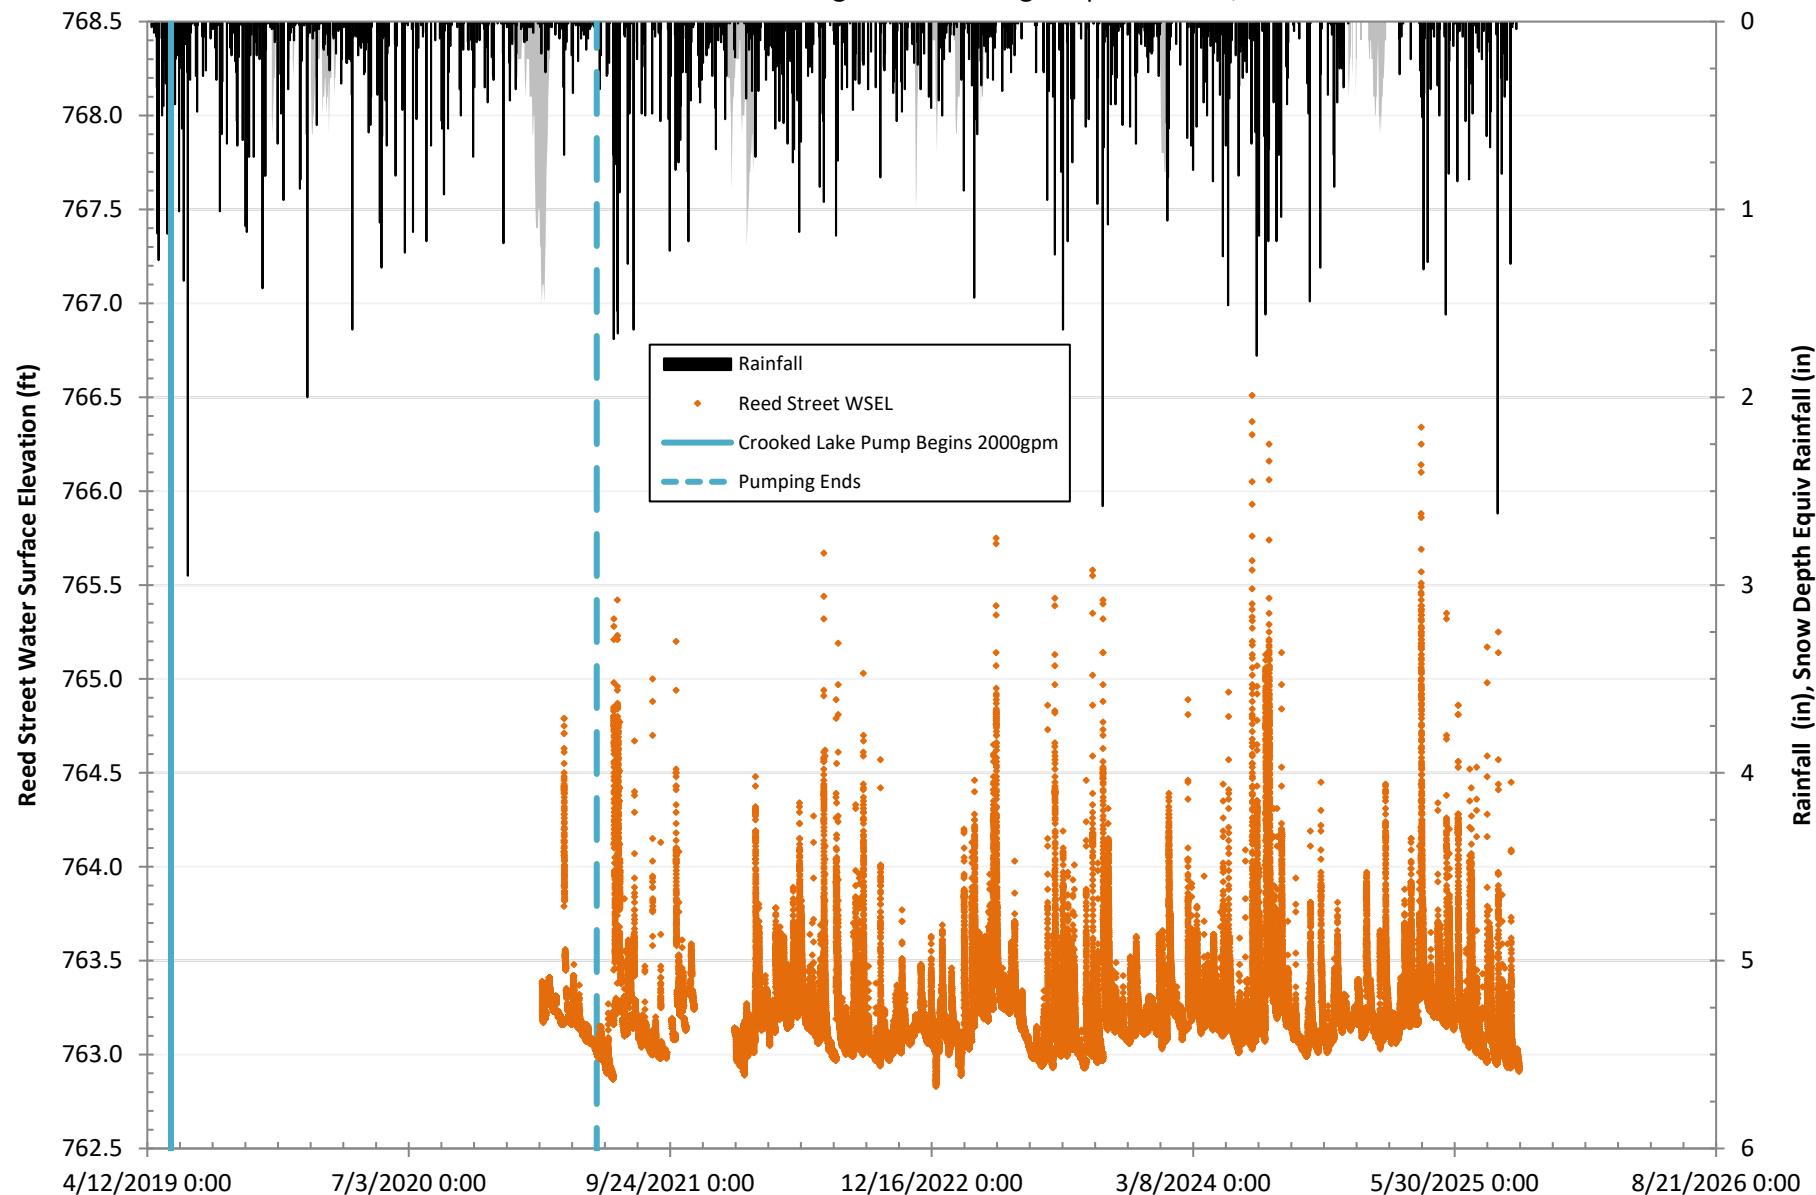
Charter Township of Texas Flood Study
Figure
Reed Street Monitoring Results through September 18, 2025
