Charter Township of Texas Flood Study

Eagle Lake Monitoring Results through September 17, 2020

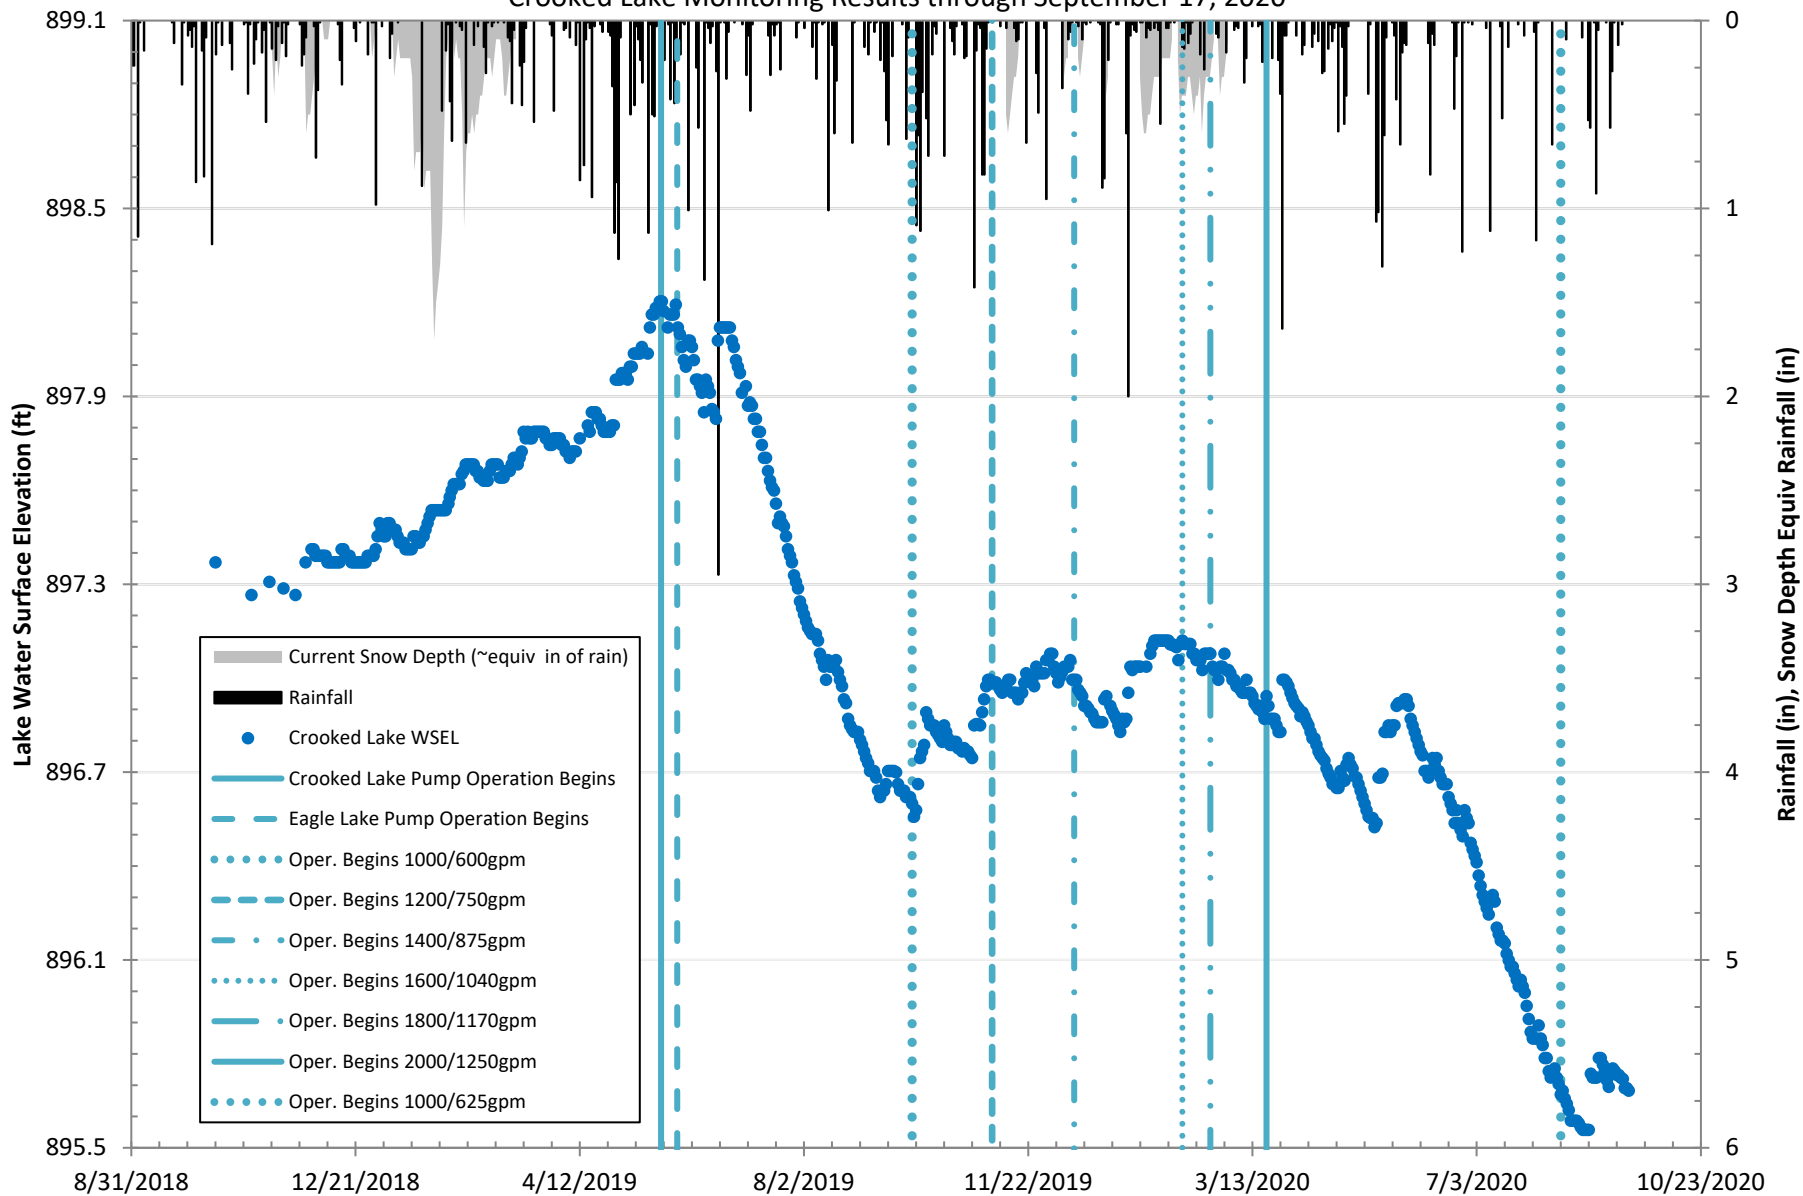
Crooked Lake Monitoring Results through September 17, 2020

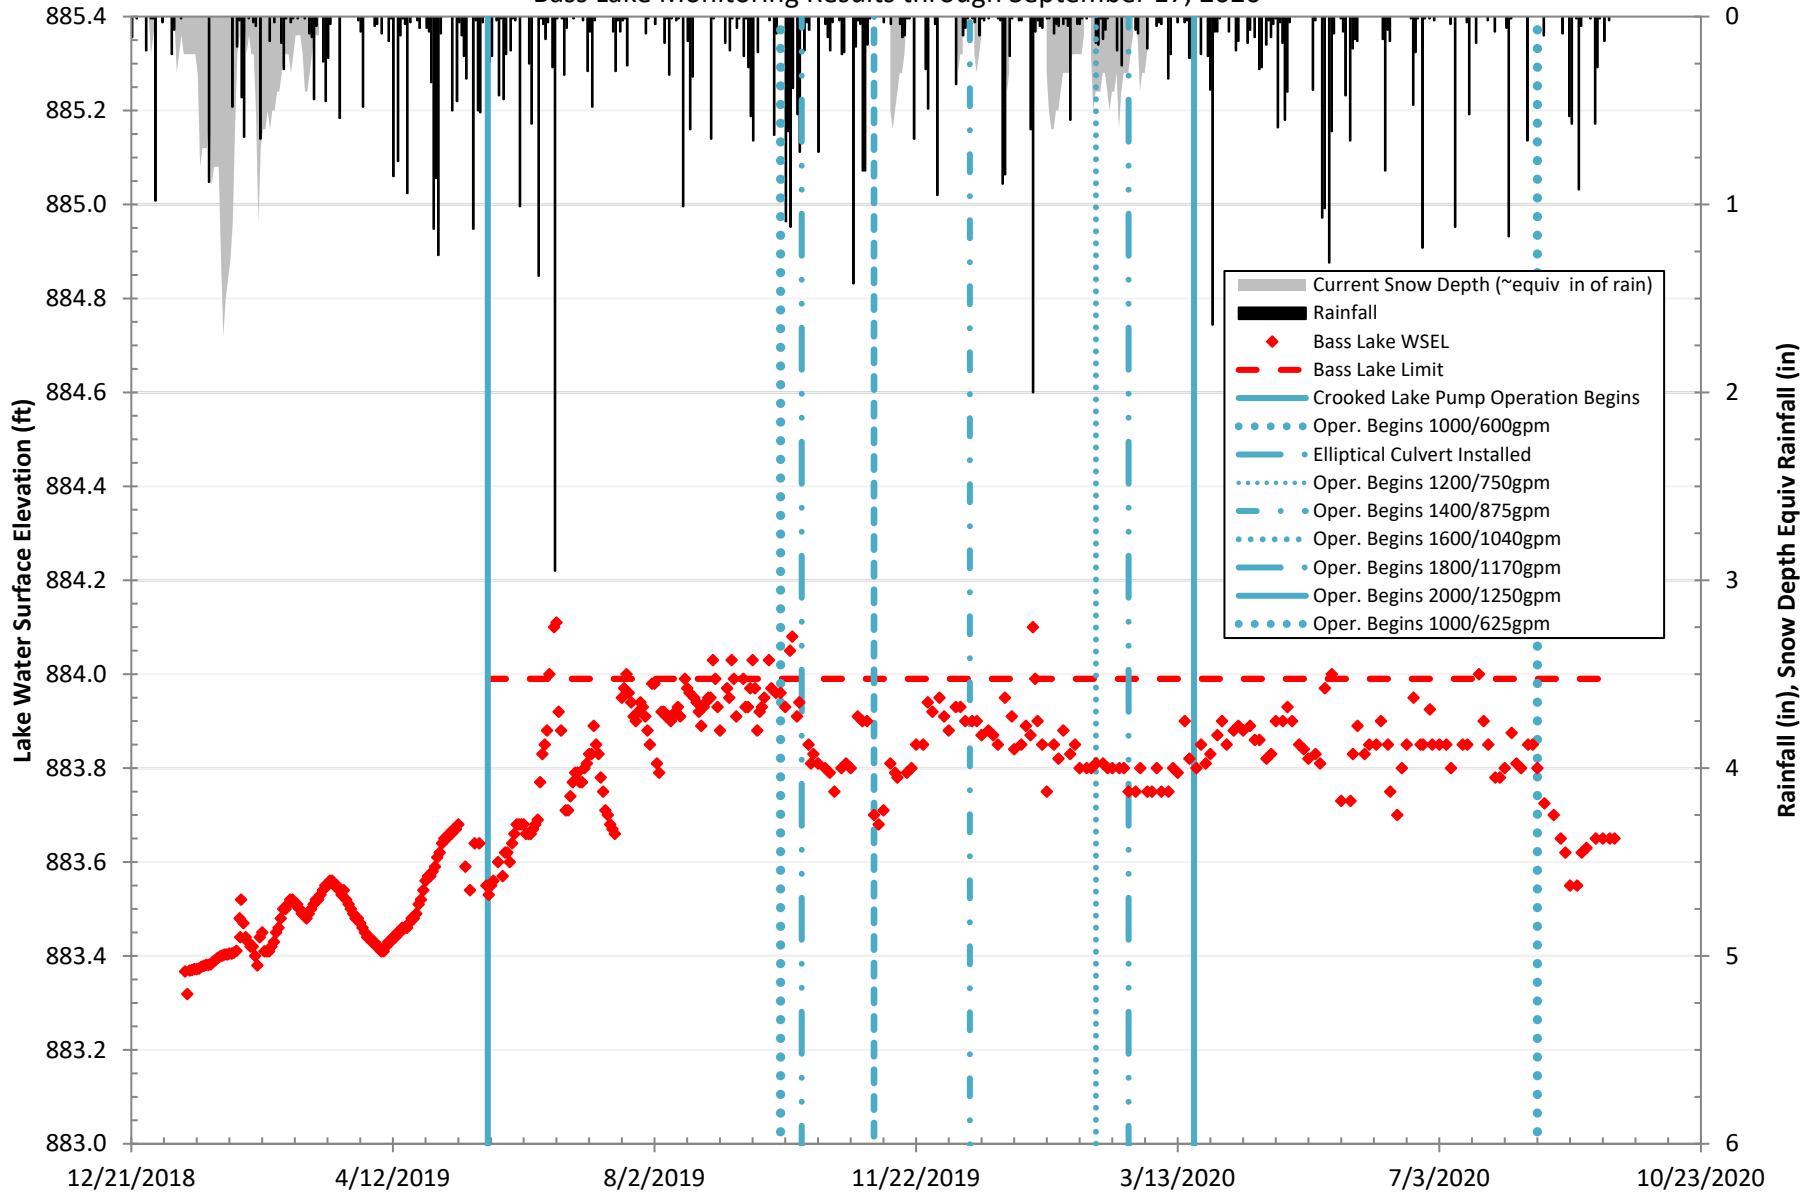
Bass Lake Monitoring Results through September 17, 2020

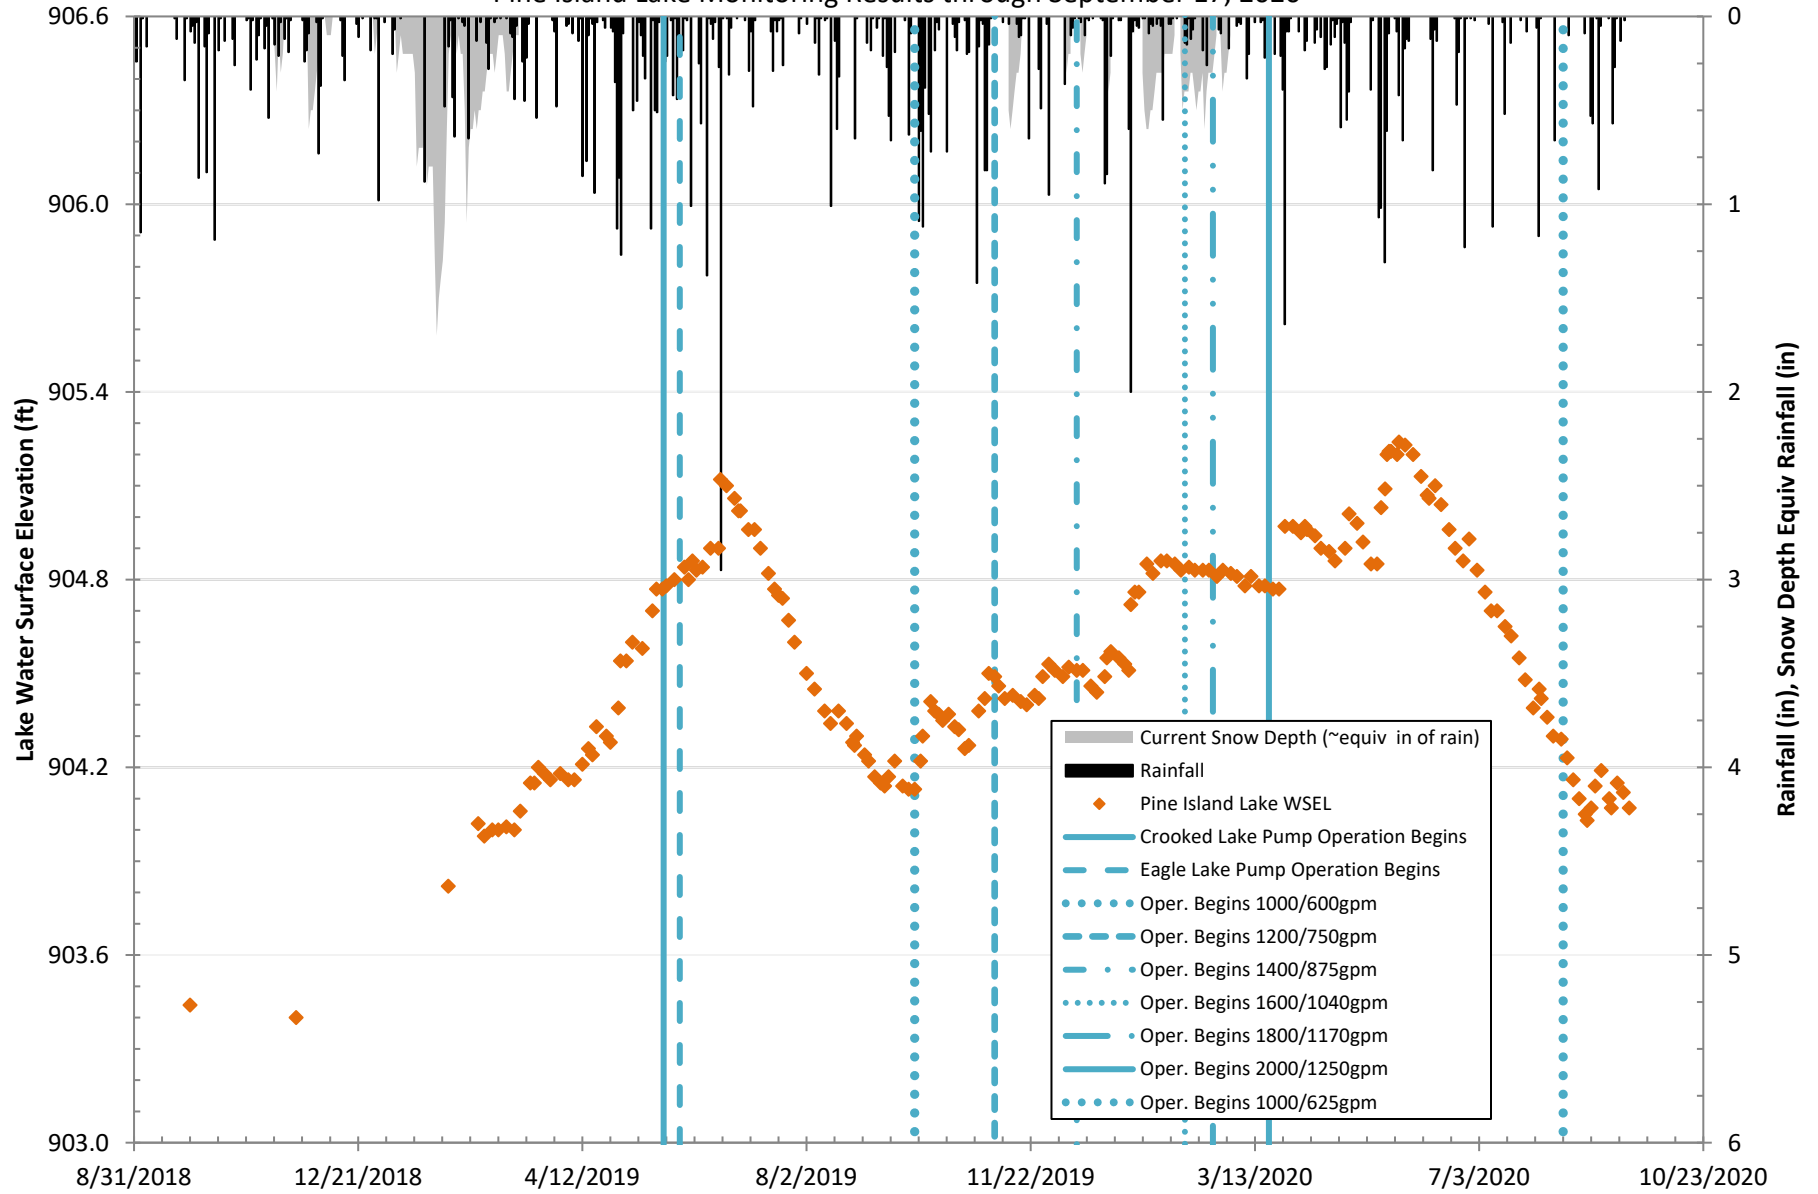
Pine Island Lake Monitoring Results through September 17, 2020

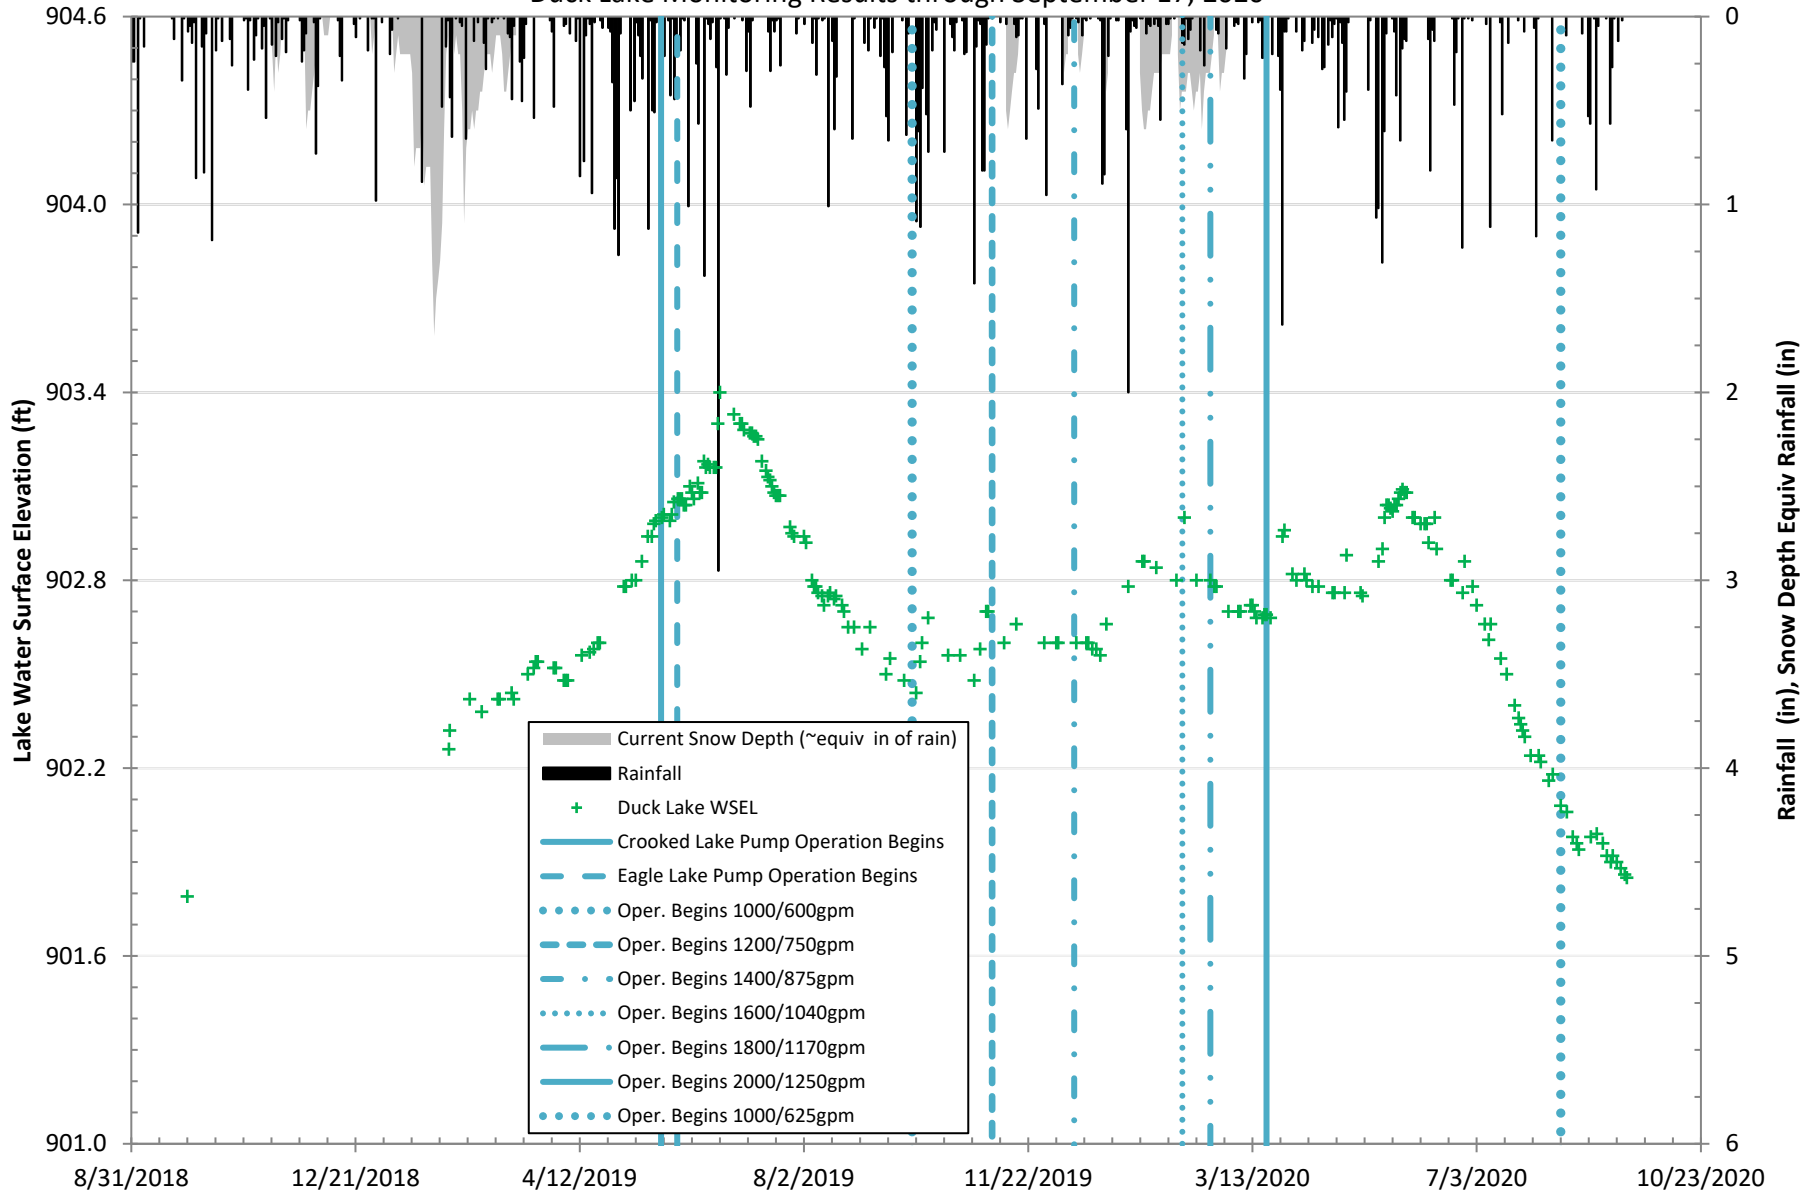
Duck Lake Monitoring Results through September 17, 2020

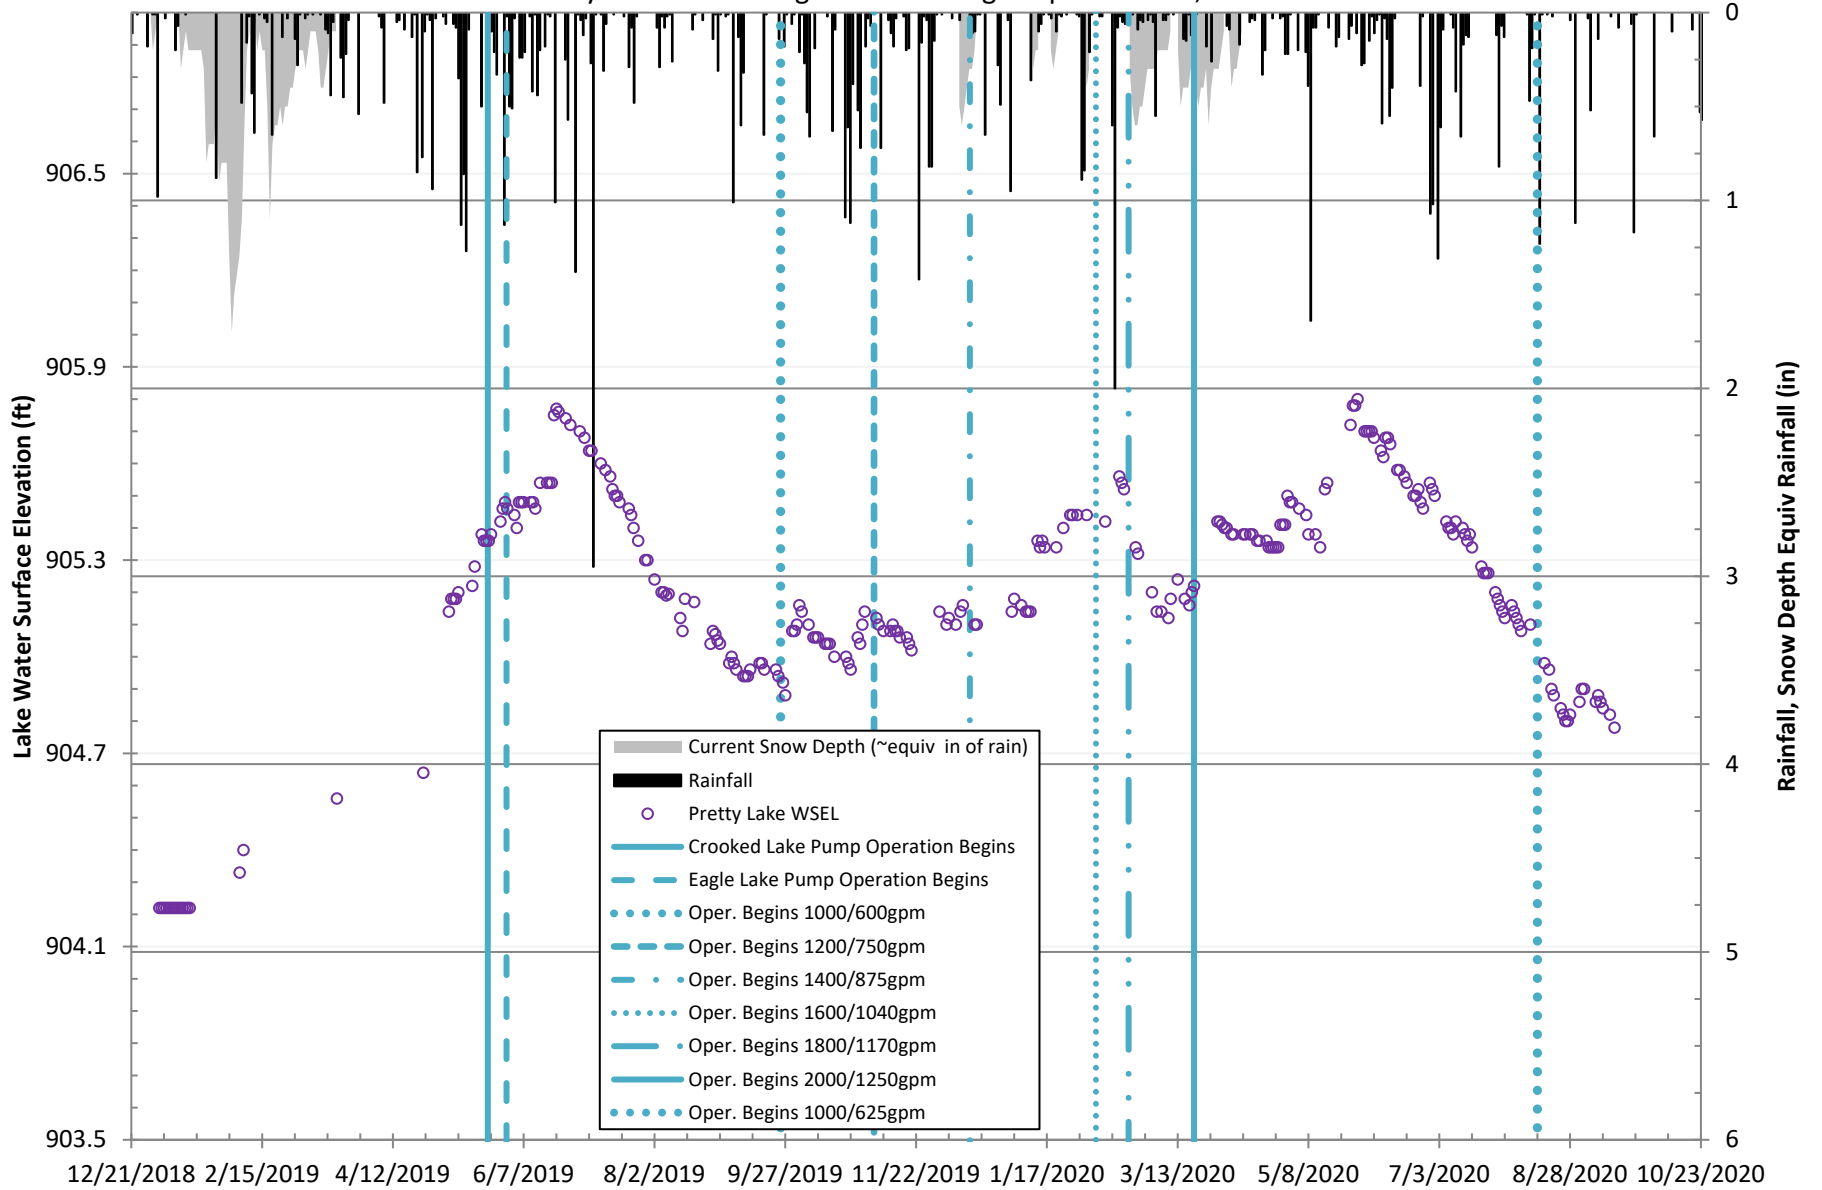
Pretty Lake Monitoring Results through September 17, 2020

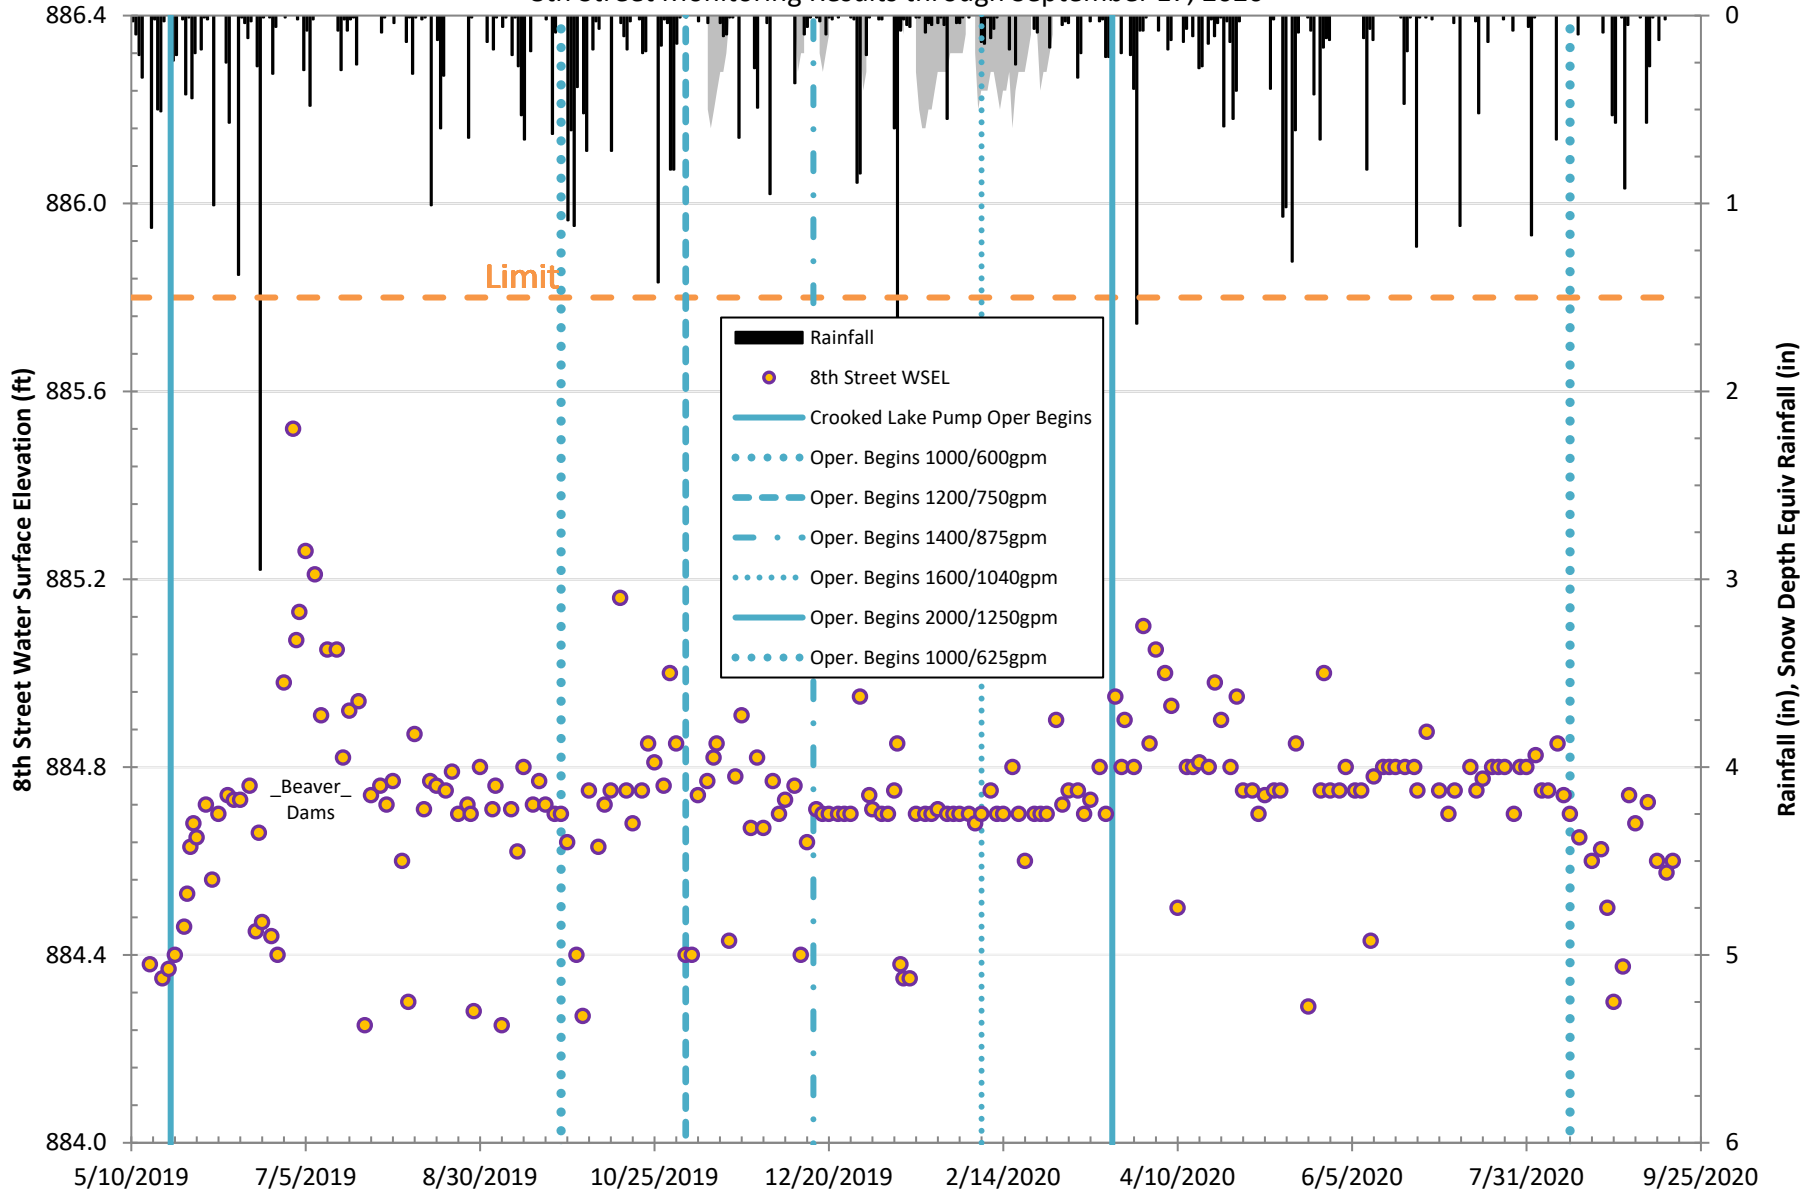
8th Street Monitoring Results through September 17, 2020

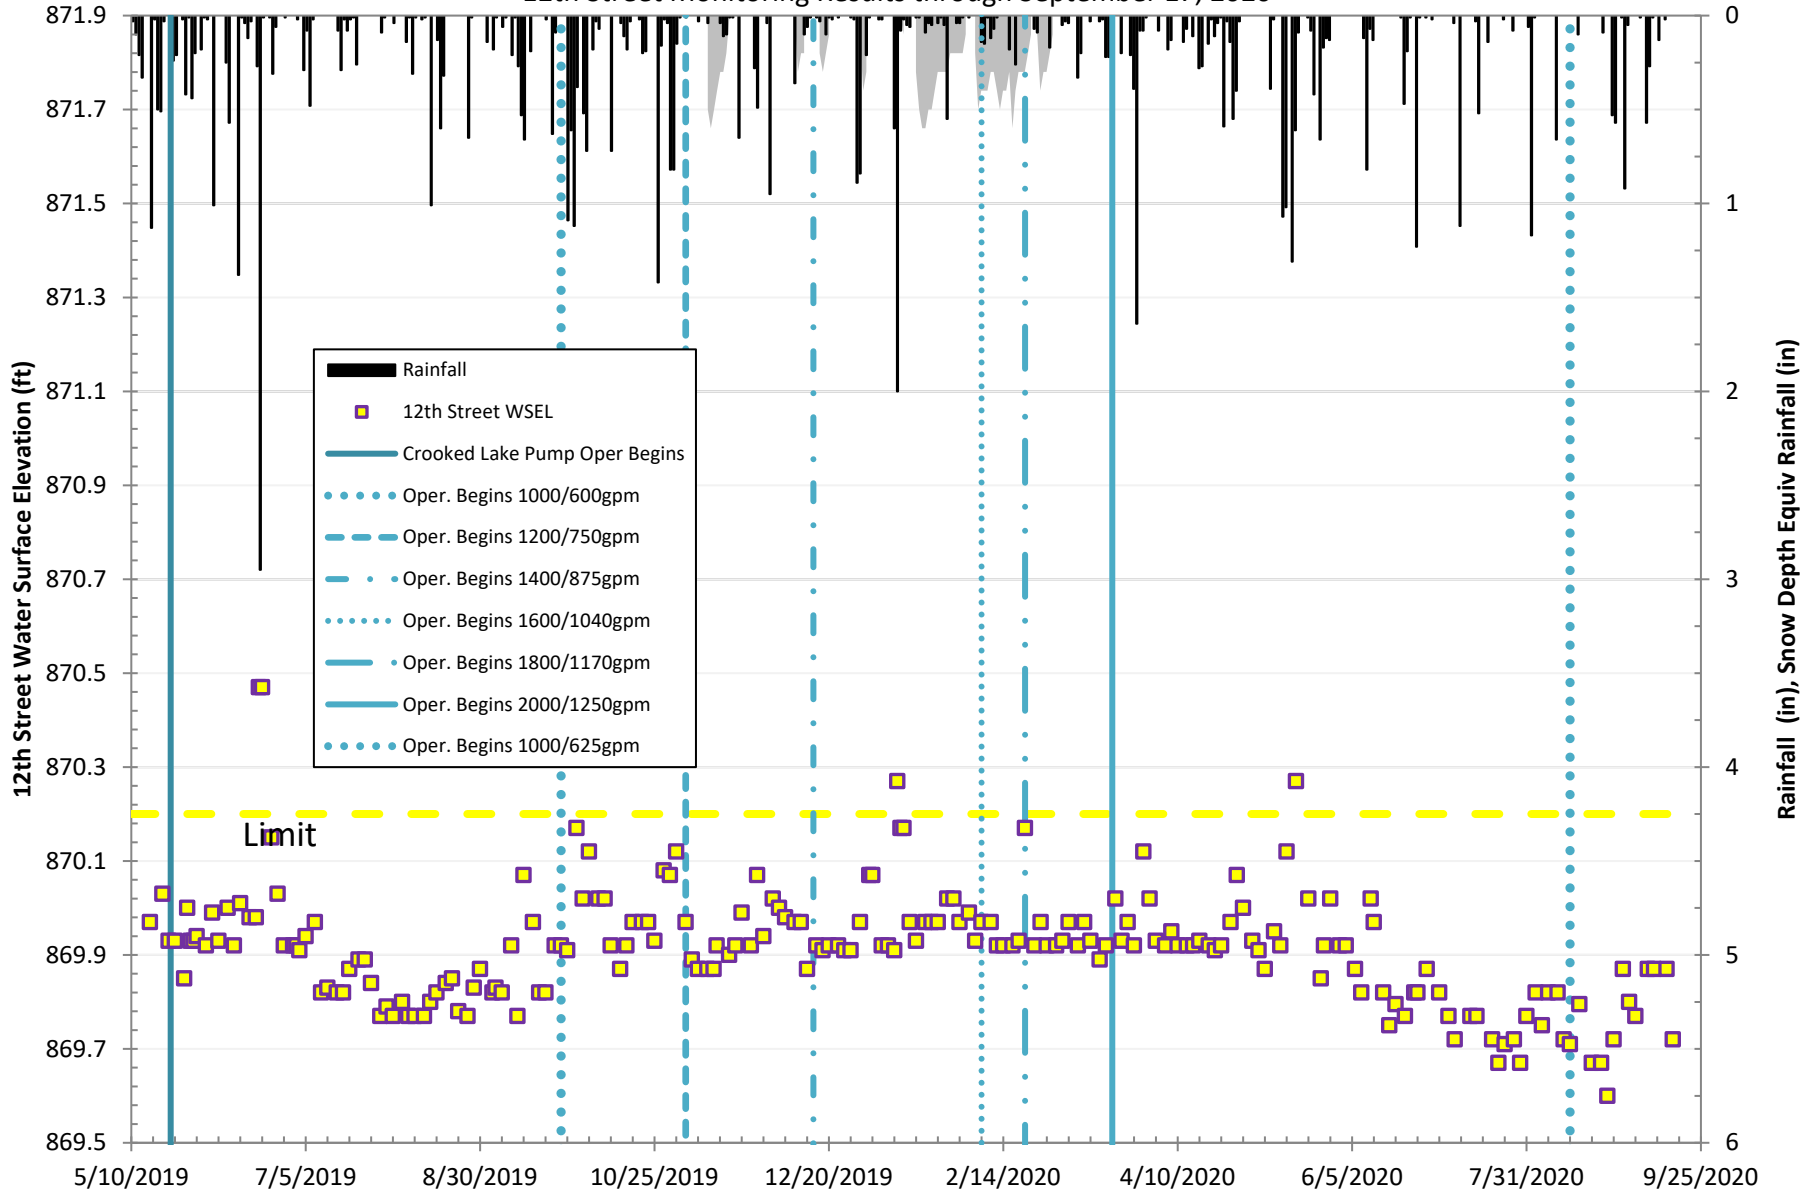
12th Street Monitoring Results through September 17, 2020

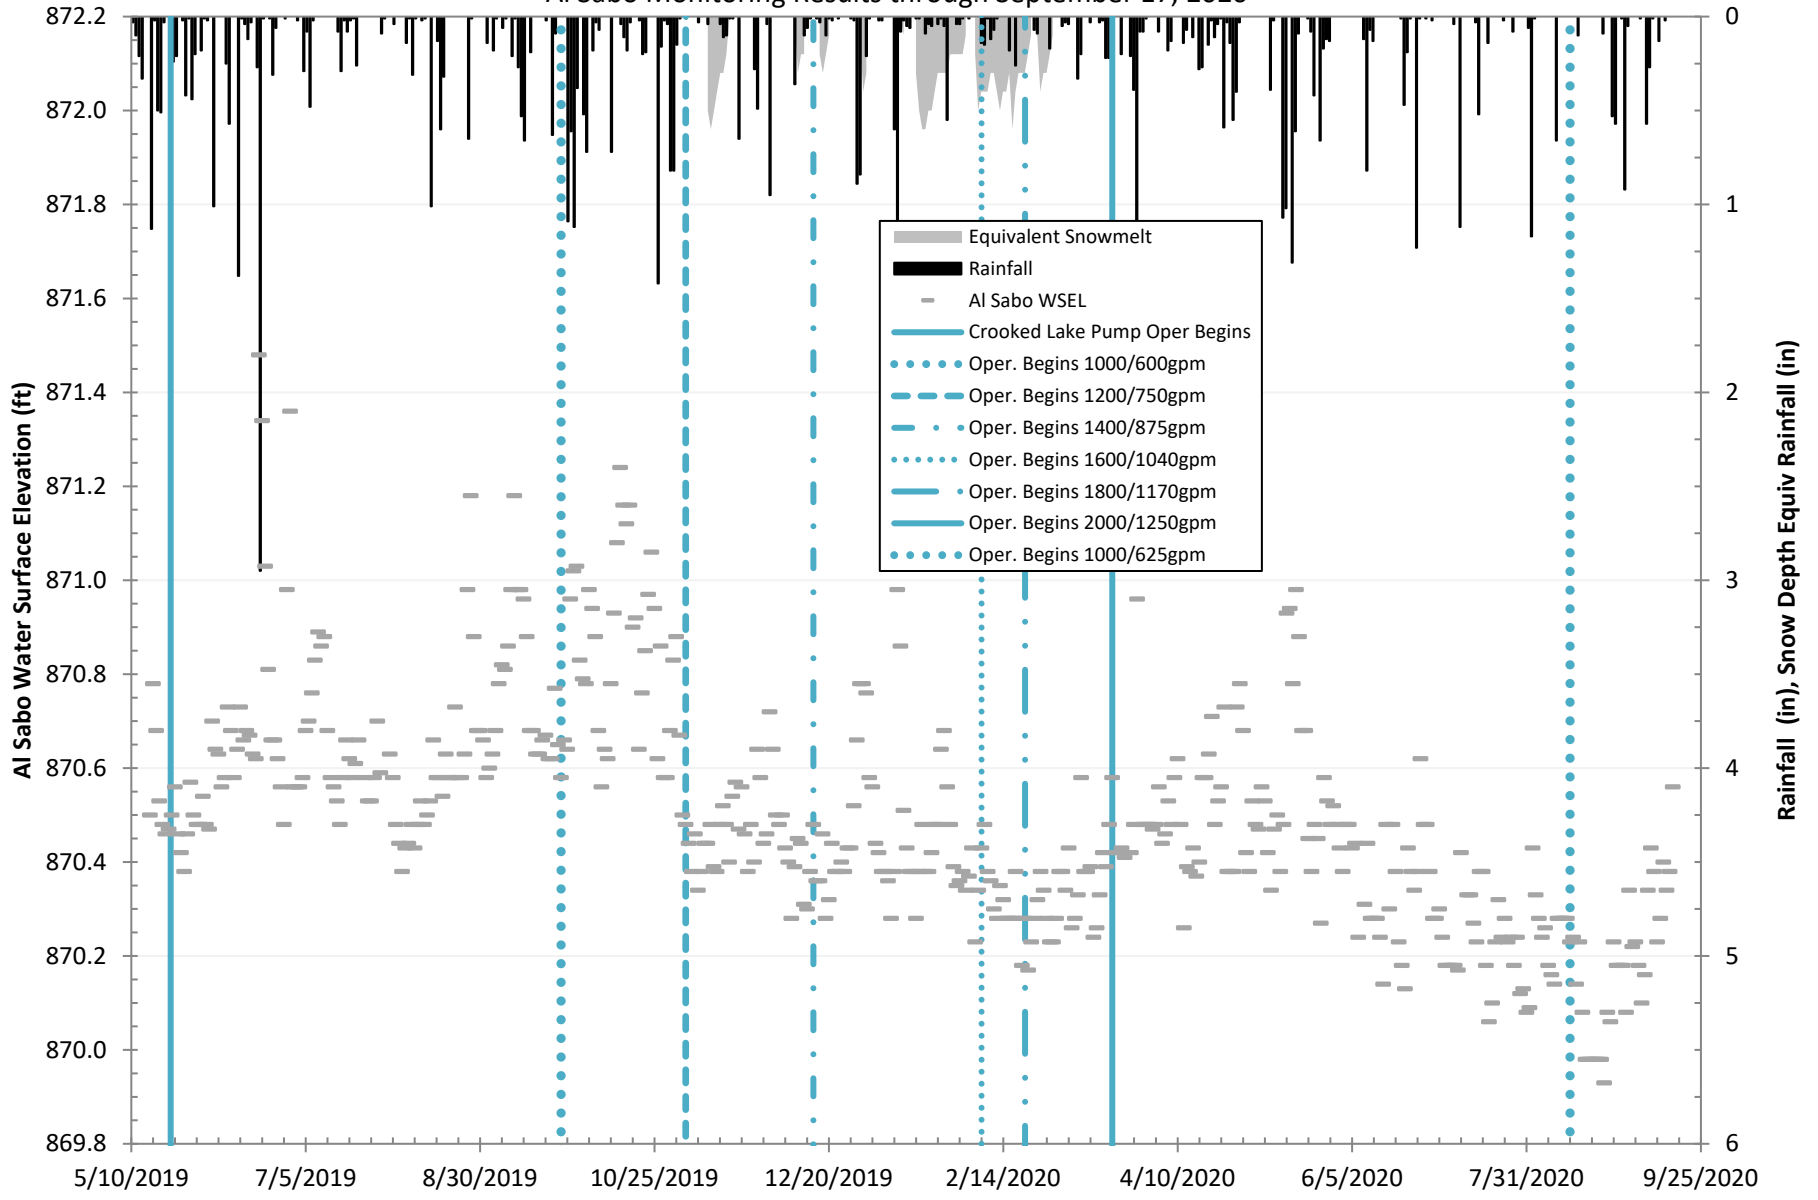
Al Sabo Monitoring Results through September 17, 2020

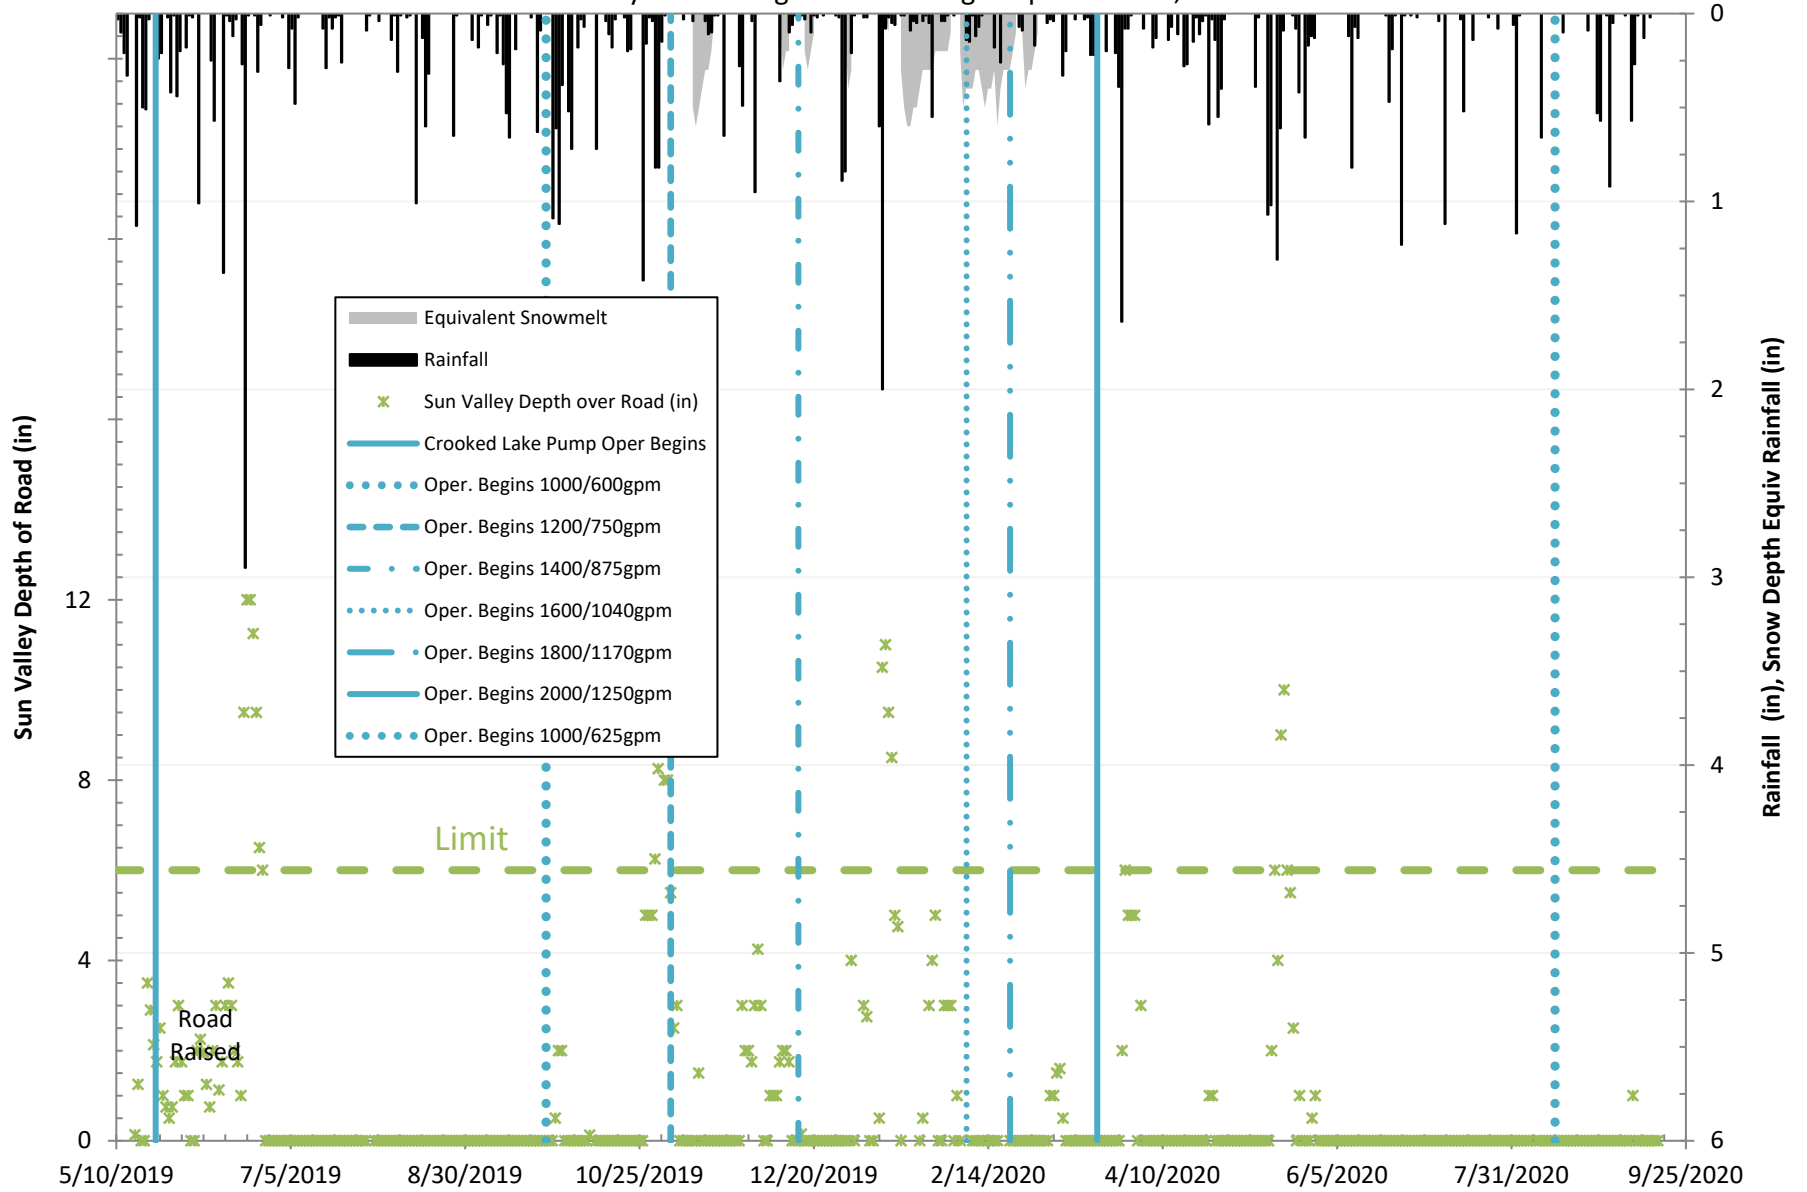
Sun Valley Monitoring Results through September 17, 2020

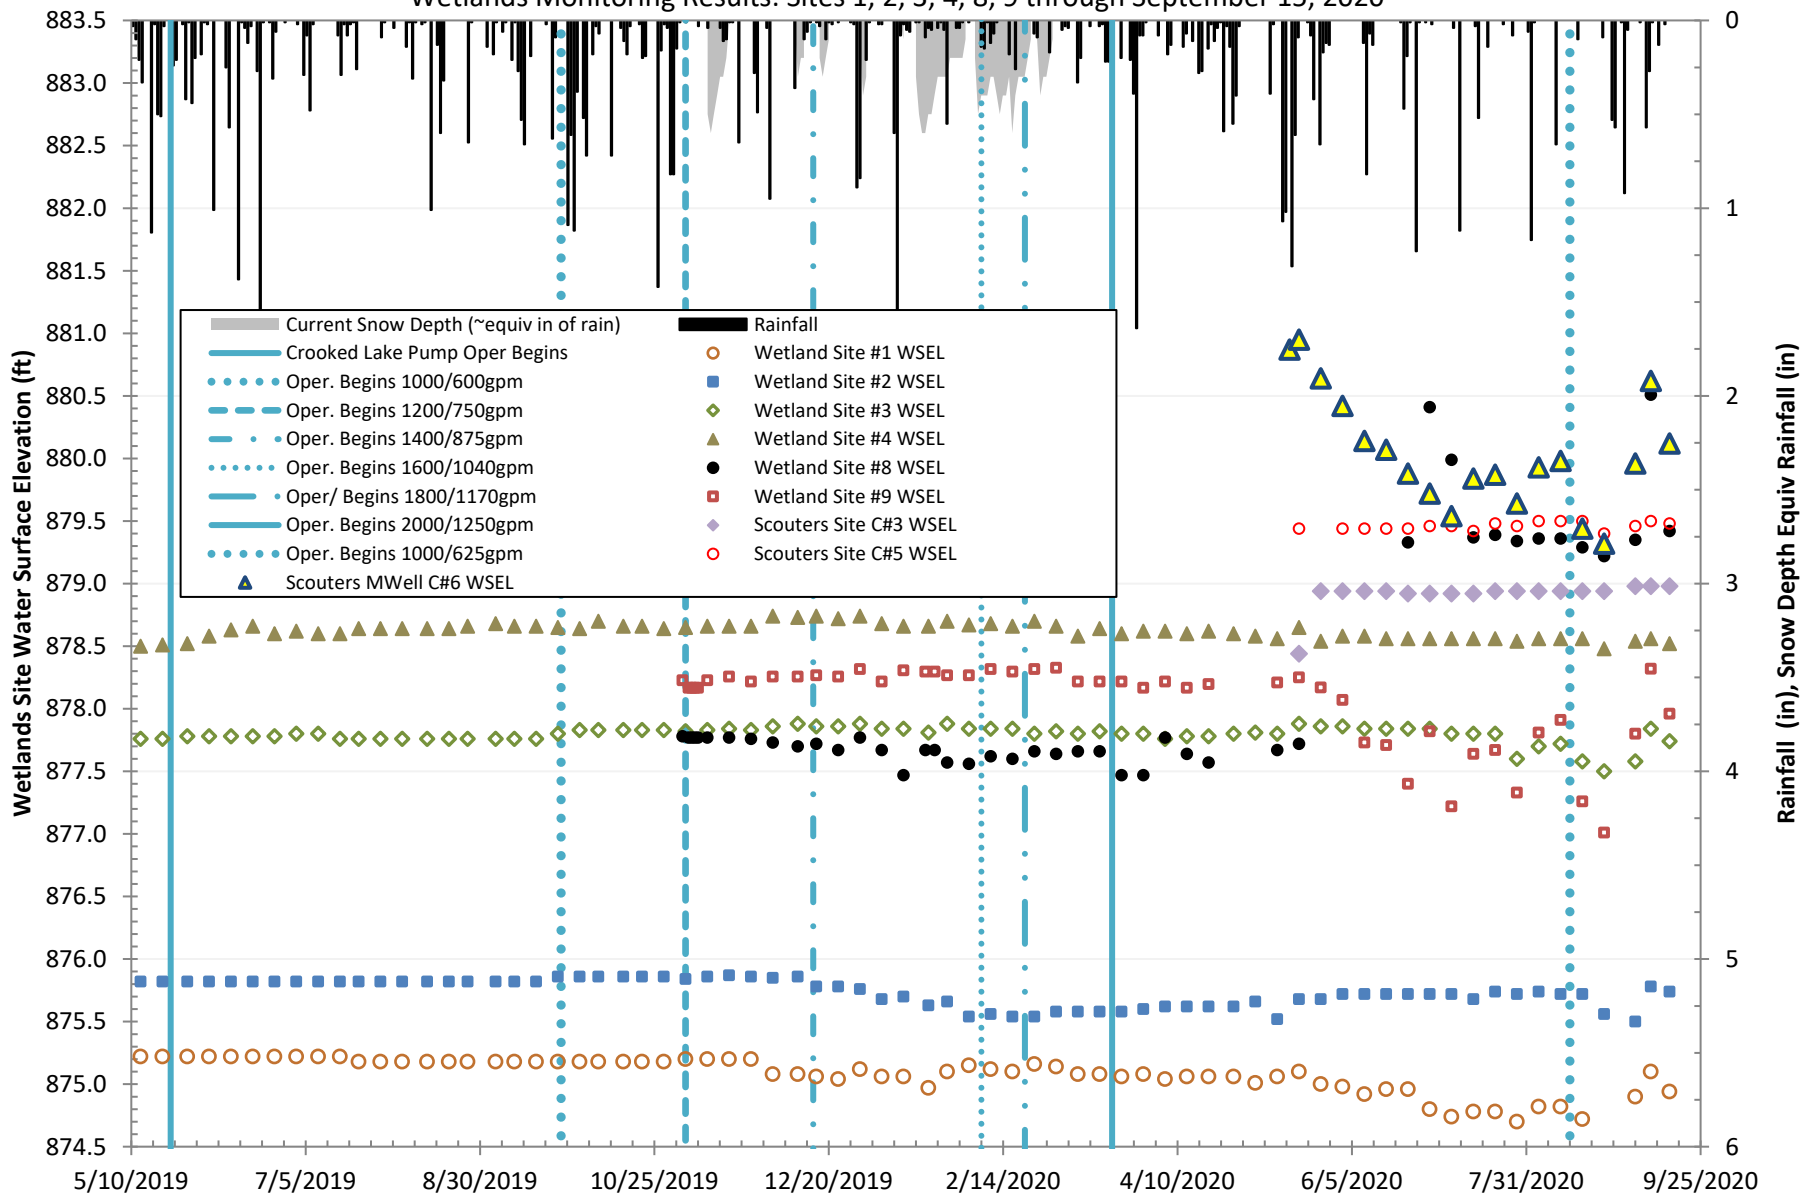
Wetlands Monitoring Results: Sites 1, 2, 3, 4, 8, 9 through September 15, 2020
