Charter Township of Texas Flood Study

Eagle Lake Monitoring Results through September 17, 2020

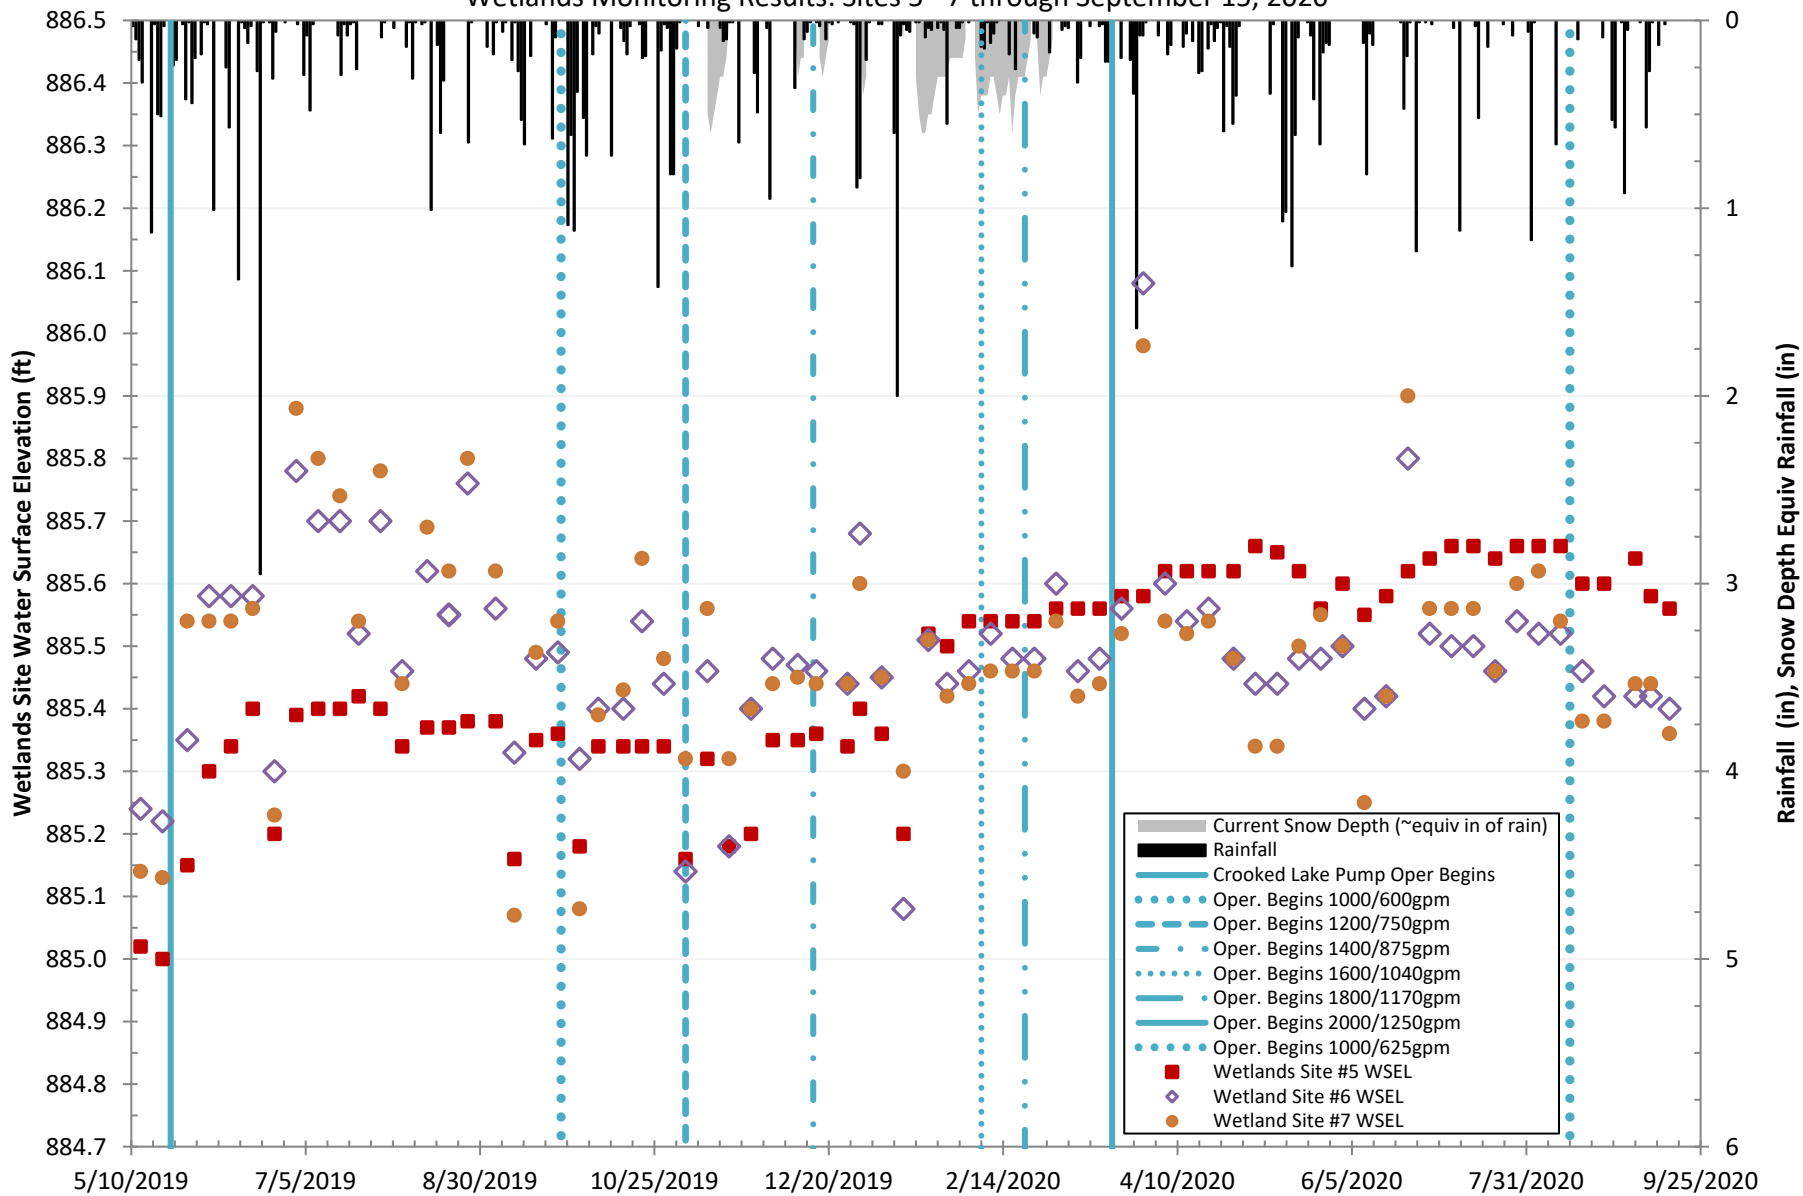
Wetlands Monitoring Results: Sites 5 - 7 through September 15, 2020

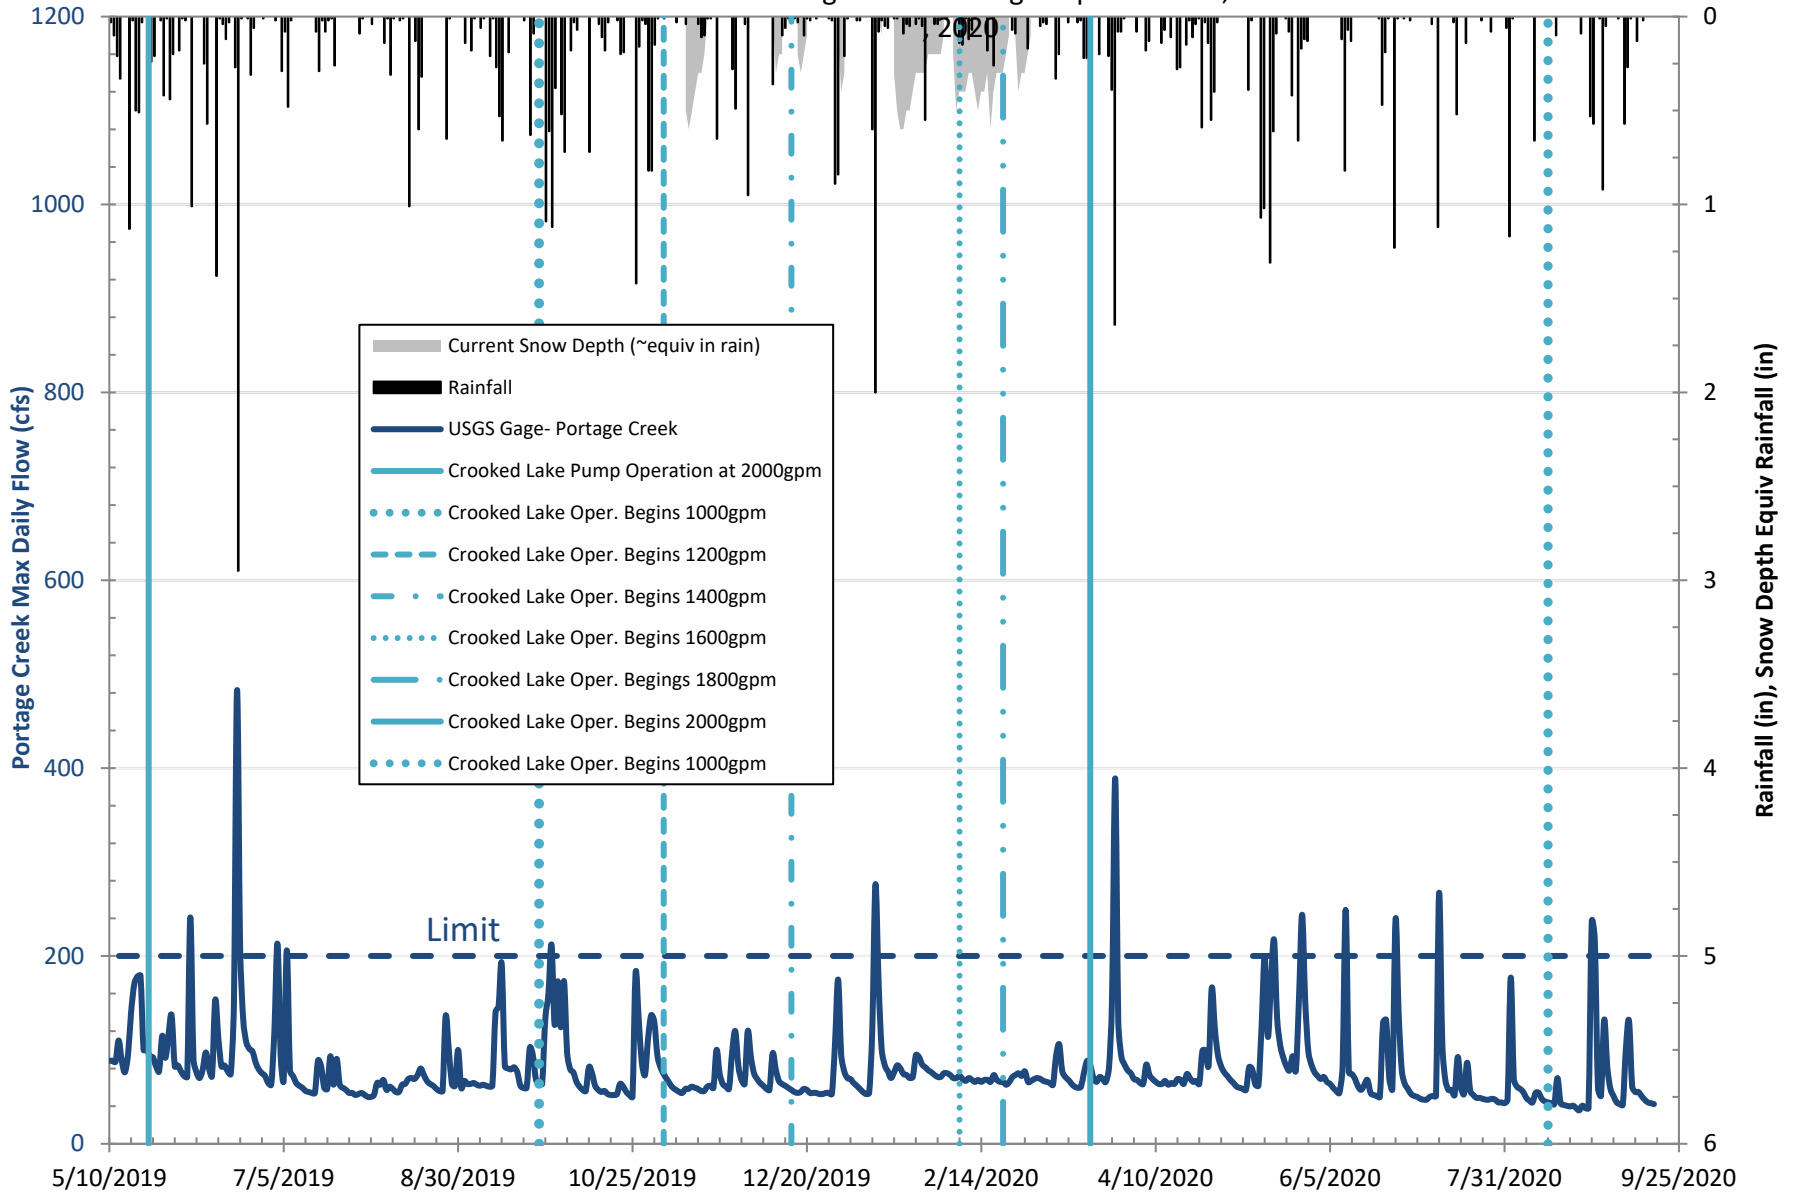
Charter Township of Texas Flood Study
 Figure
 USGS Monitoring Results through September 17, 2020

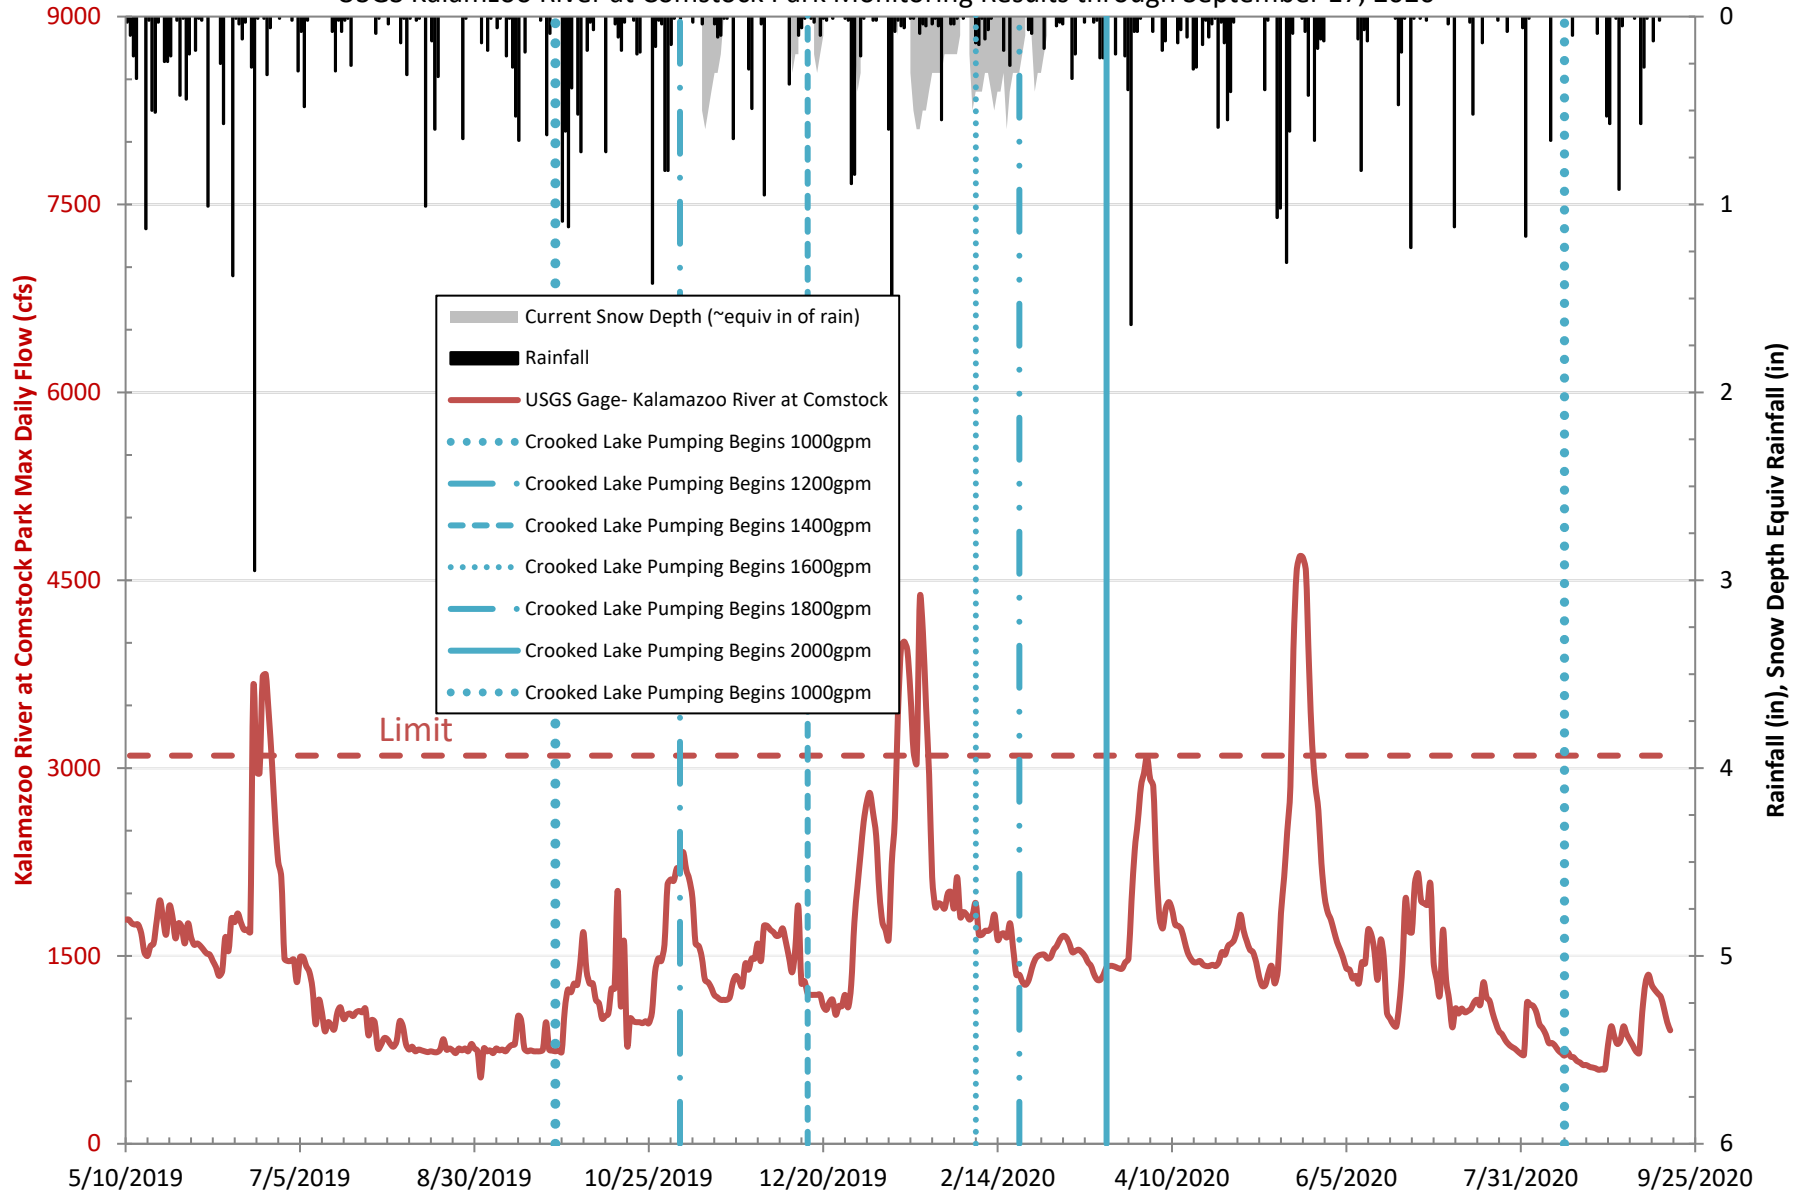
USGS Kalamazoo River at Comstock Park Monitoring Results through September 17, 2020

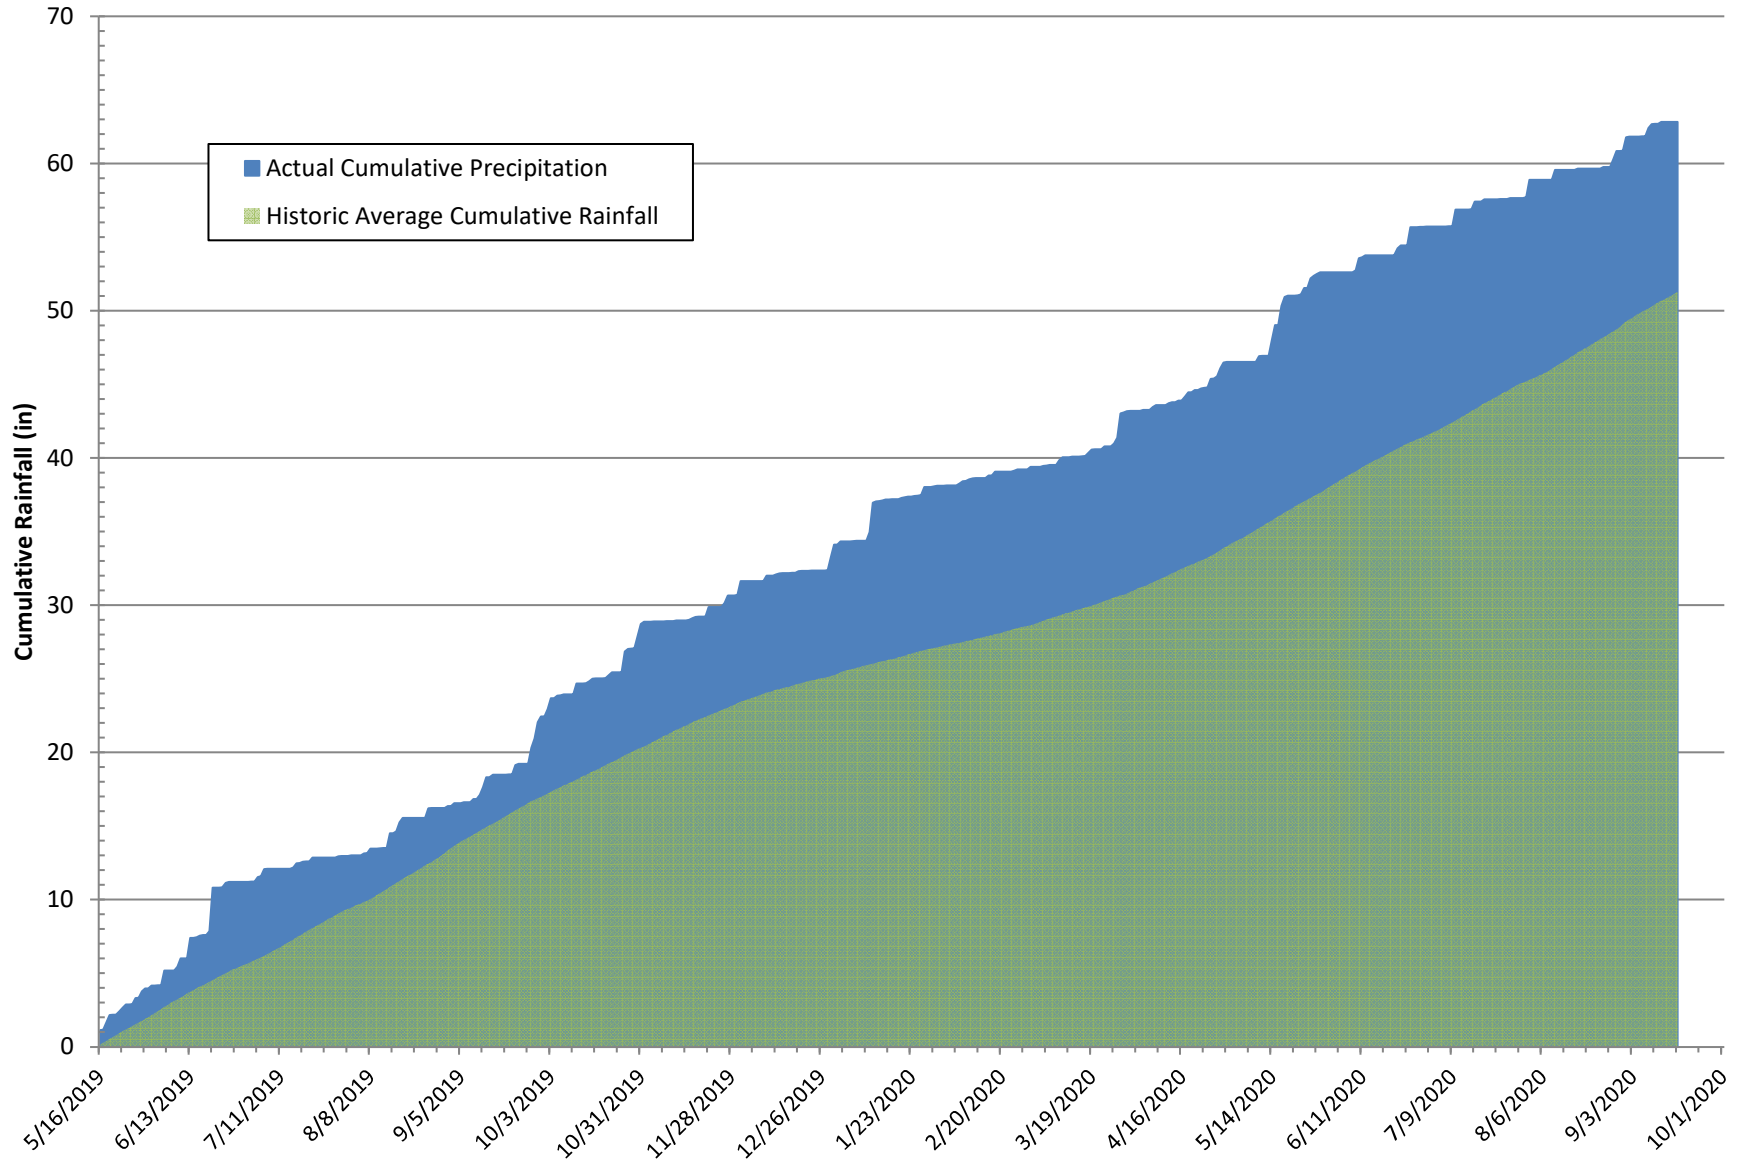
Average Rainfall vs Actual Rainfall from May 16, 2019 through September 17, 2020

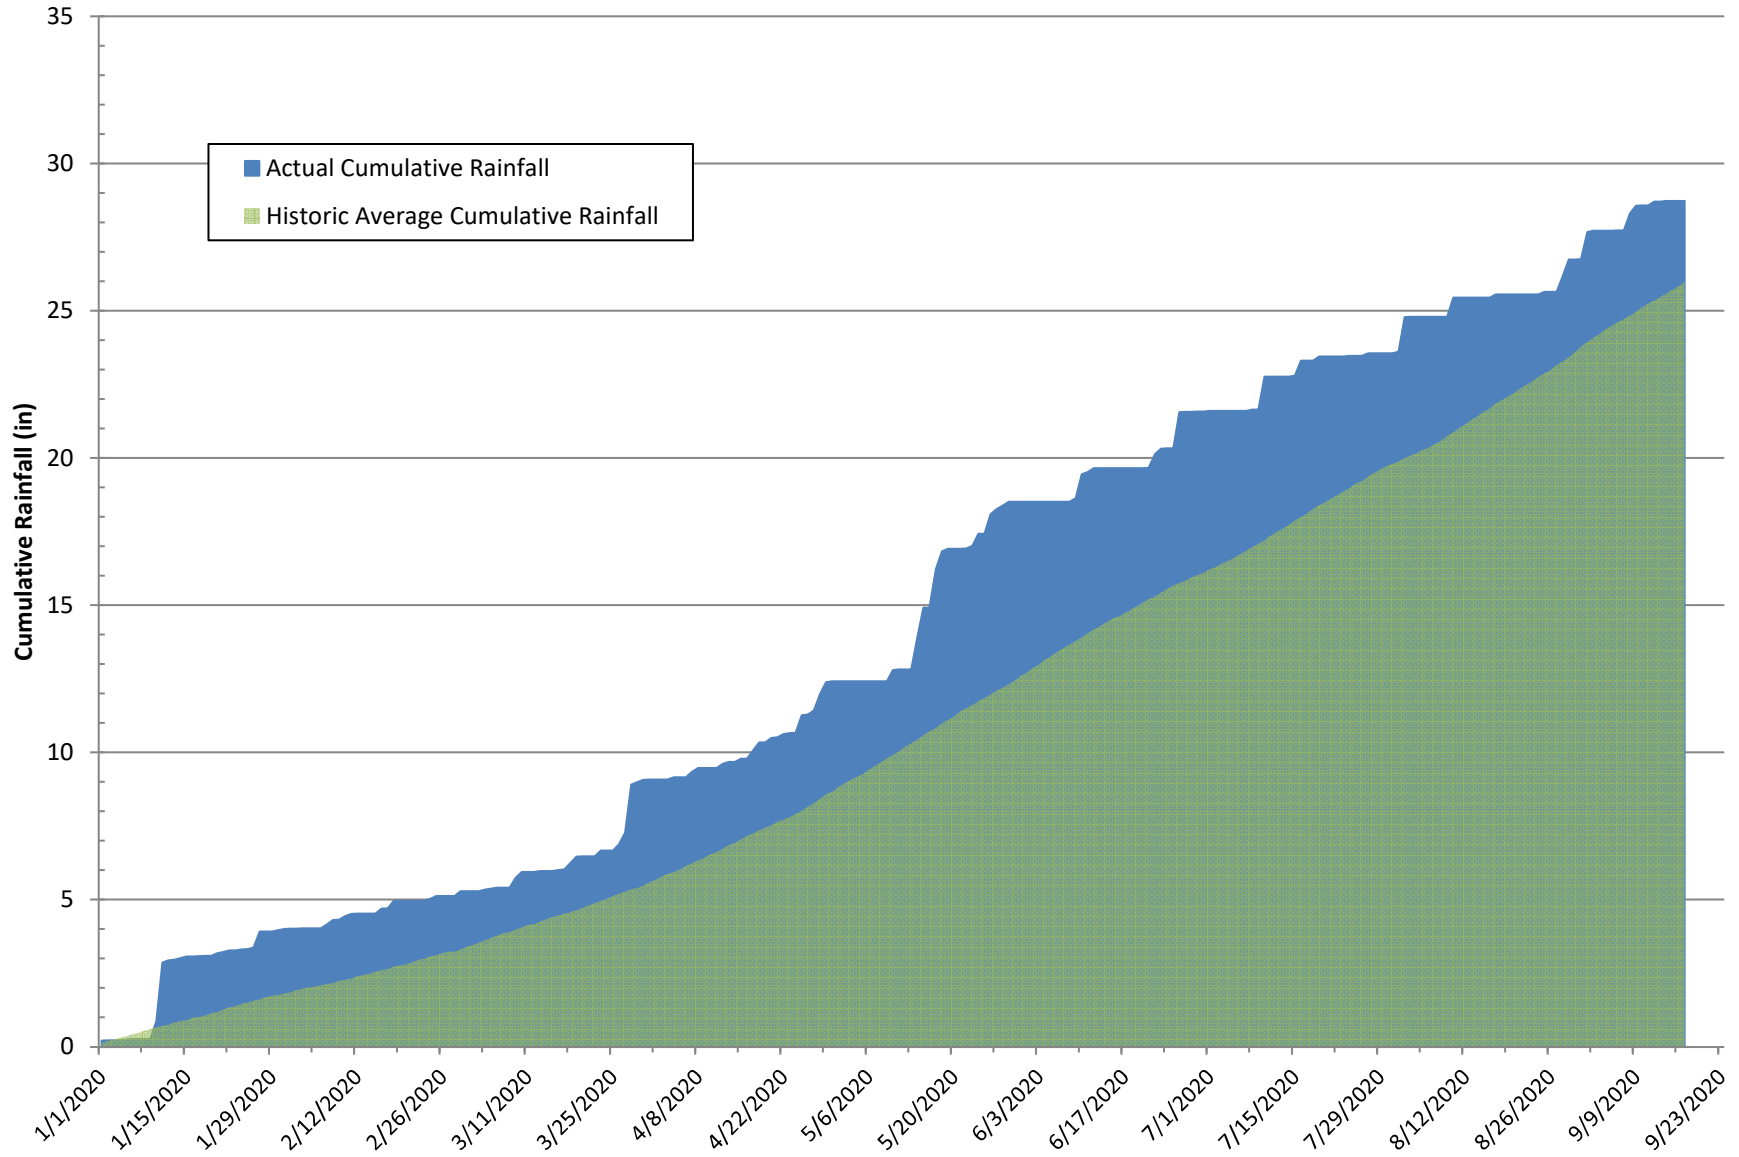
Average Rainfall vs Actual Rainfall - January 1, 2020 through September 17, 2020

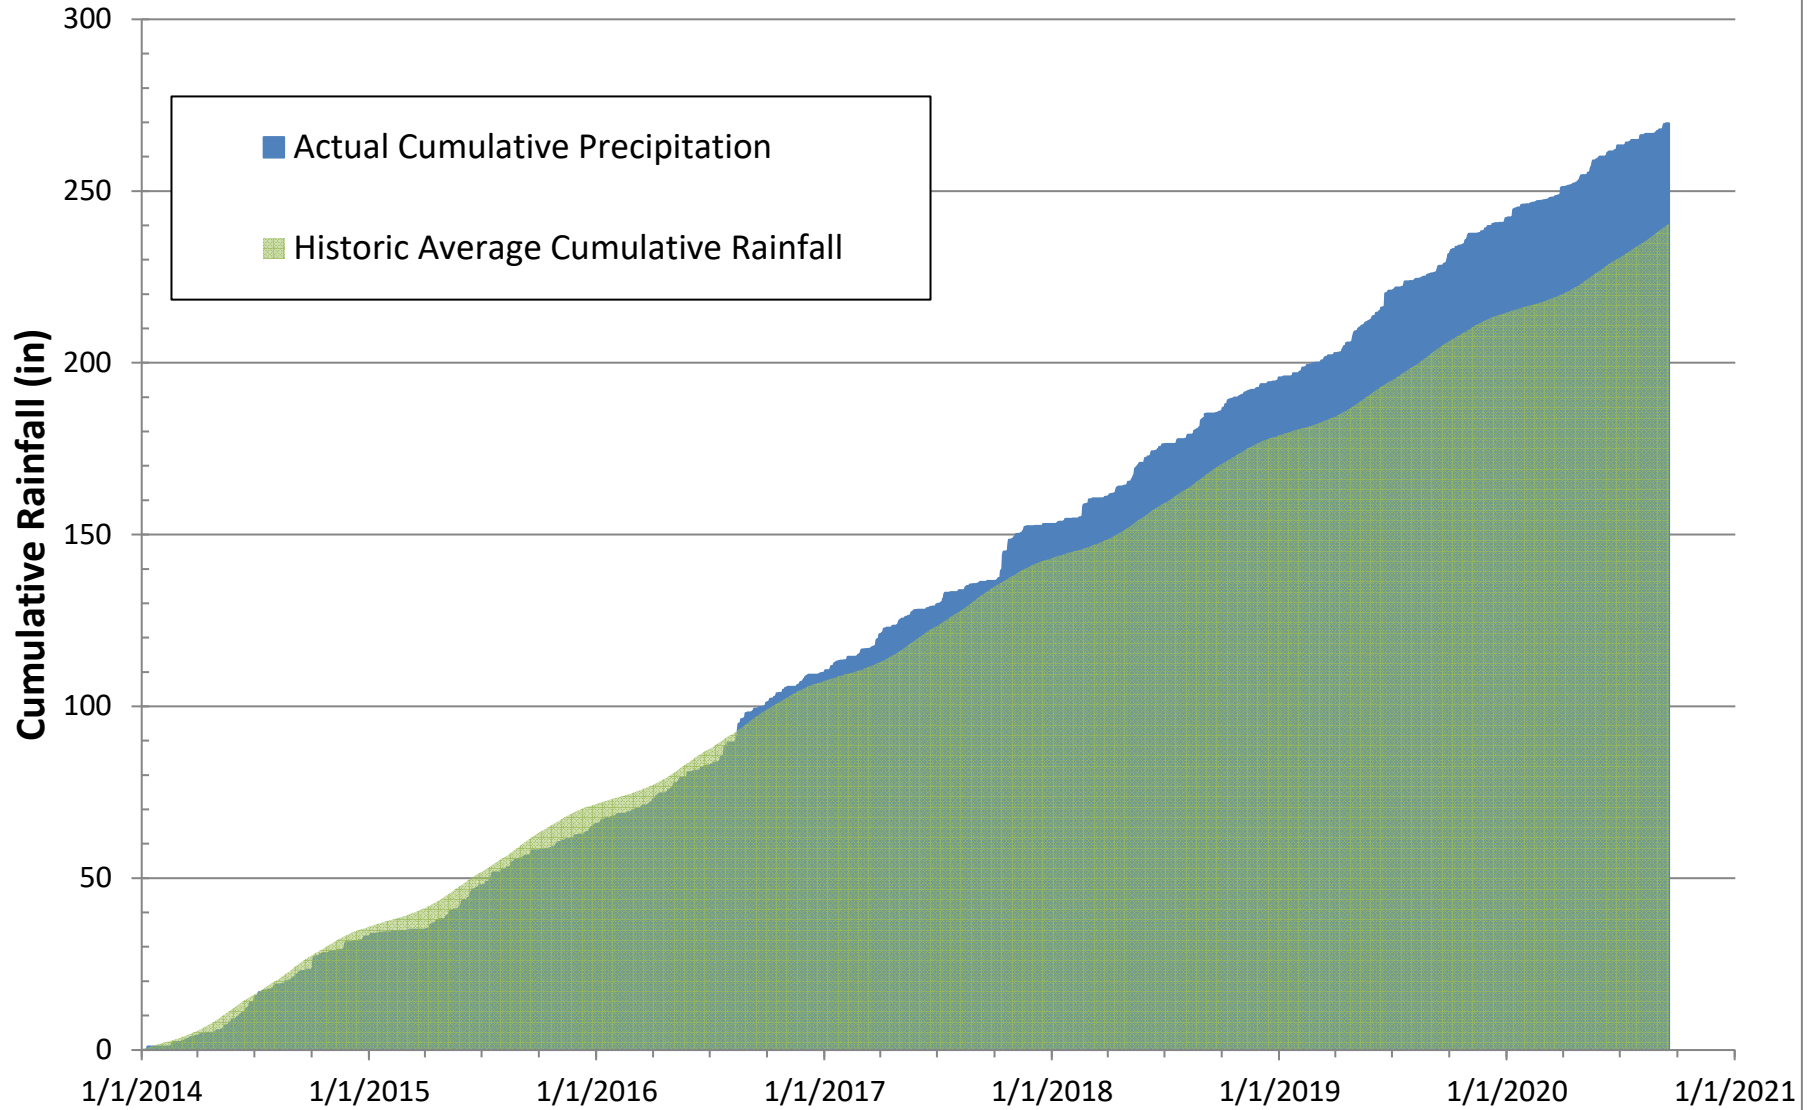
Average Rainfall vs Actual Rainfall - January 1, 2014 through September 17, 2020

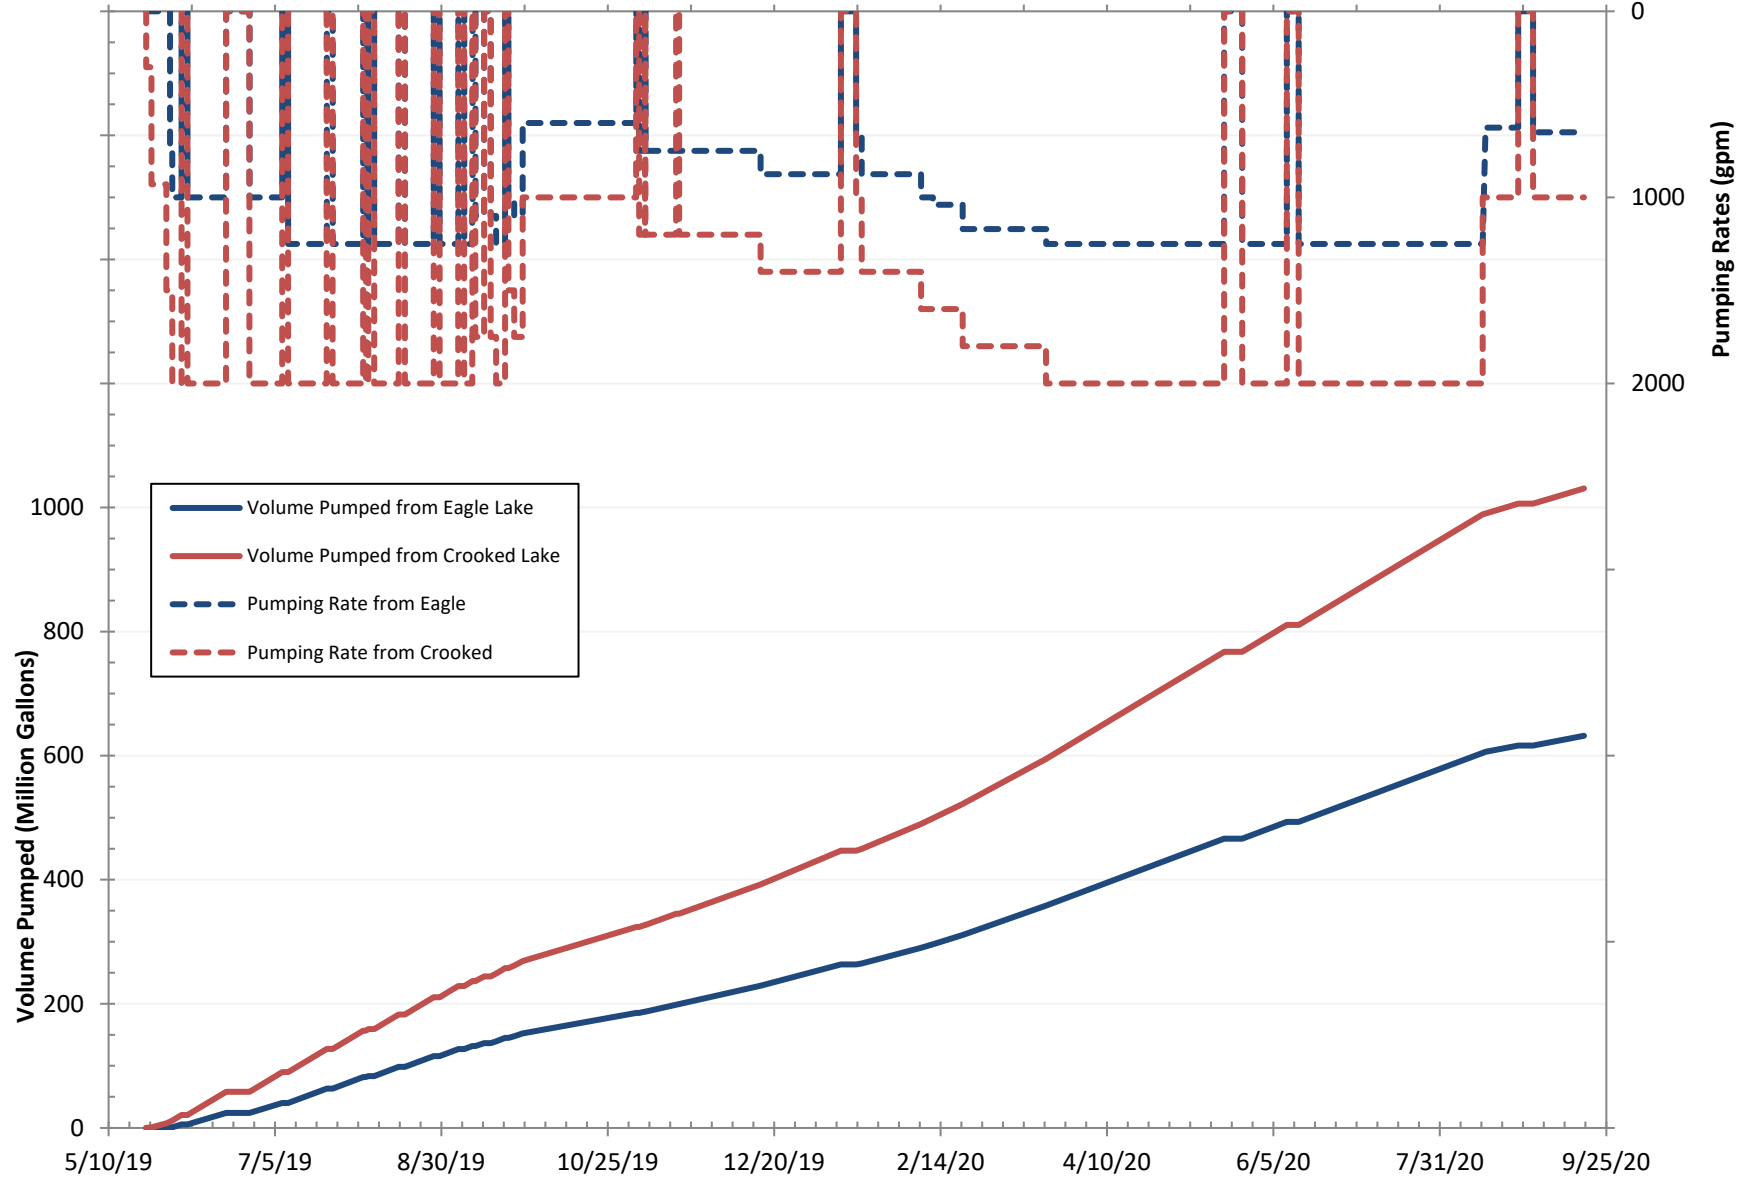
Charter Township of Texas Flood Study
Figure
Pumping Data through September 17, 2020

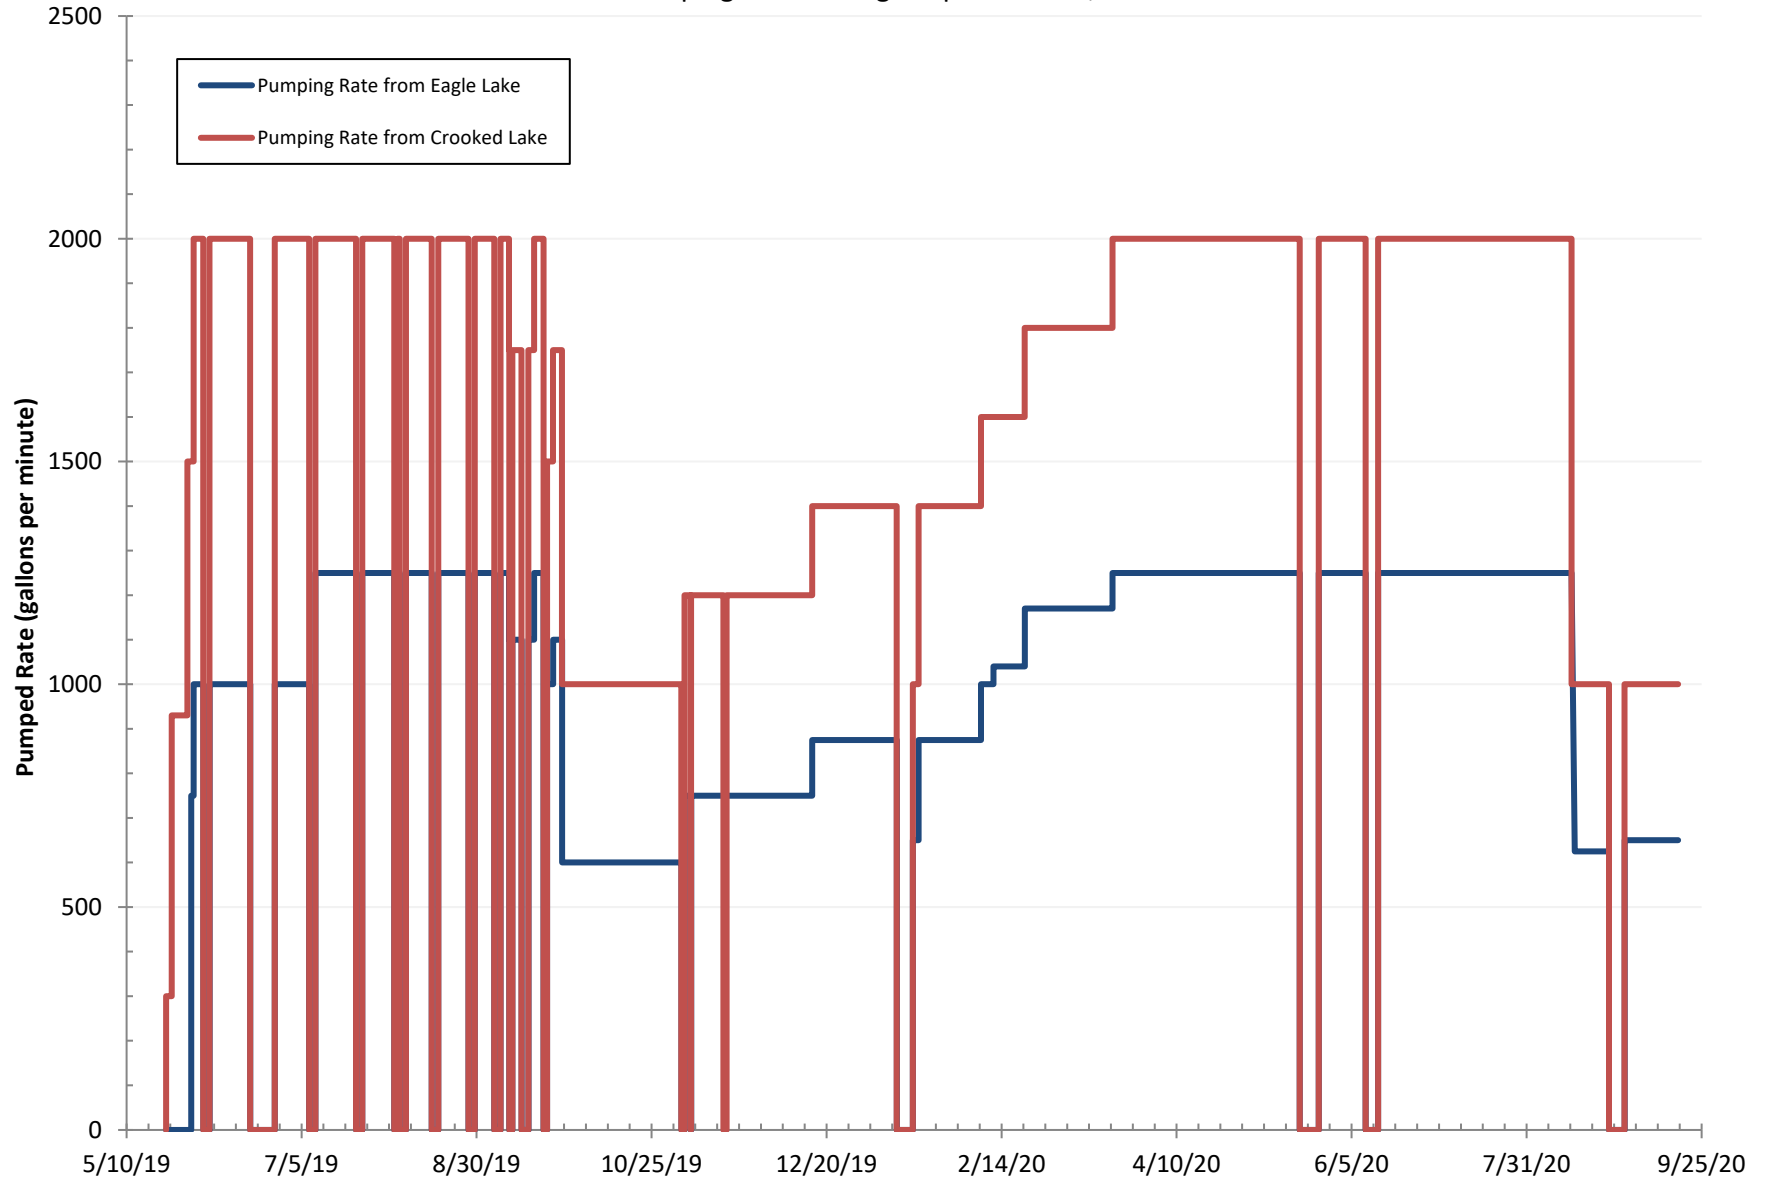
Charter Township of Texas Flood Study
Figure
Pumping Data through September 17, 2020

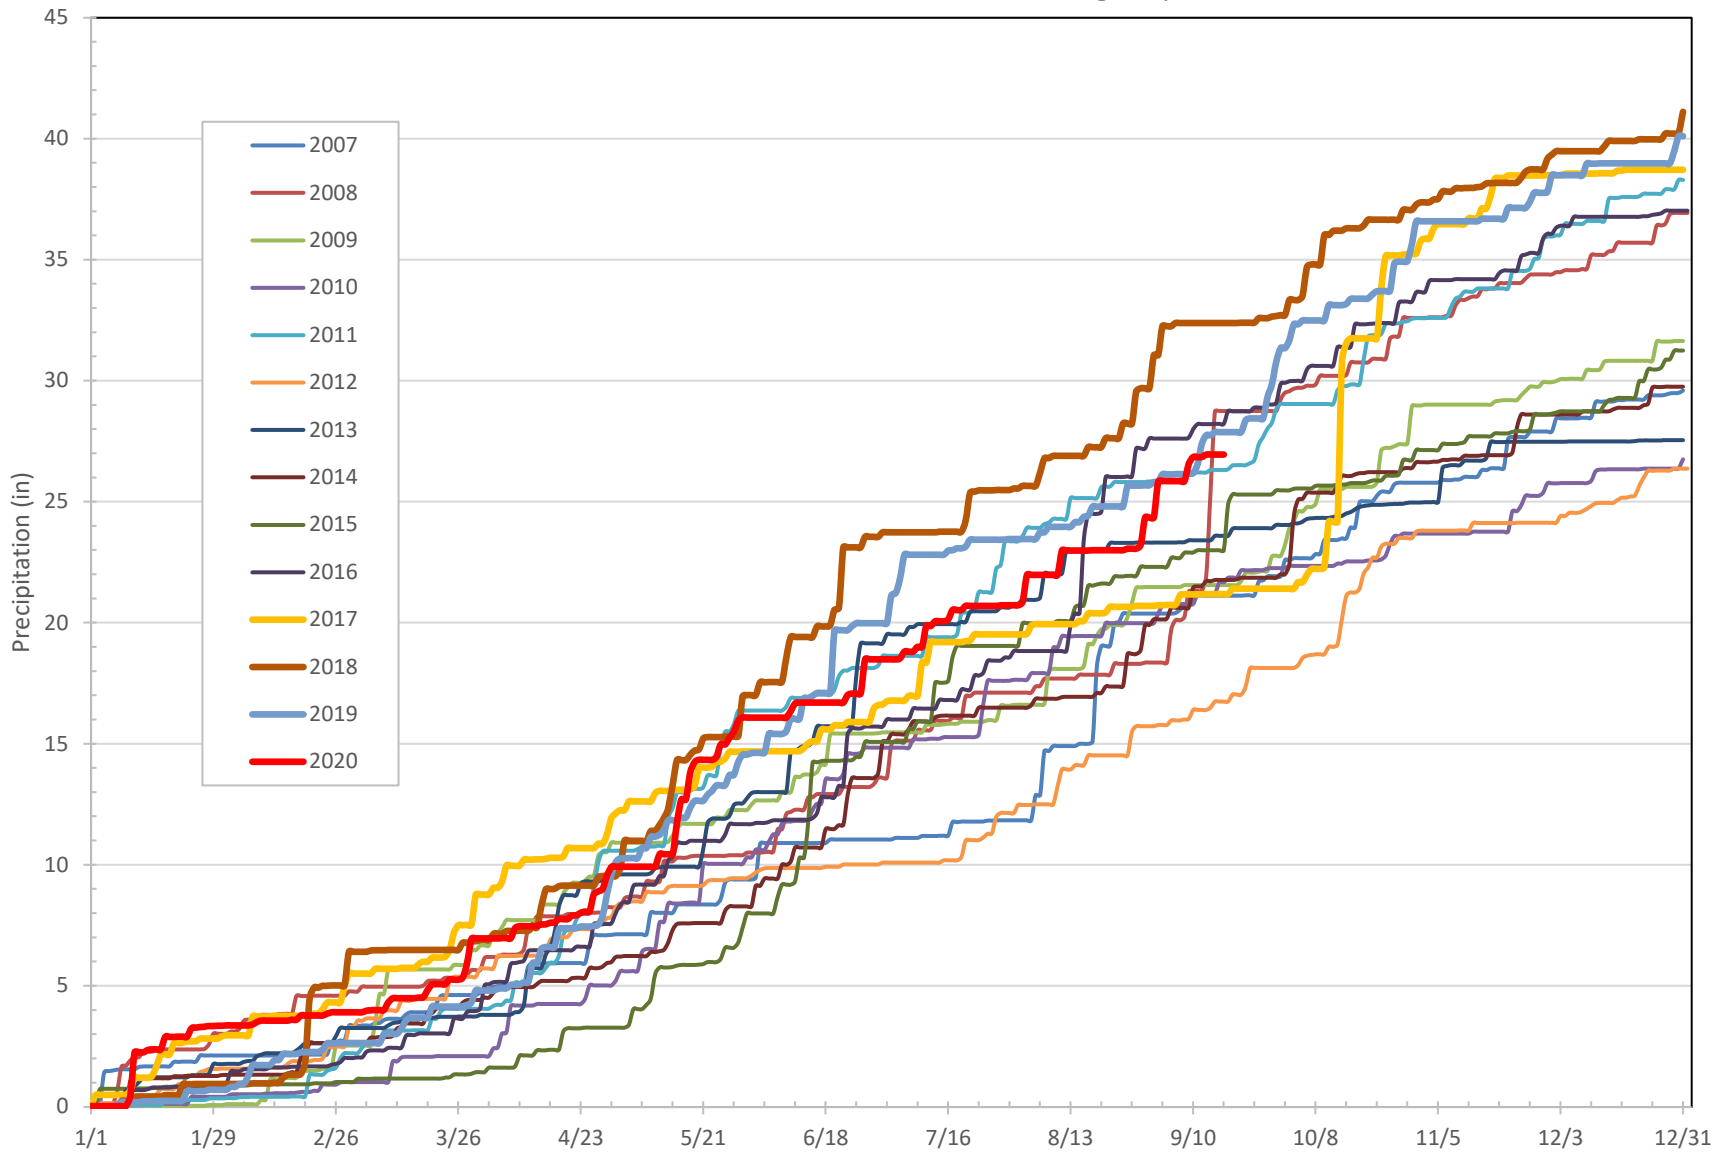
Charter Township of Texas Flood Study
Figure
Historic Cumulative Rainfall Data at Lawton, MI through September 17, 2020

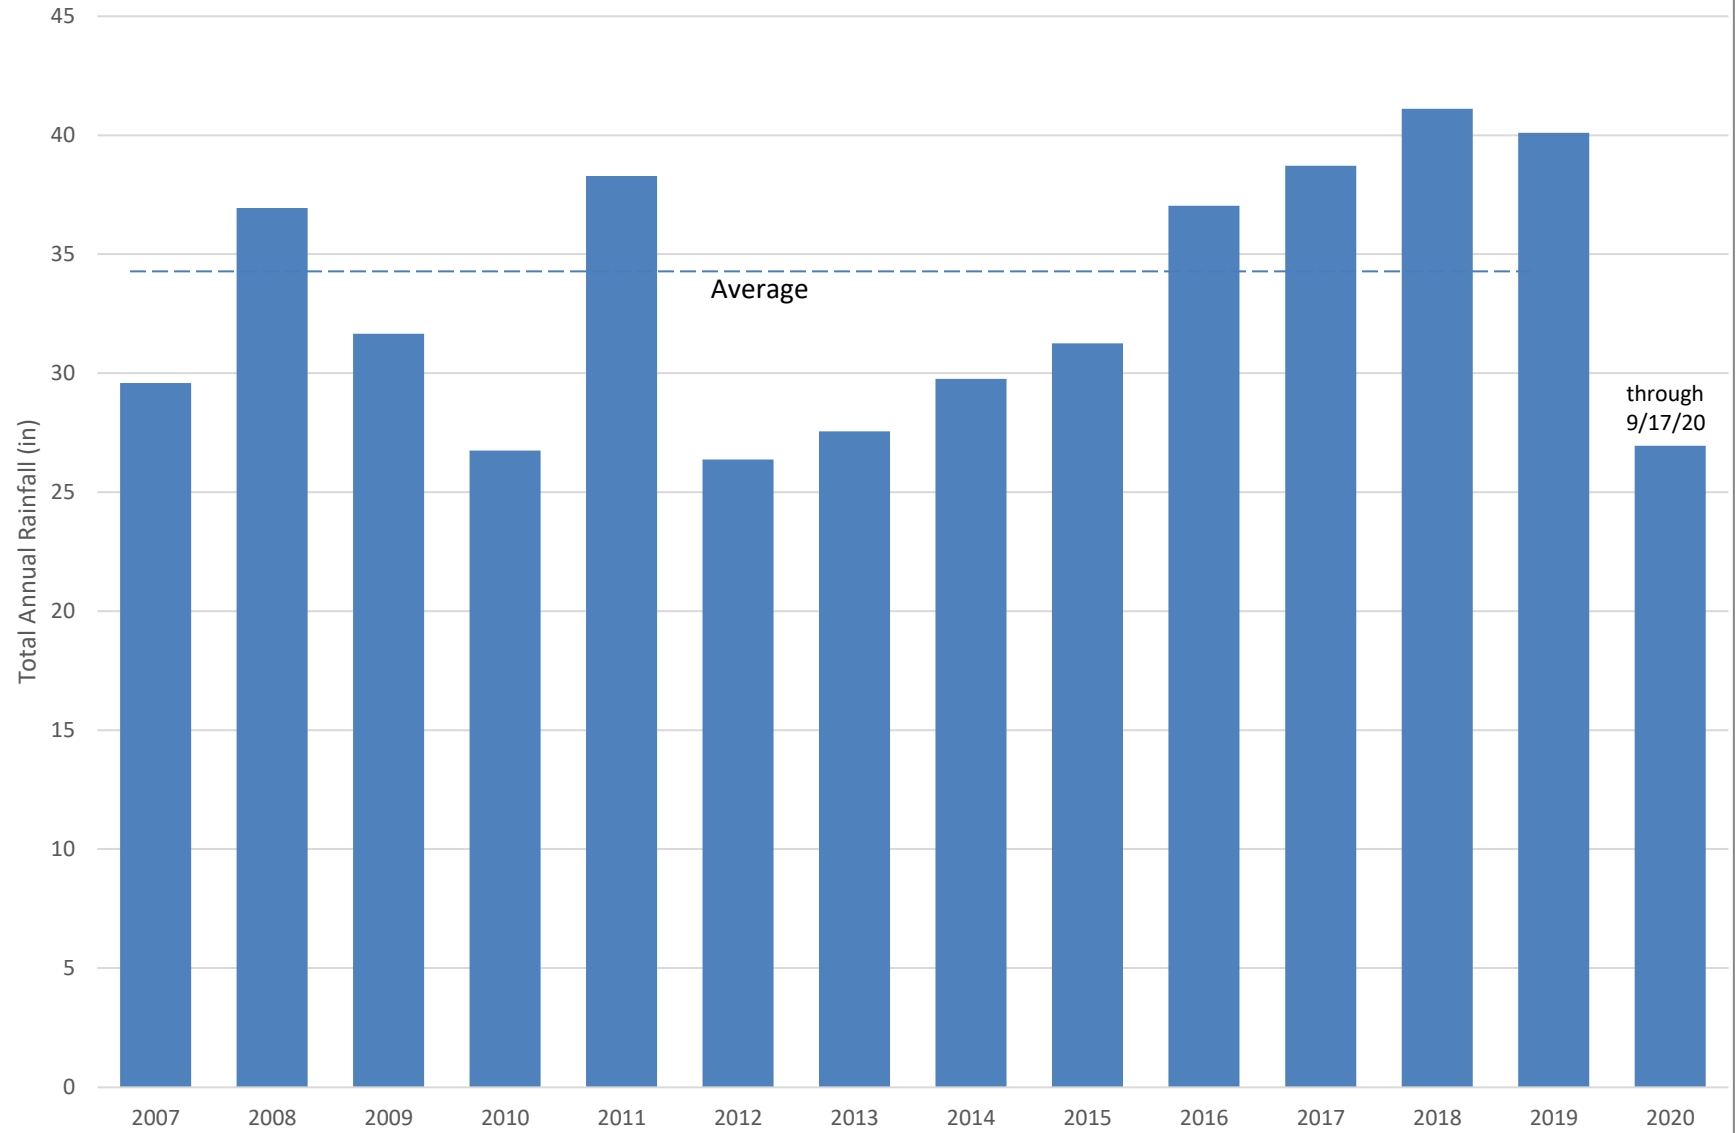
Historical Annual Rainfall in Lawton, MI
Figure
Historic Rainfall Data
