## MEMO

To: Julie VanderWiere, Charter Township of Texas  
From: Steven M. Rice, CWB, GEI Consultants of Michigan, P.C. (GEI)  
cc: Thomas Wheat, P.E., Prein & Newhof  
Date: May 3, 2021  
Re: Weekly Wetland Survey and Assessment Report  
EGLE Permit No: WRP015489 v.1, Site Name: 39-7244 Bentwood Trail-Kalamazoo

## 2020 VEGETATION MONITORING PLOTS

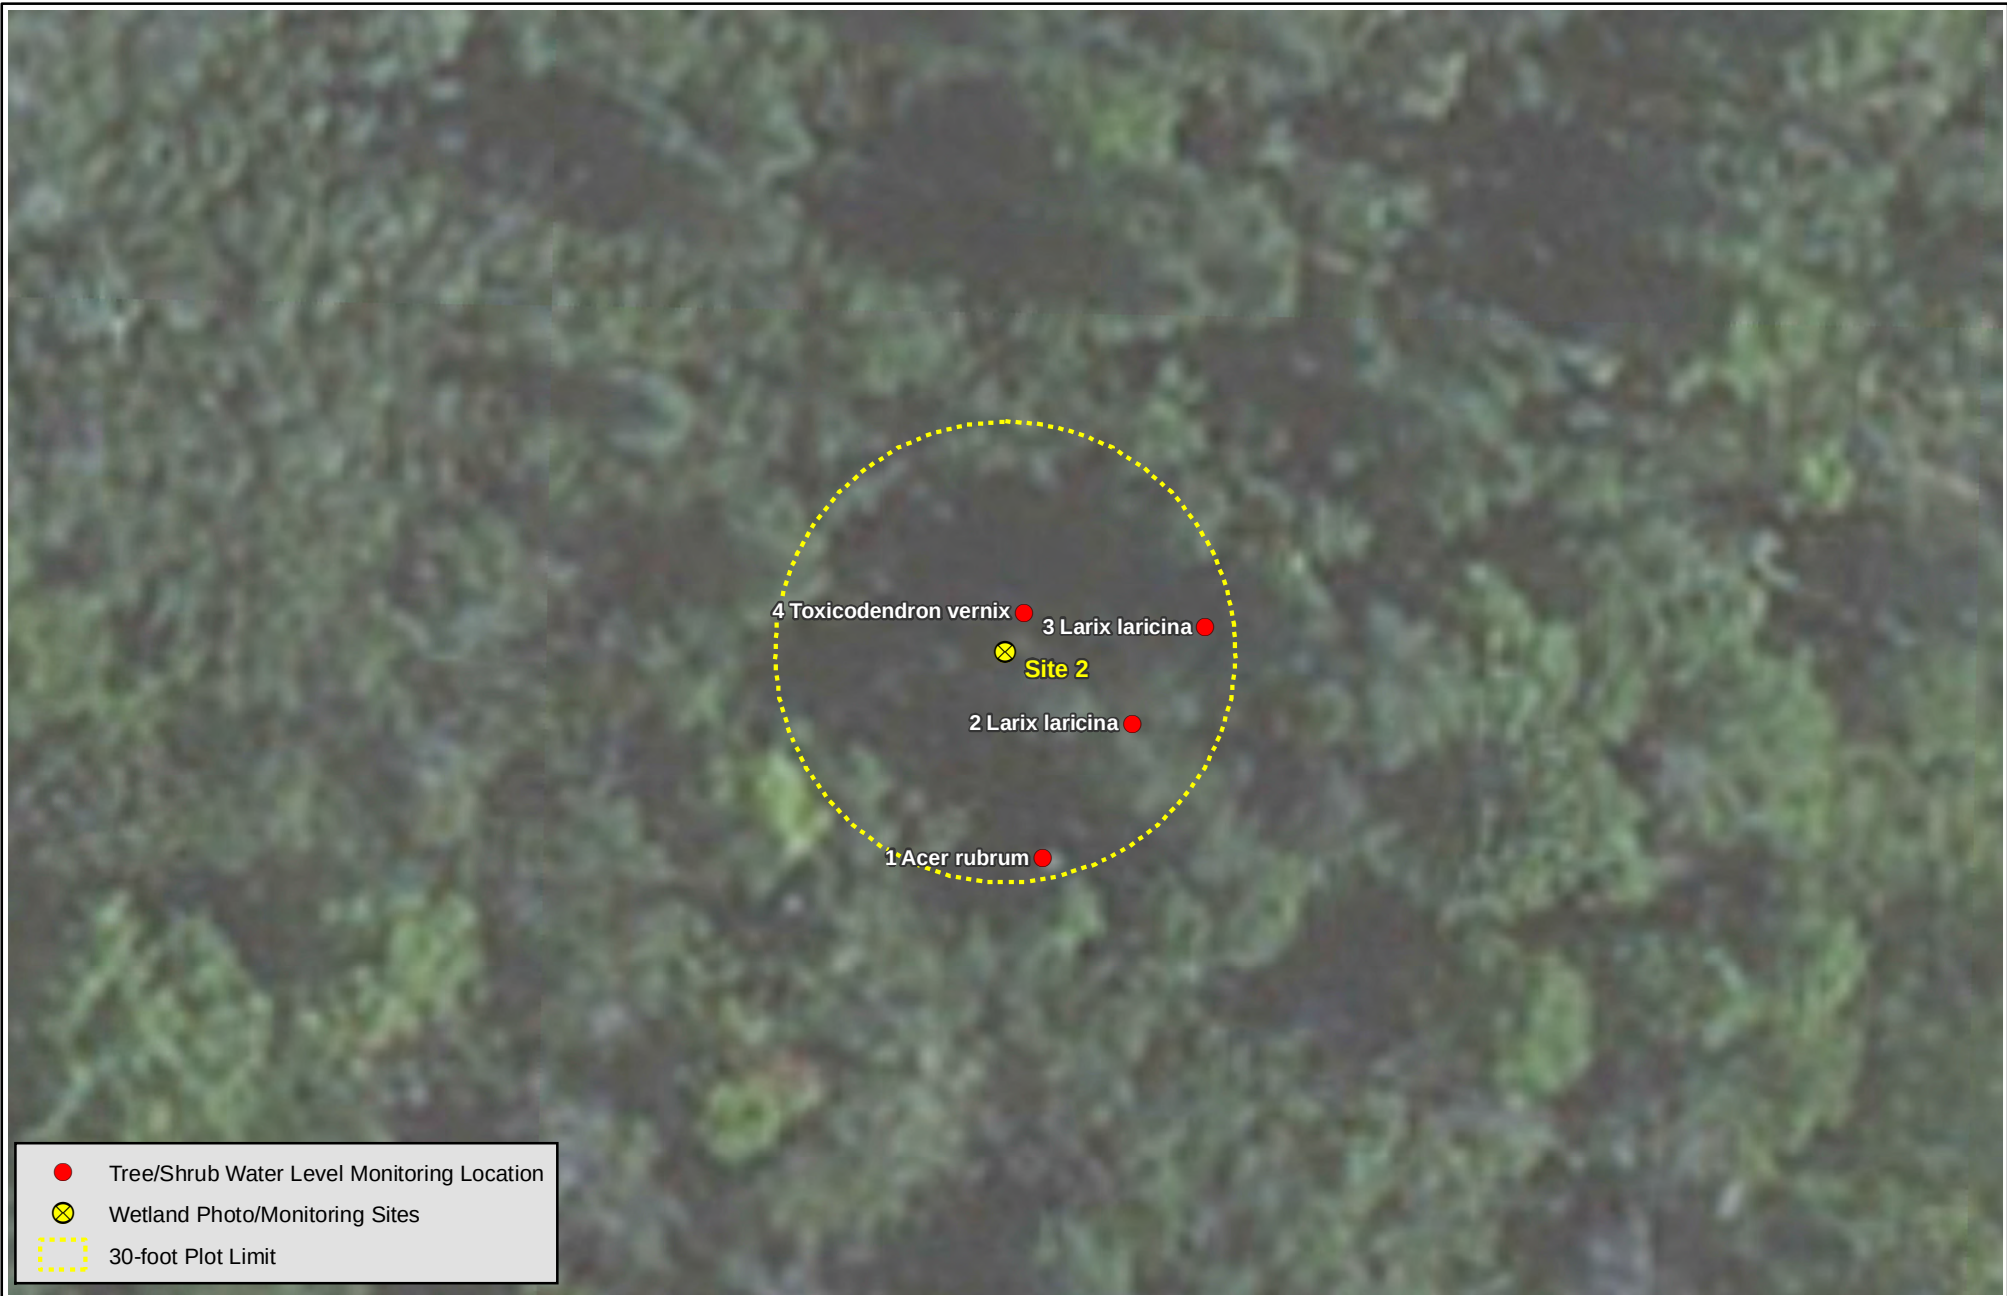
Project: 1902439 Figure: 2

**WETLAND MONITORING  
 SITE PLOT 2**

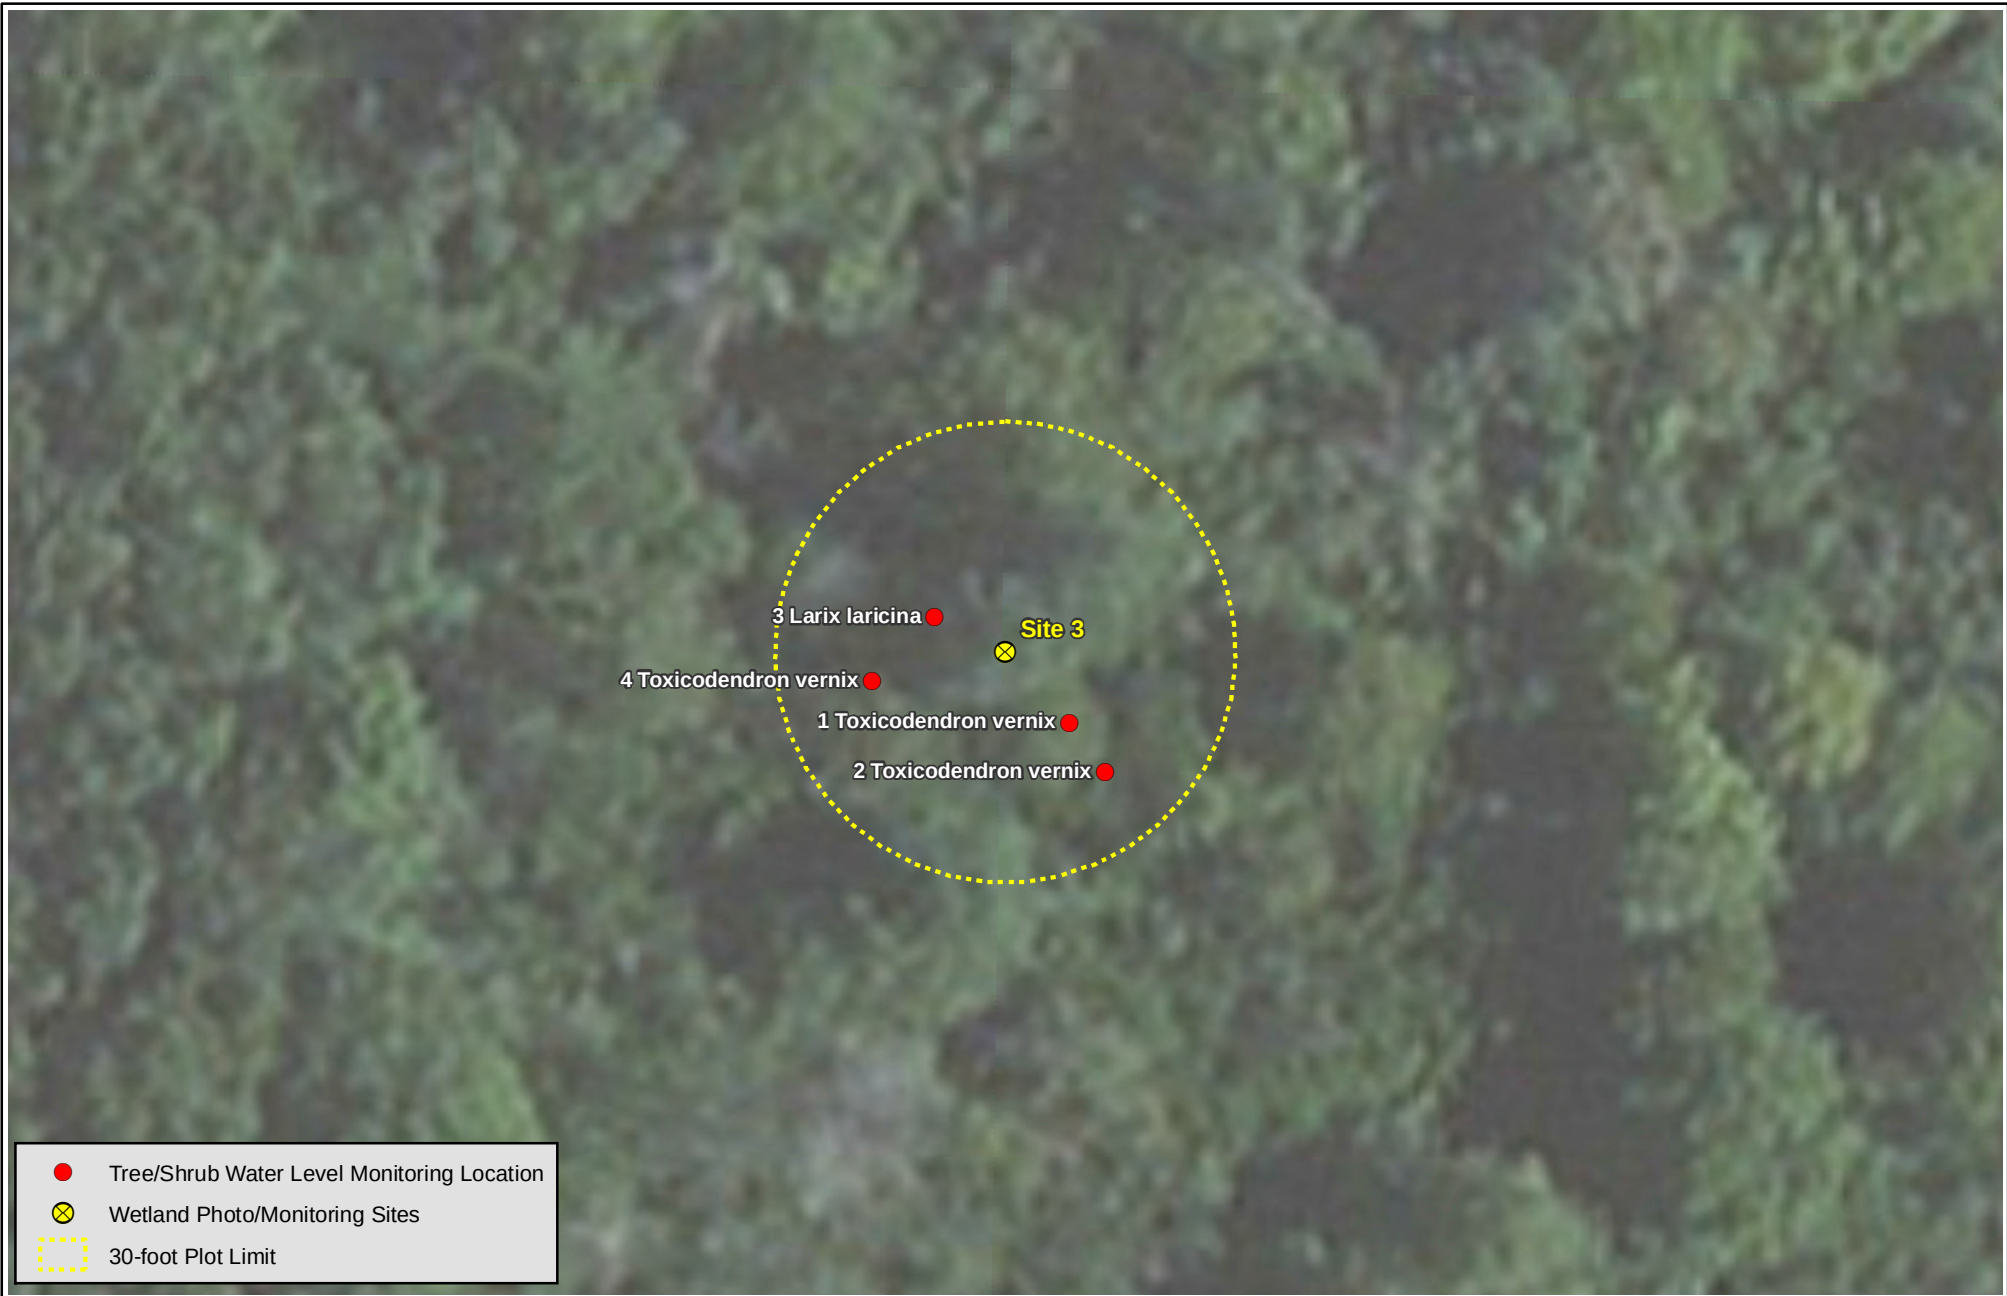
Figure: 2

**WETLAND MONITORING  
SITE PLOT 3**

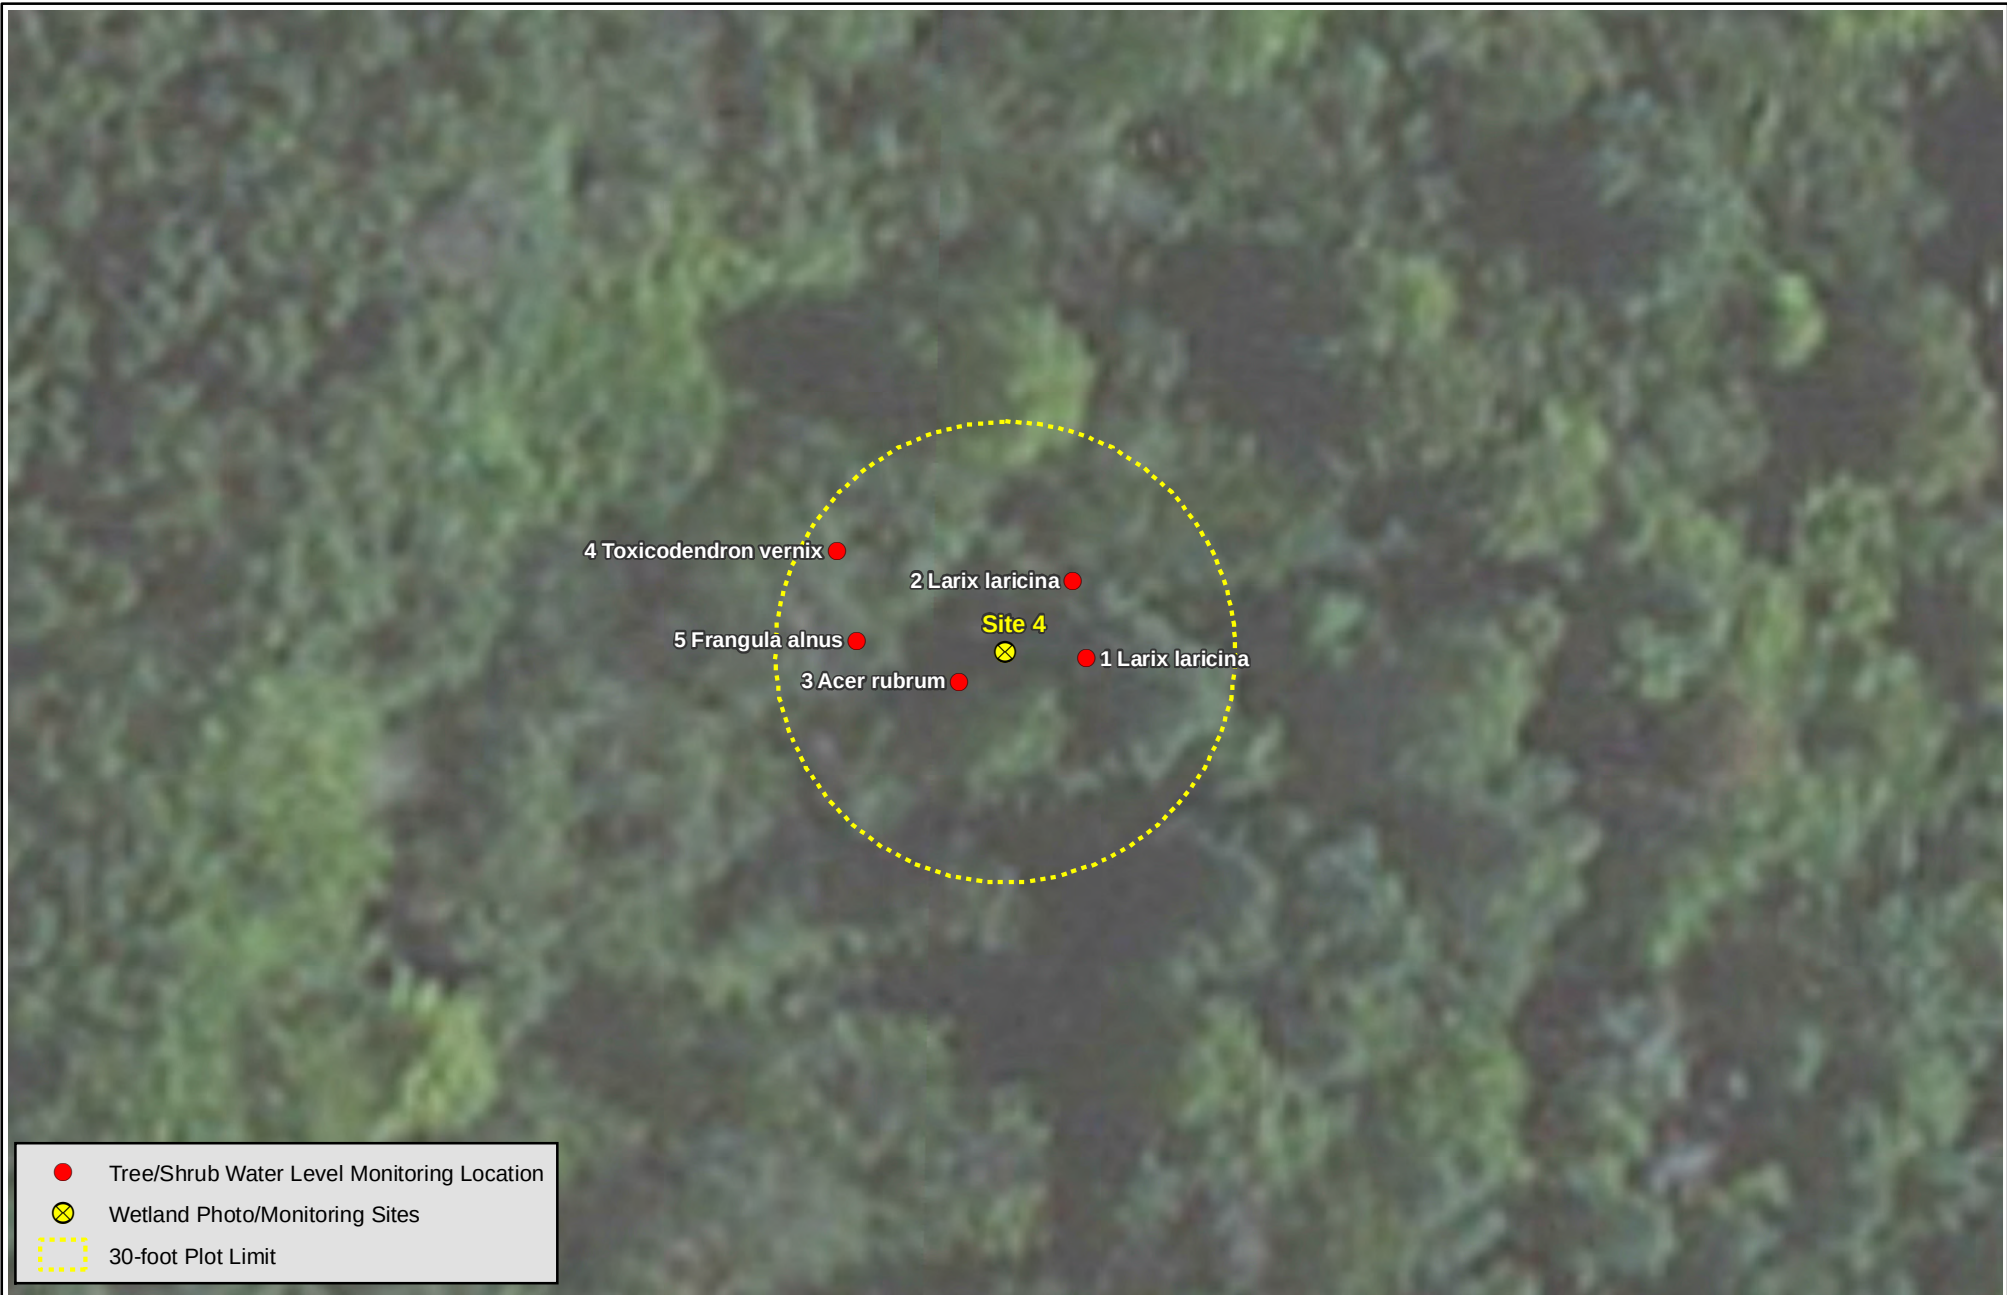
Figure: 2

## WETLAND MONITORING SITE PLOT 4

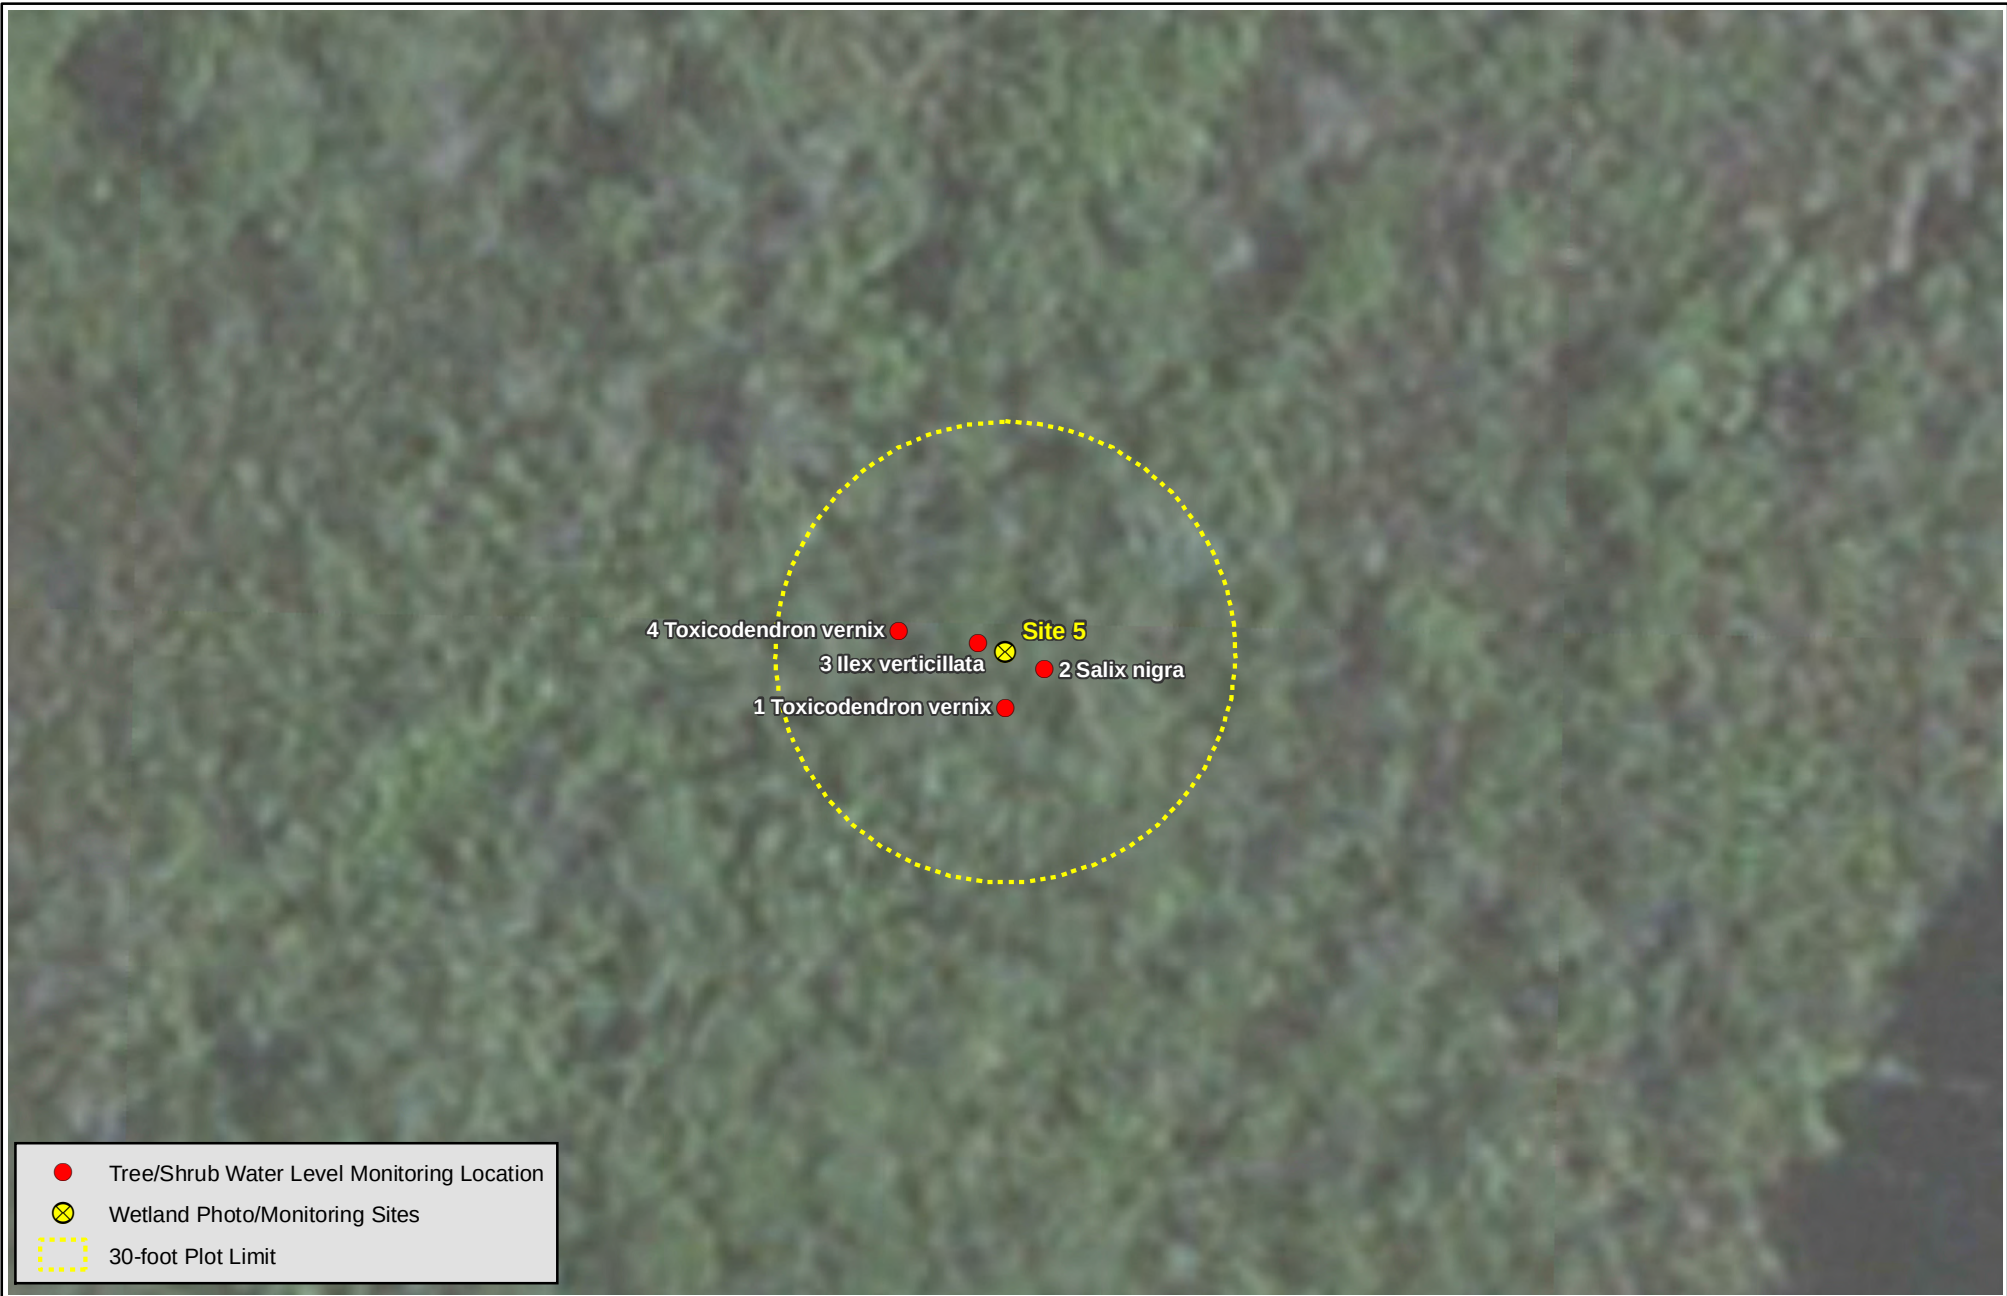
| MDEQ Permit No. WRP015489 v.1<br>Bentwood Trail<br>Kalamazoo County, Michigan | <br><br>1 inch = 25 feet | | <b>WETLAND MONITORING<br/>SITE PLOT 5</b> | |

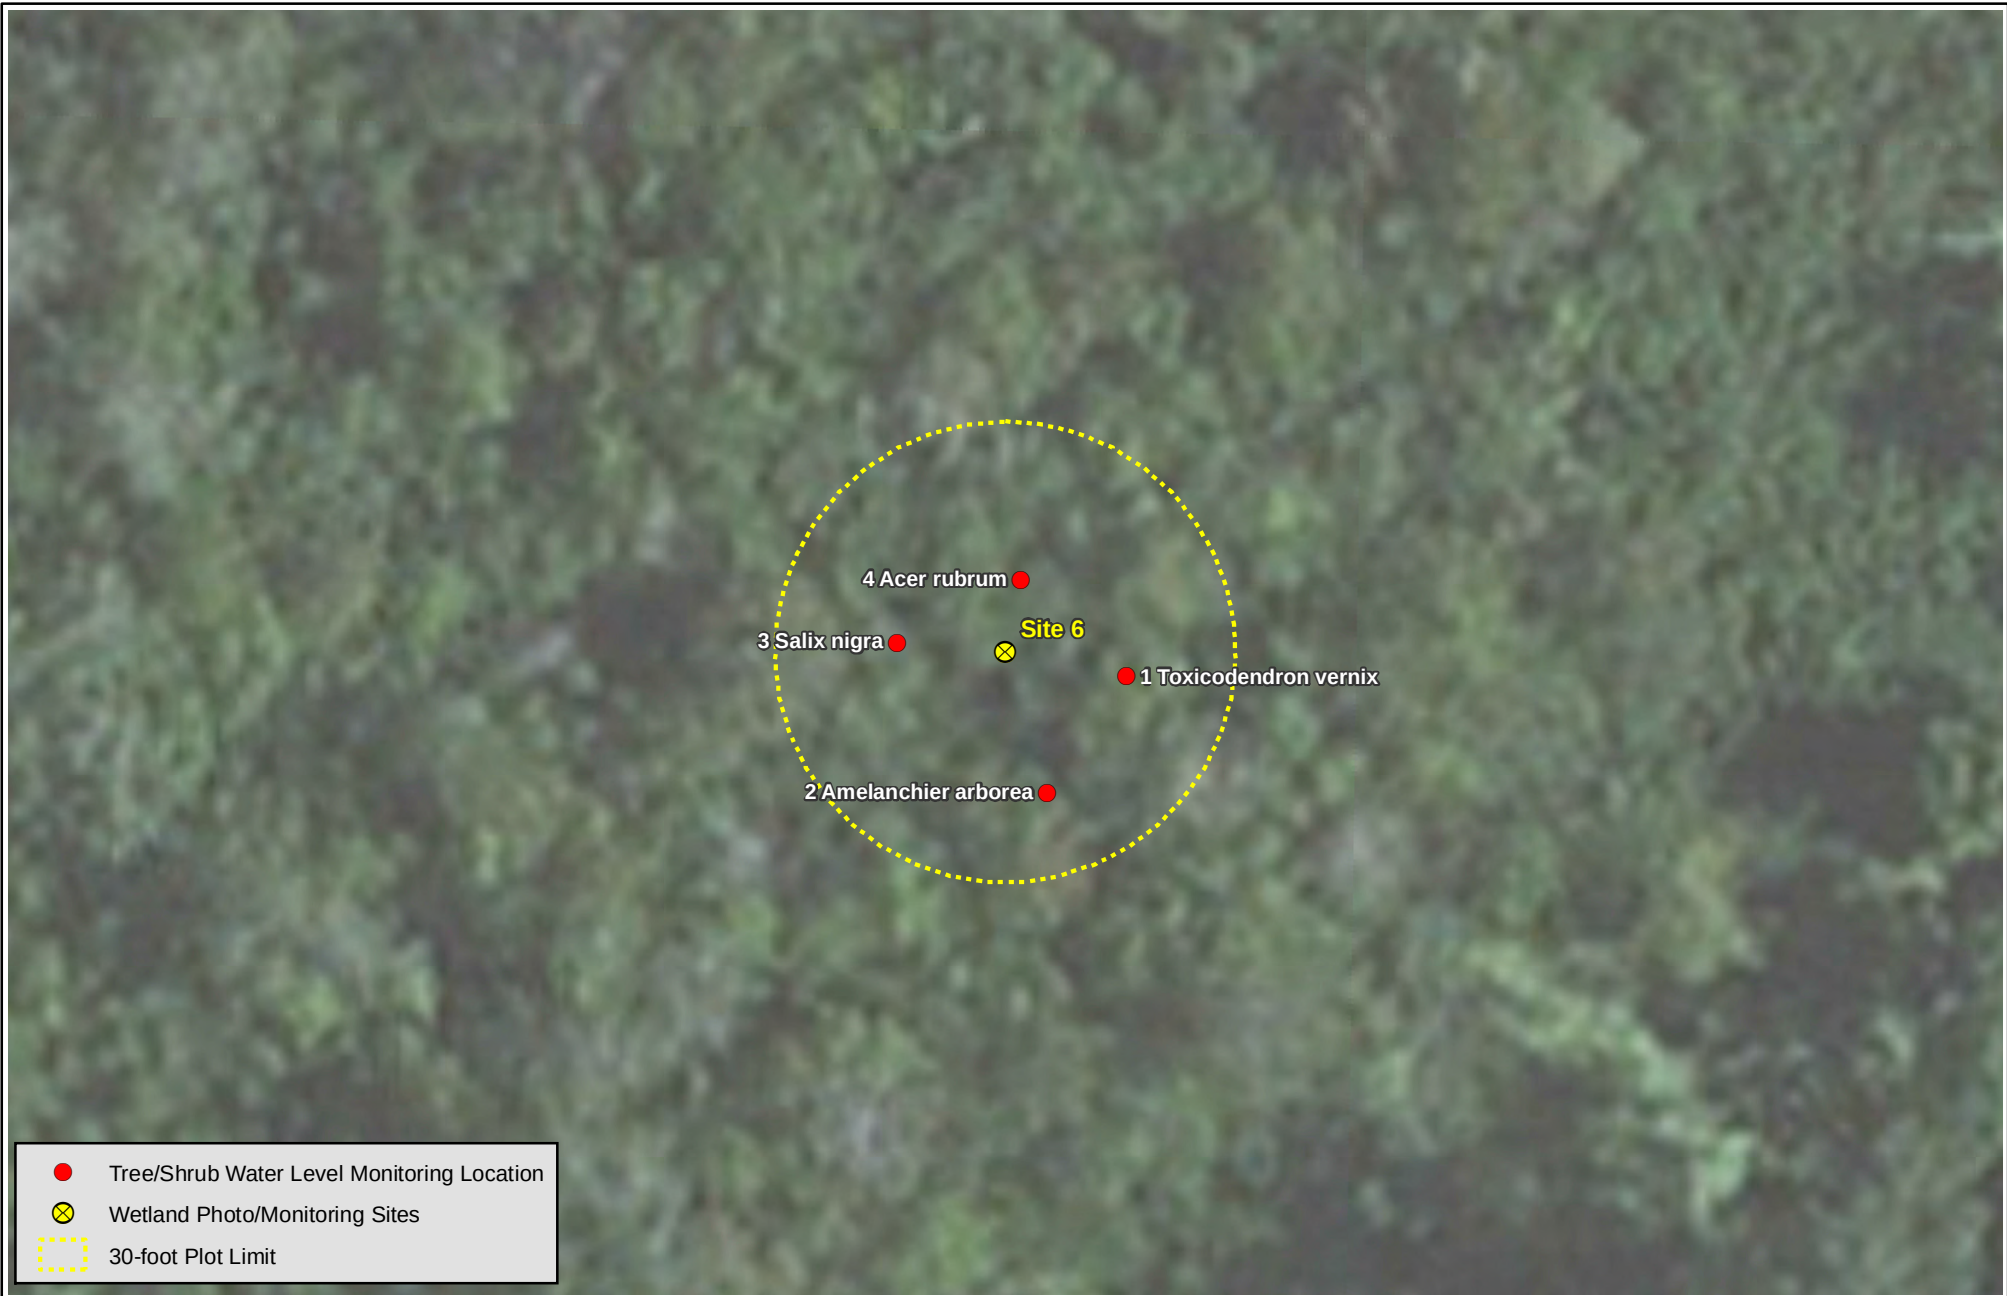
| MDEQ Permit No. WRP015489 v.1<br>Bentwood Trail<br>Kalamazoo County, Michigan | <br><br>1 inch = 25 feet | | <b>WETLAND MONITORING<br/>SITE PLOT 6</b> | |

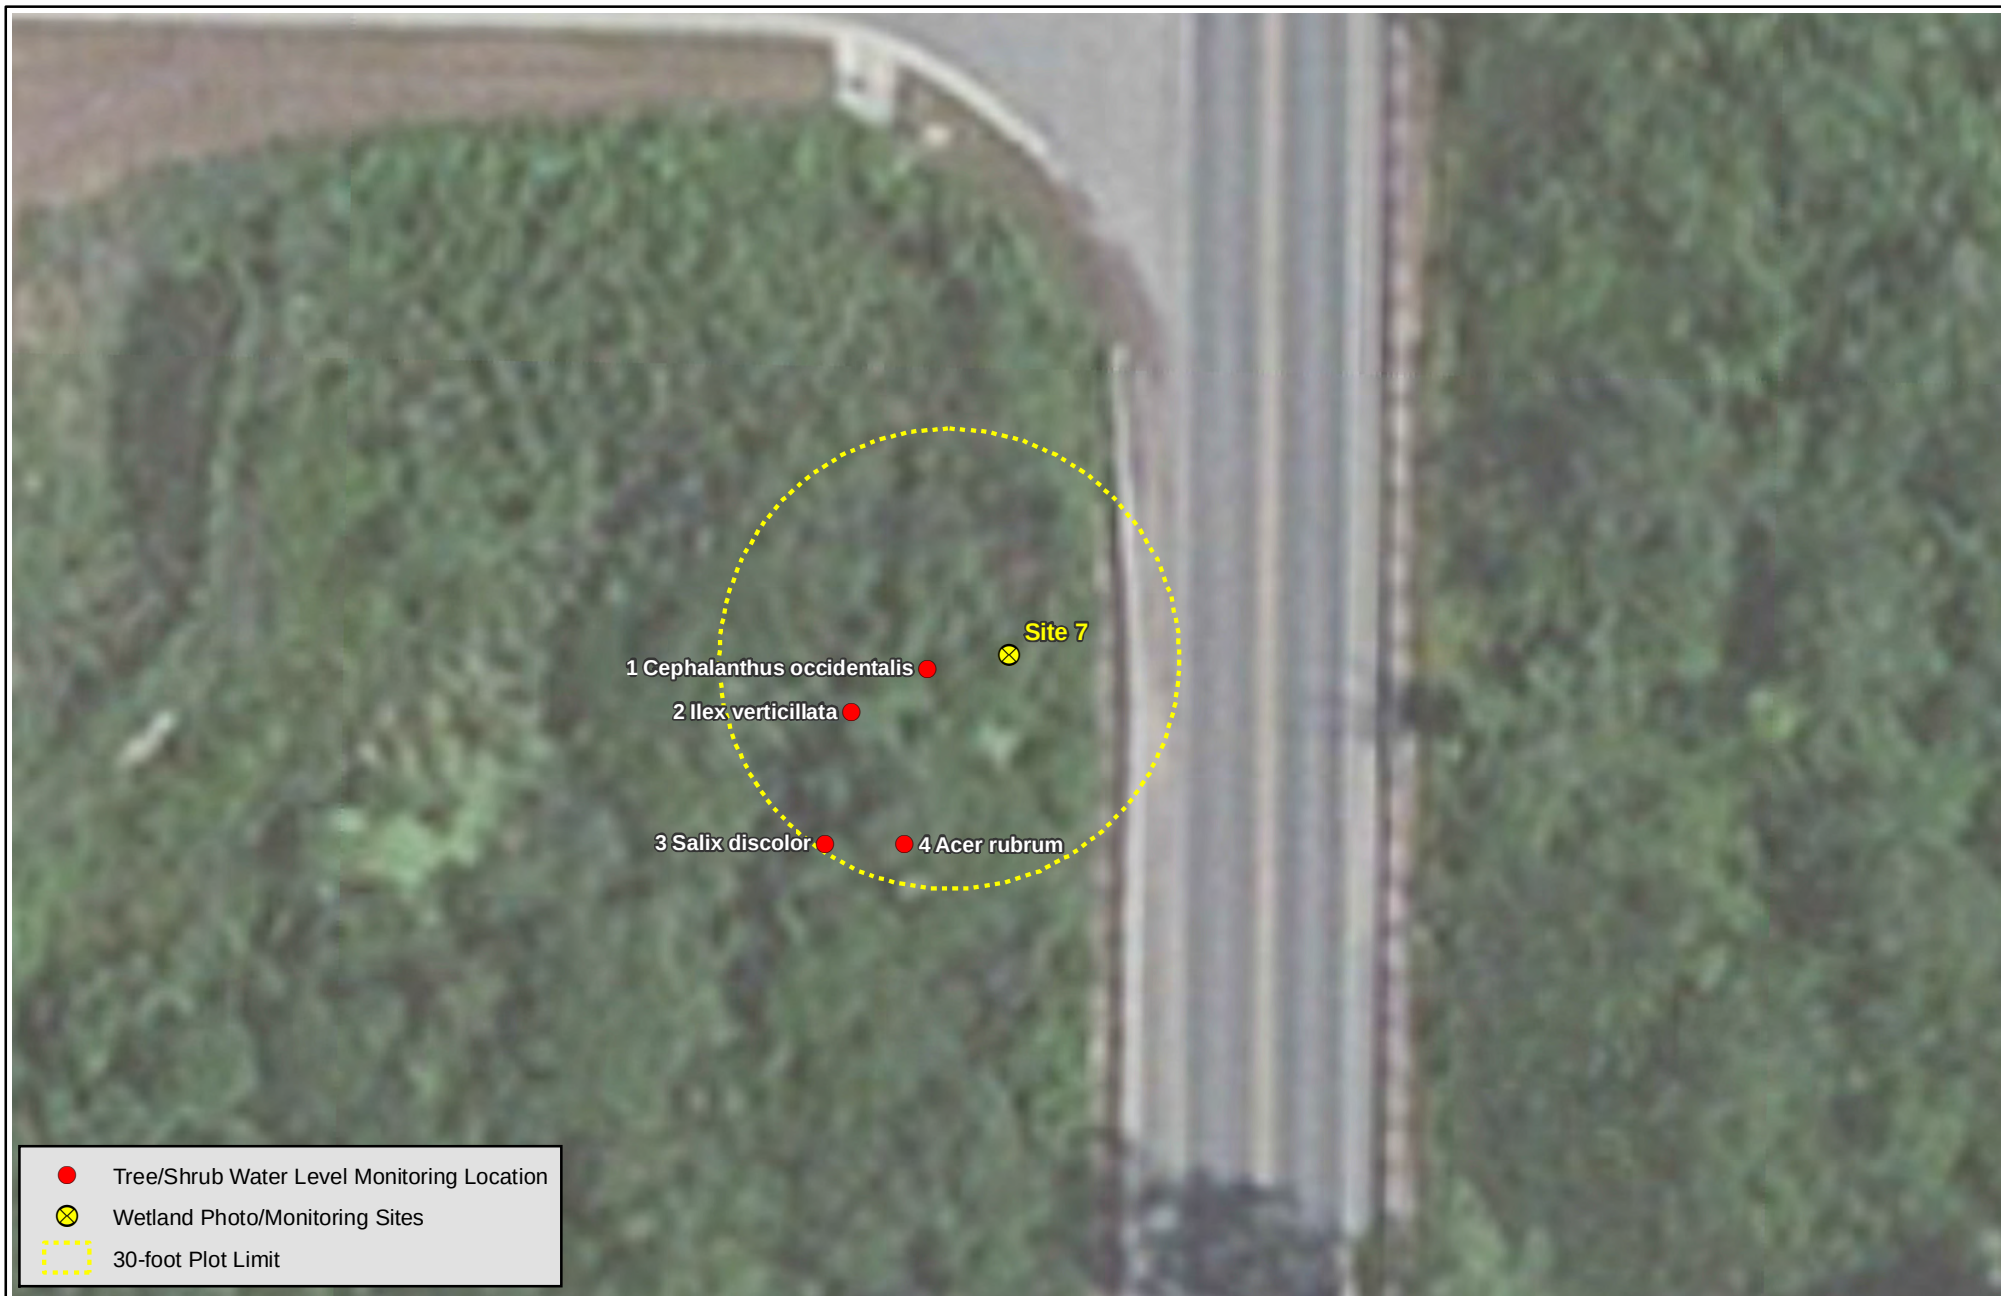
Figure: 2

## WETLAND MONITORING SITE PLOT 7

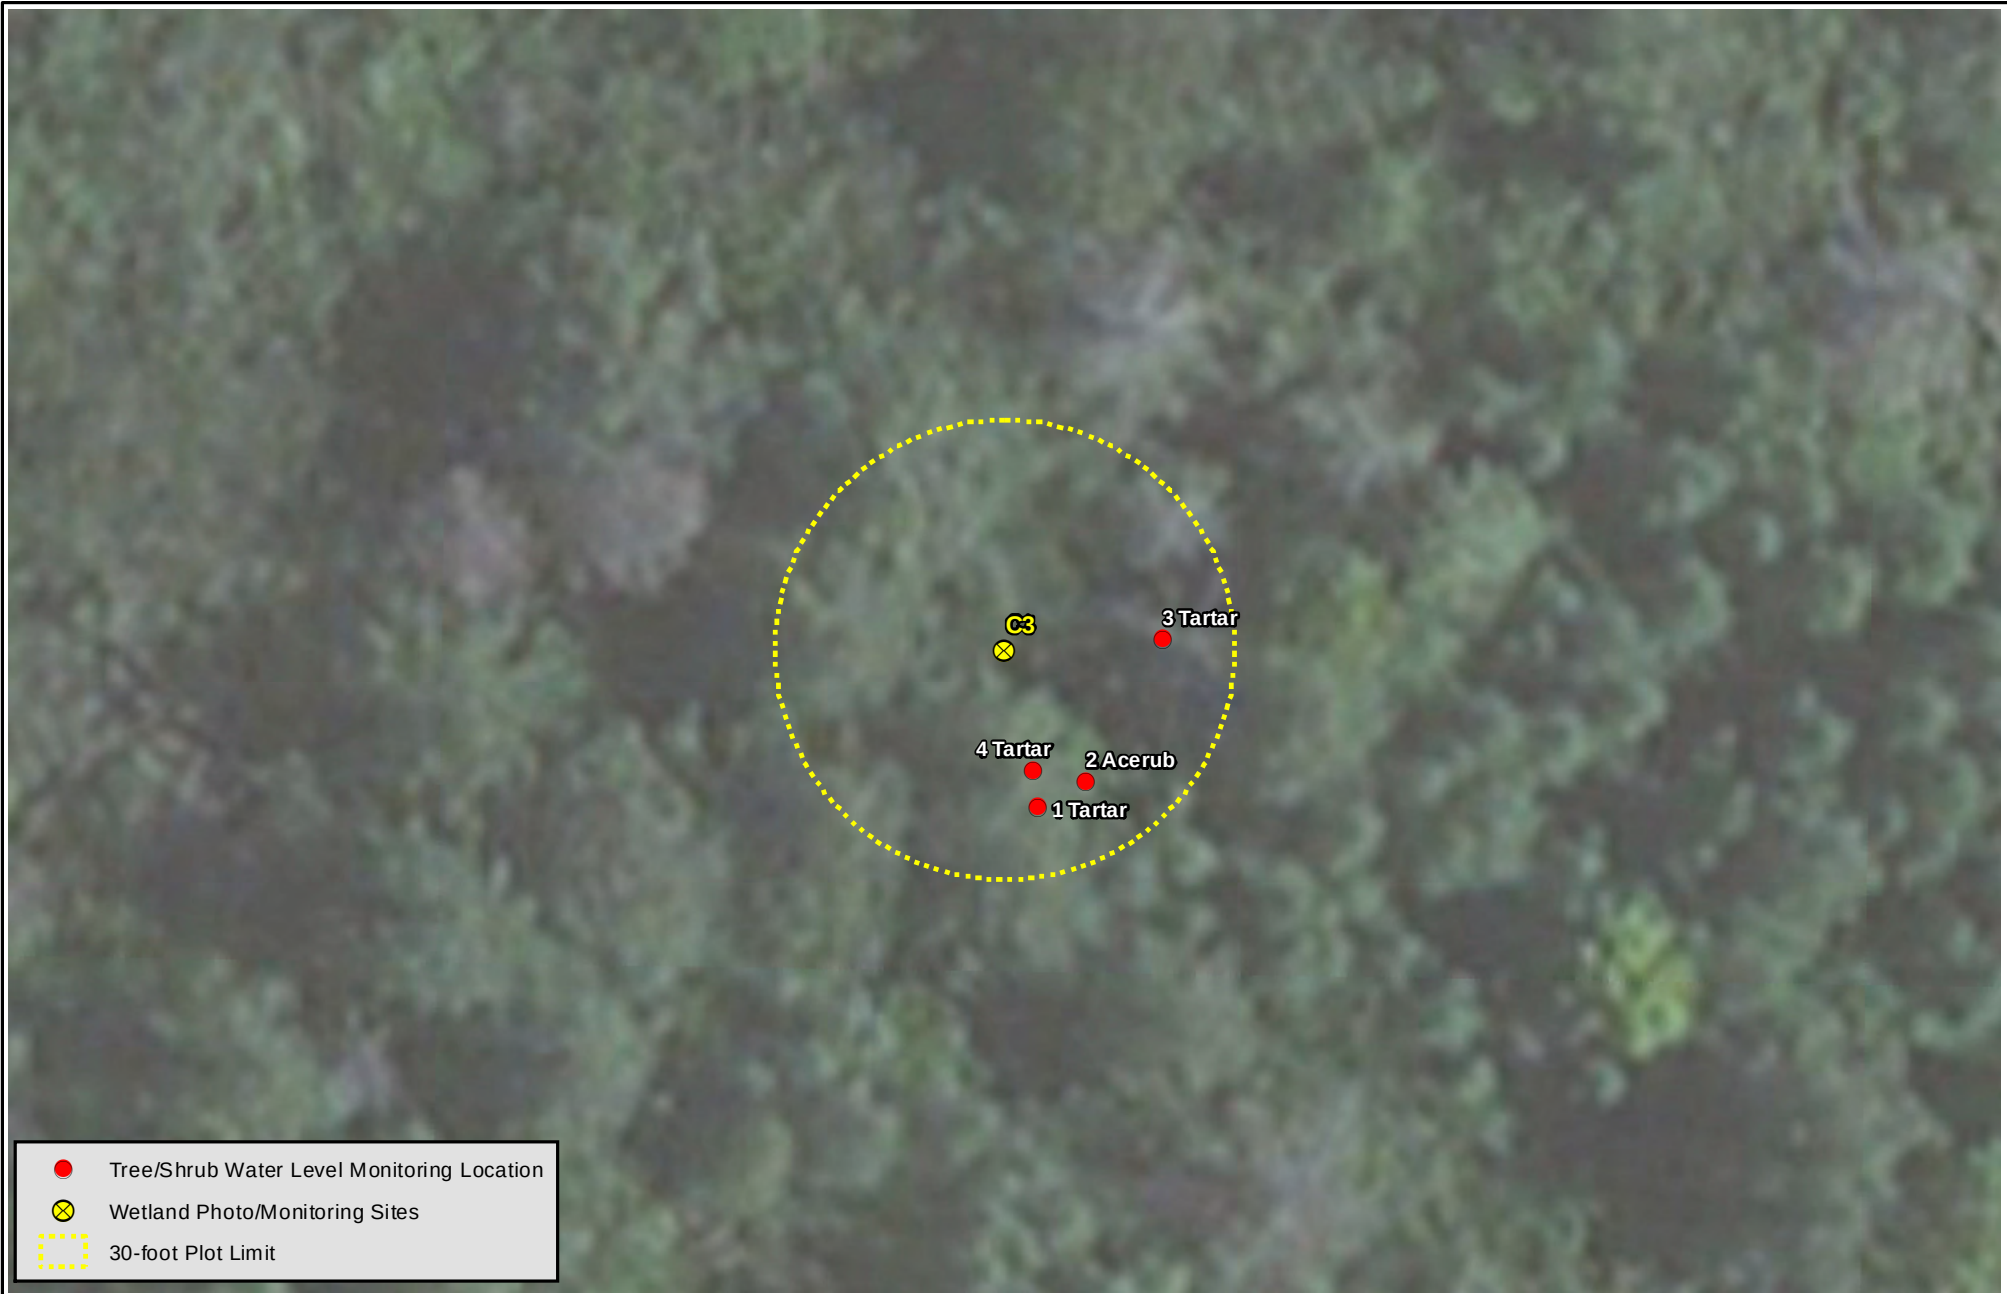
| MDEQ Permit No. WRP015489 v.1<br>Bentwood Trail<br>Kalamazoo County, Michigan | <br><br>1 inch = 25 feet | | <b>WETLAND MONITORING<br/>SITE PLOT C3</b> | |

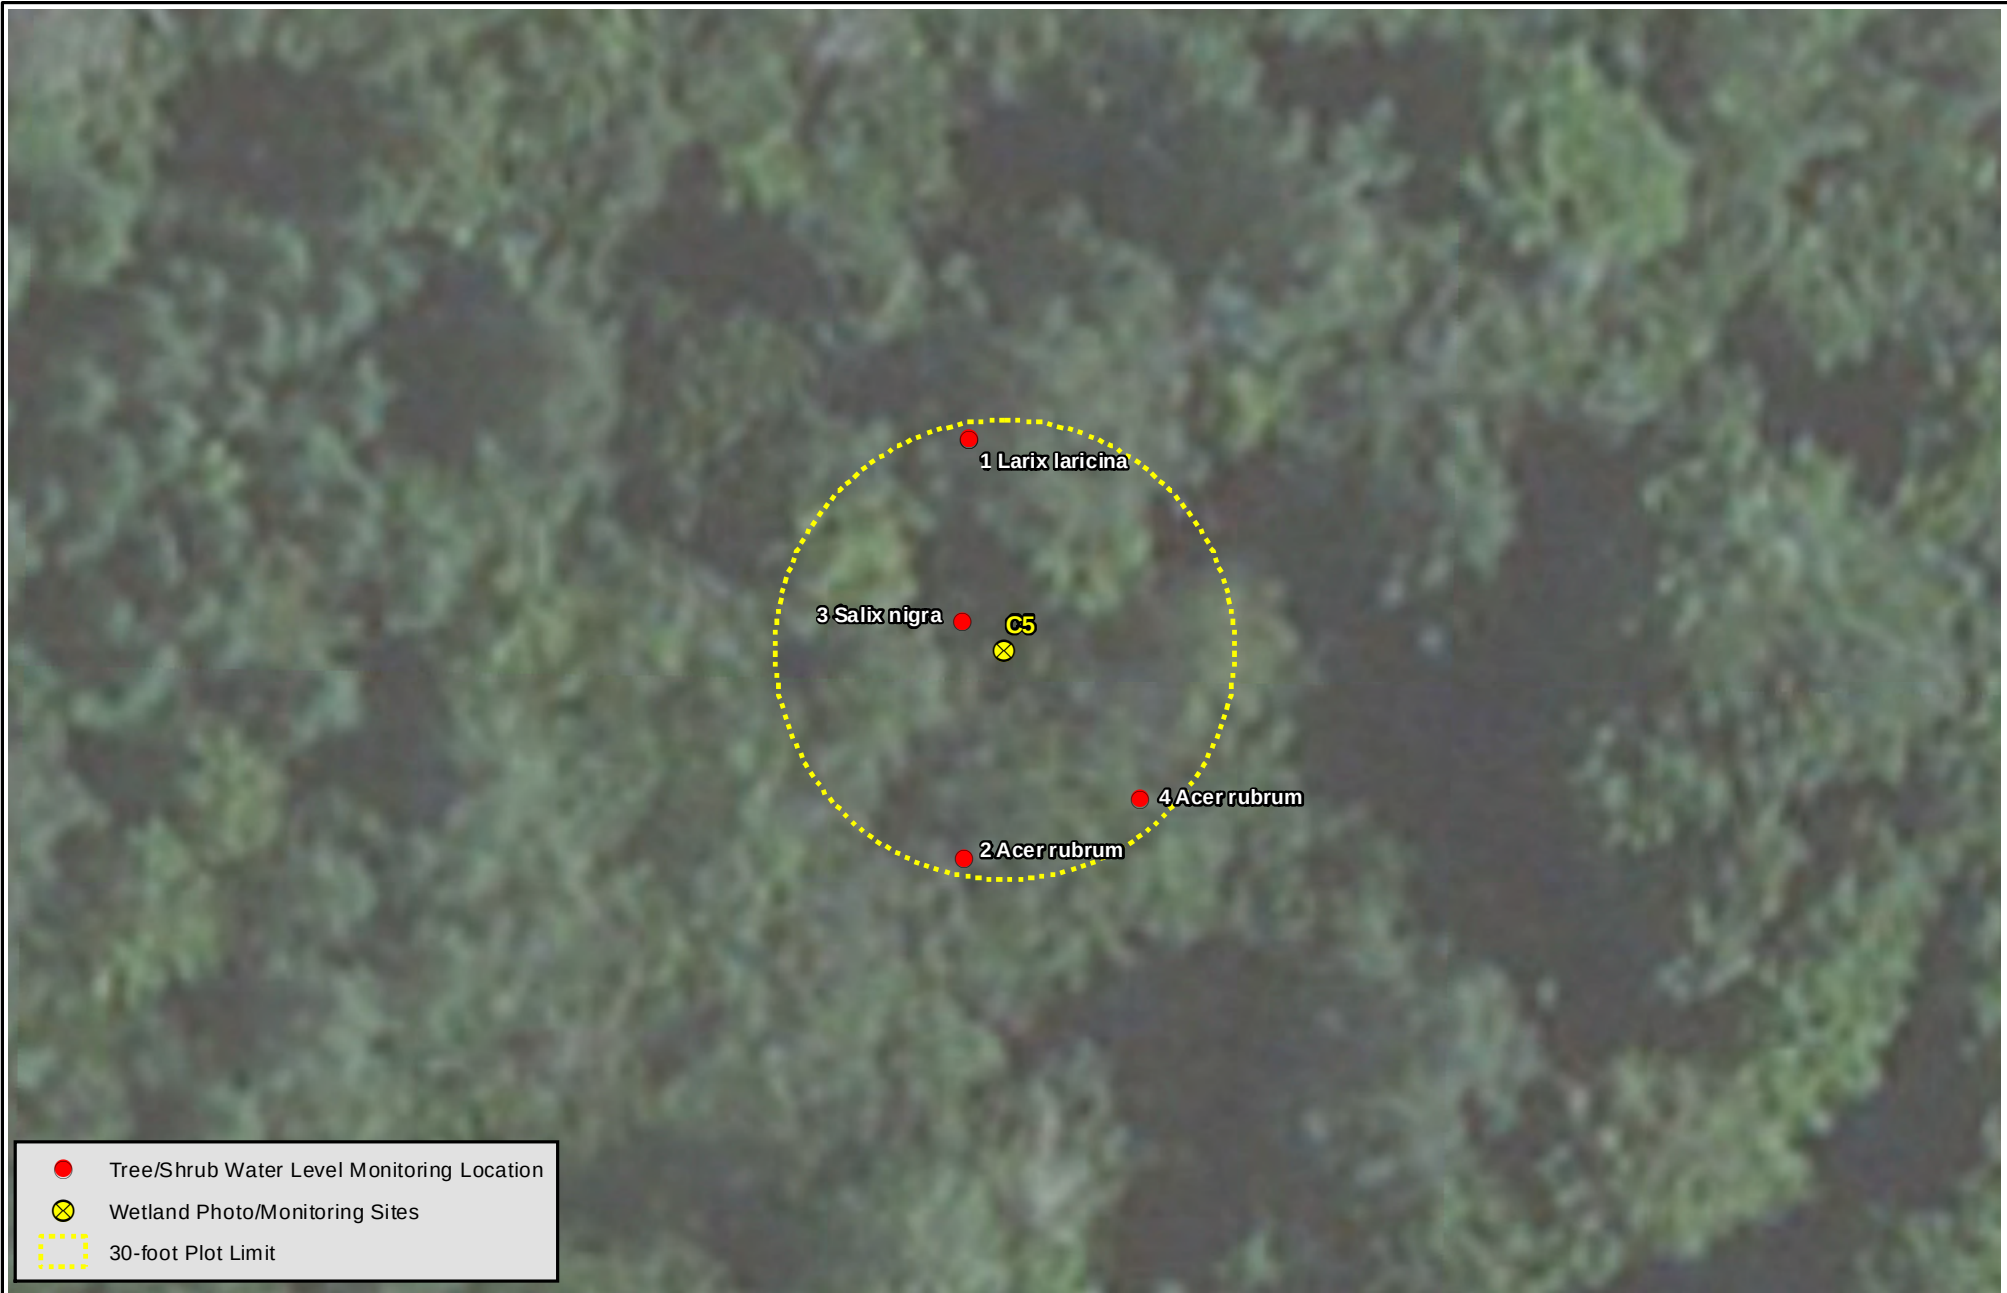
| MDEQ Permit No. WRP015489 v.1<br>Bentwood Trail<br>Kalamazoo County, Michigan | <br><br>1 inch = 25 feet | | <b>WETLAND MONITORING<br/>SITE PLOT C5</b> |
