## MEMO

To: Julie VanderWiere, Charter Township of Texas  
From: Steven M. Rice, CWB, GEI Consultants of Michigan, P.C. (GEI)  
cc: Thomas Wheat, P.E., Prein & Newhof  
Date: May 19, 2021  
Re: Weekly Wetland Survey and Assessment Report  
EGLE Permit No: WRP015489 v.1, Site Name: 39-7244 Bentwood Trail-Kalamazoo

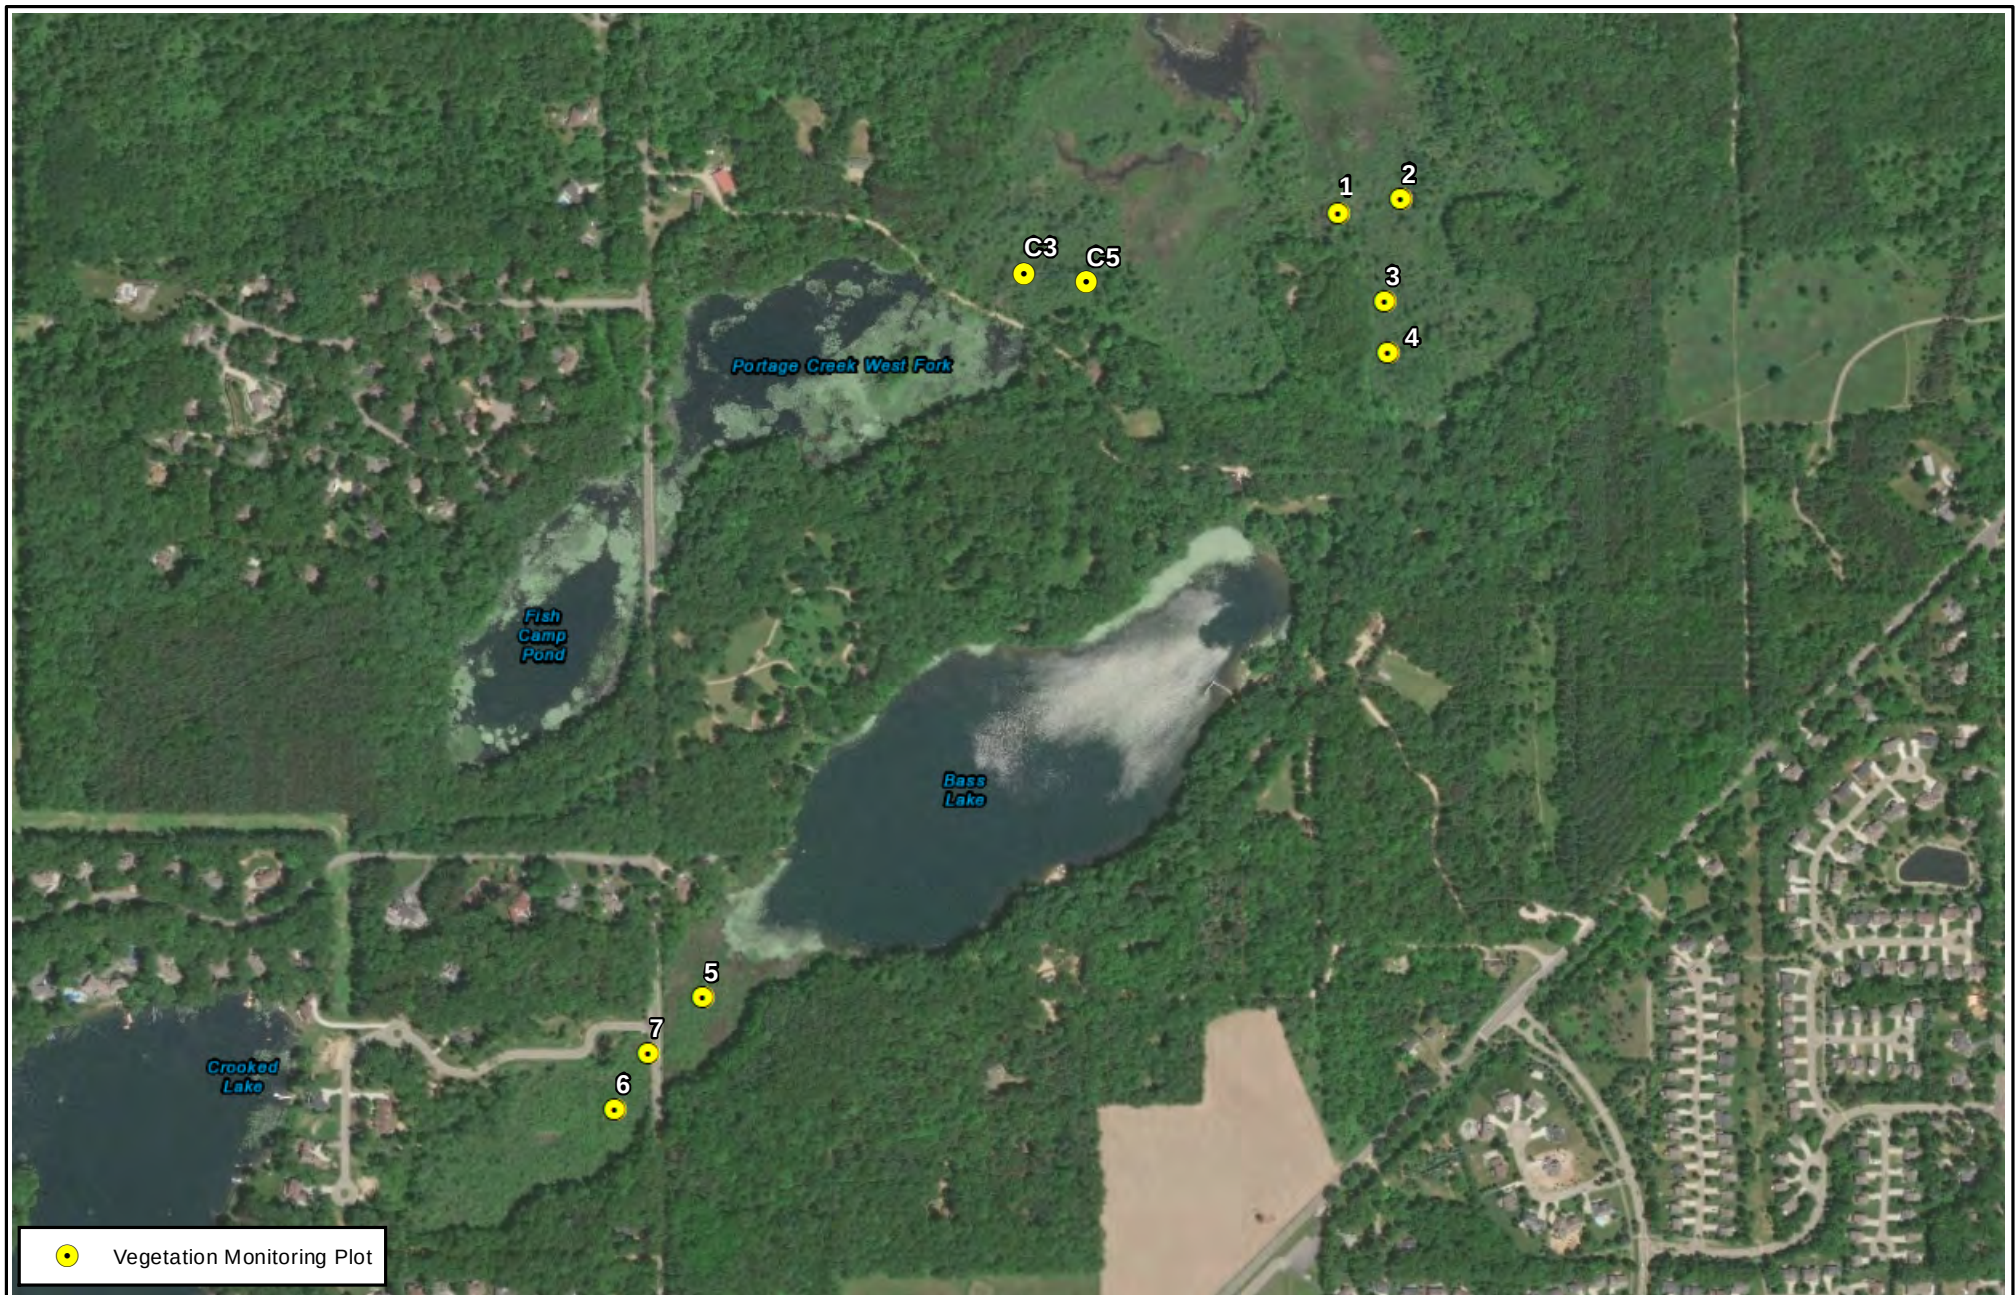
Figure 1. Wetland Monitoring Site Location Map

The nine monitoring sites are located within two vegetative communities including rich tamarack swamp (Sites 1-4, C3 and C5) and high-quality shrub/emergent wetland (Sites 5-7) (Figure 1).

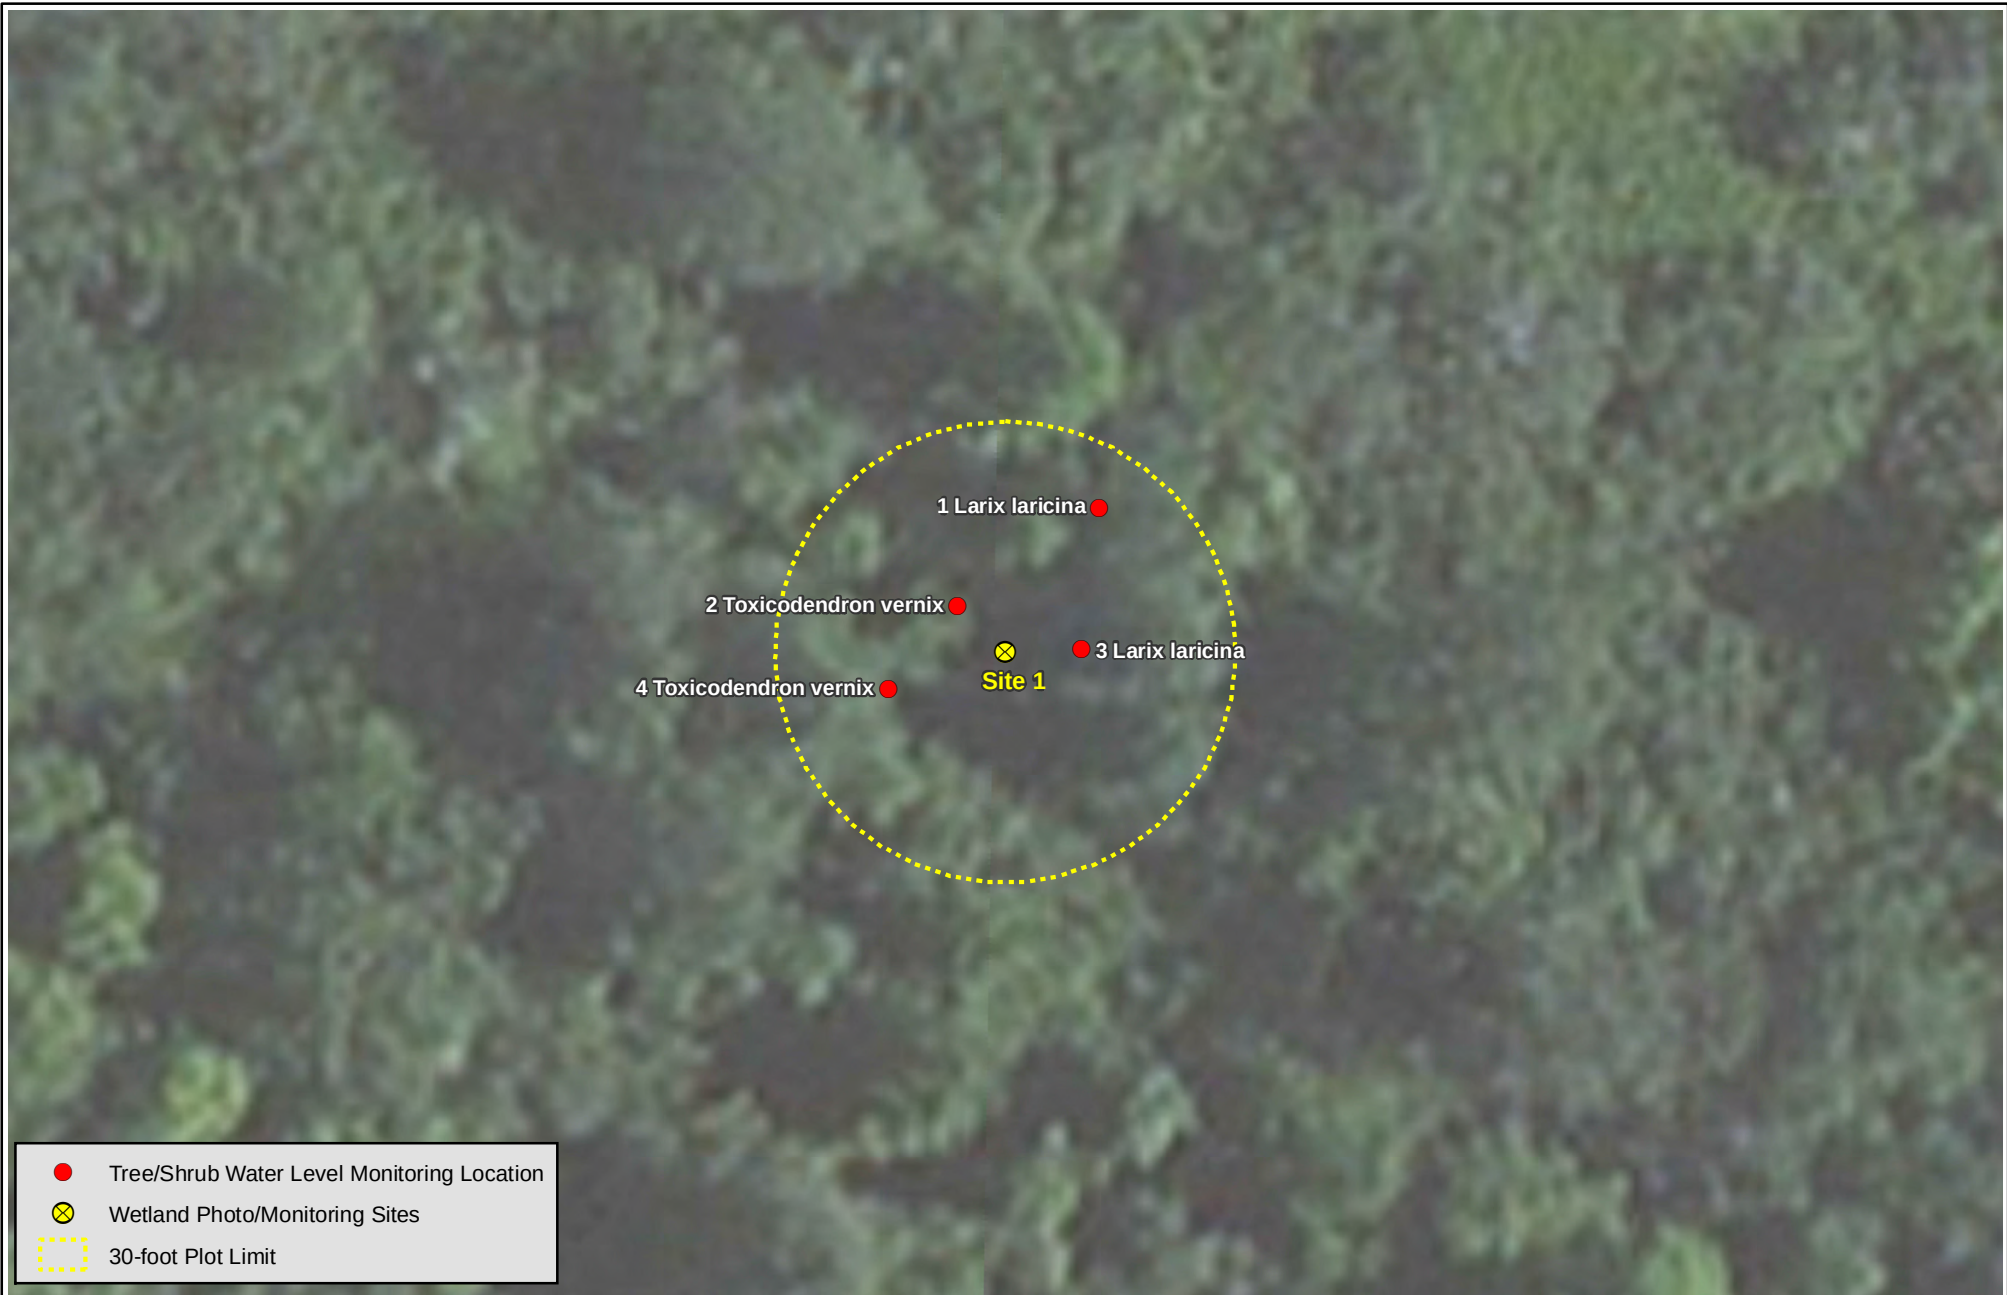
## WETLAND MONITORING SITE PLOT 1

Trees and shrubs were growing on hummocks at all monitoring sites, and water levels were recorded at those representative woody shrubs and trees (Figure 2) and water depths were measured (Table 11). During the site assessment on May 14, 2021, water depths at all representative trees and shrubs were zero except in Site 5 (Table 11). Minimum and maximum pool depths within each 30-foot monitoring plot were estimated for each site and recorded to the nearest inch (Table 12).

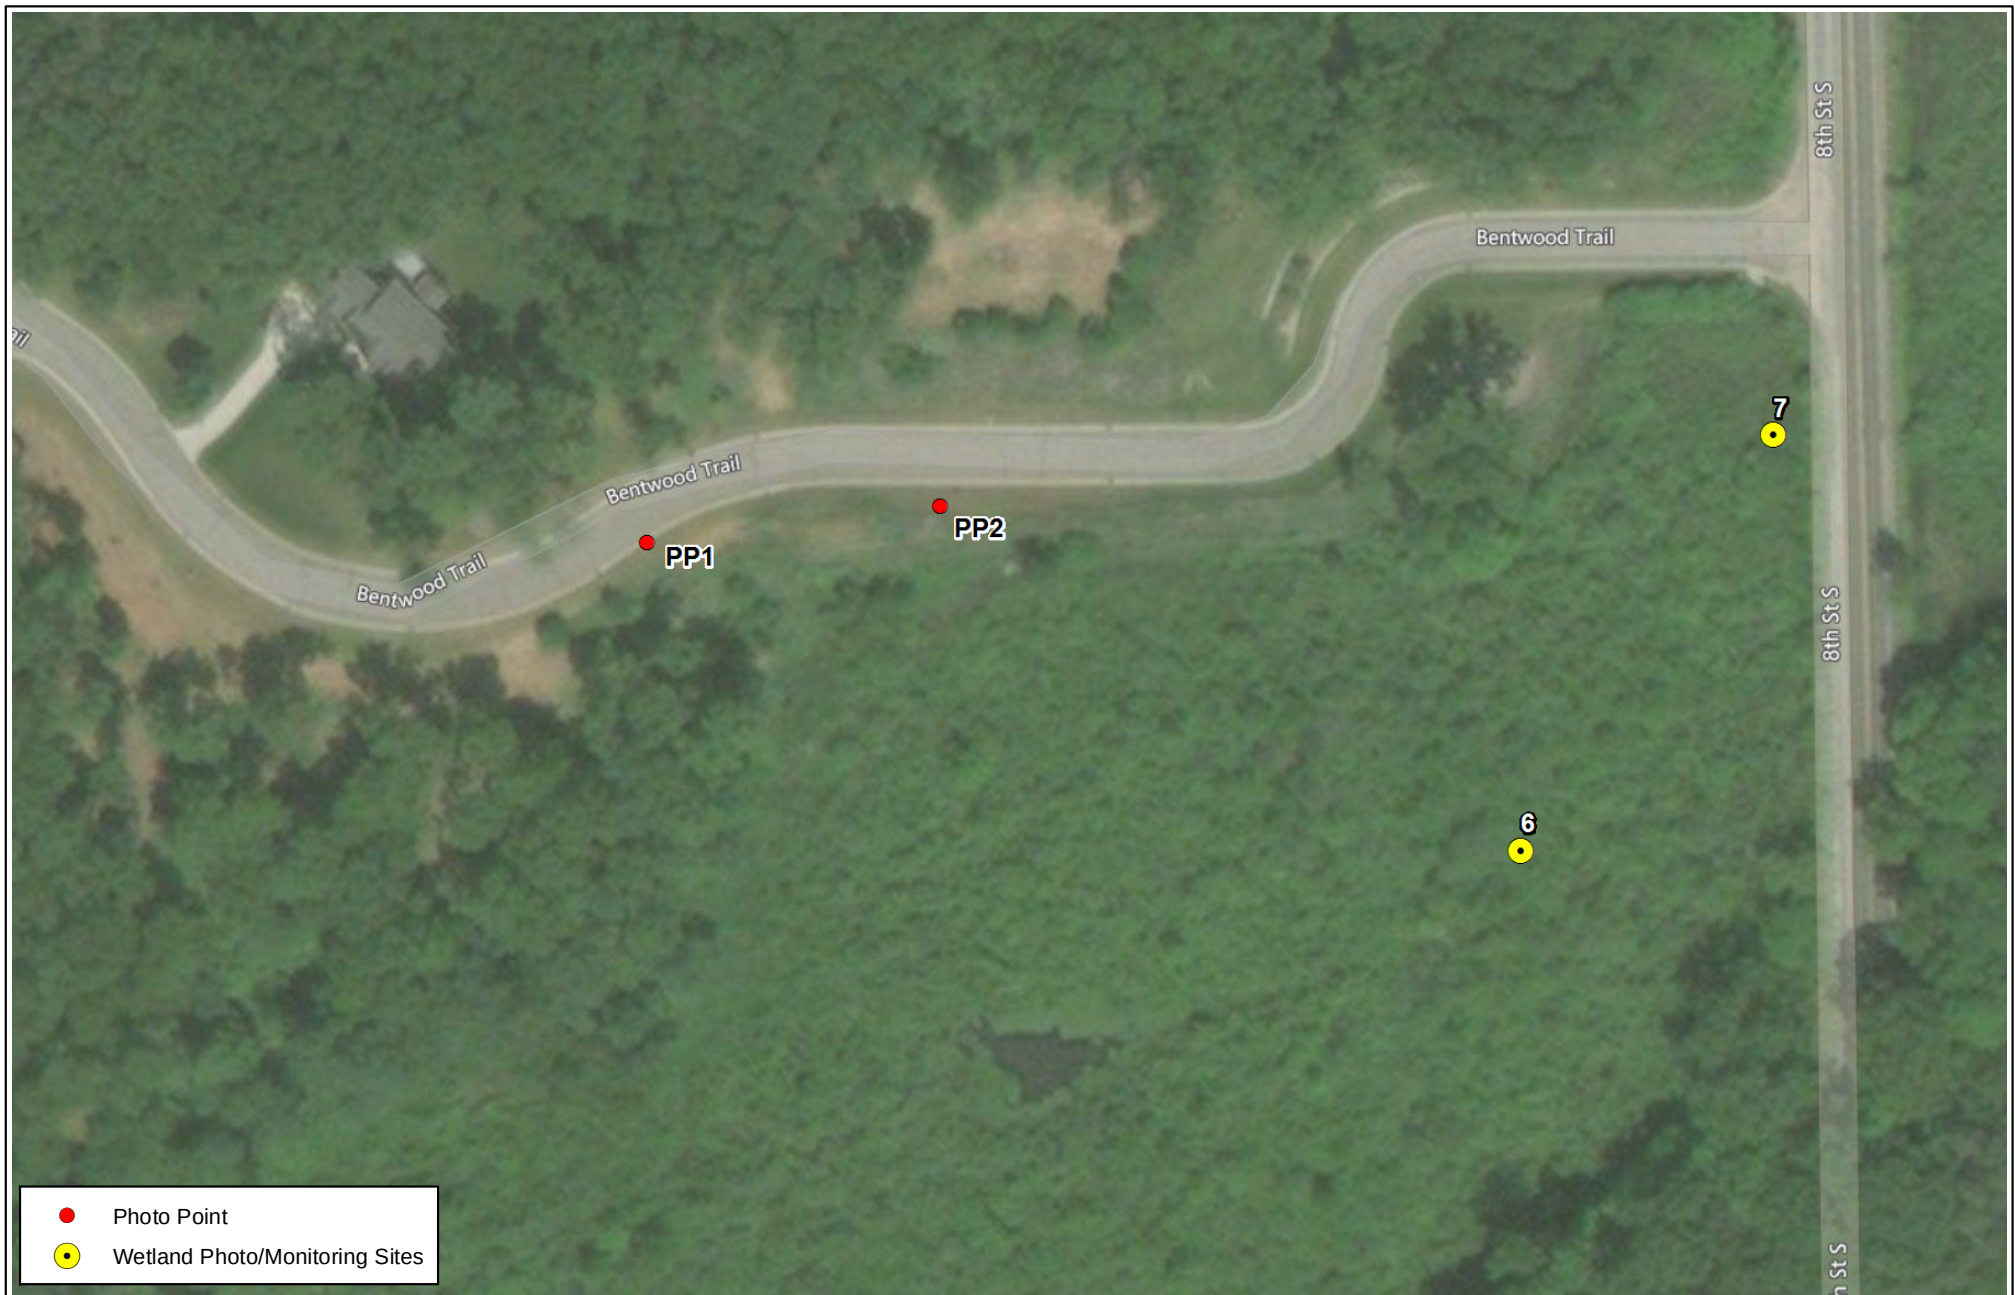
| <p>Charter Township of Texas</p> | | | <p>Project: 1902439</p> | <p>Figure: 3</p> |

| <p>MDEQ Permit No. WRP015489 v.1<br/>Bentwood Trail<br/>Kalamazoo County, Michigan</p> | <p>0 50 100 150 Feet</p> <p>1 inch = 100 feet</p> | <p>GEI Consultants</p> | <p><b>BENTWOOD TRAIL<br/>SUPPLEMENTAL<br/>PHOTO POINT LOCATIONS</b></p> | |

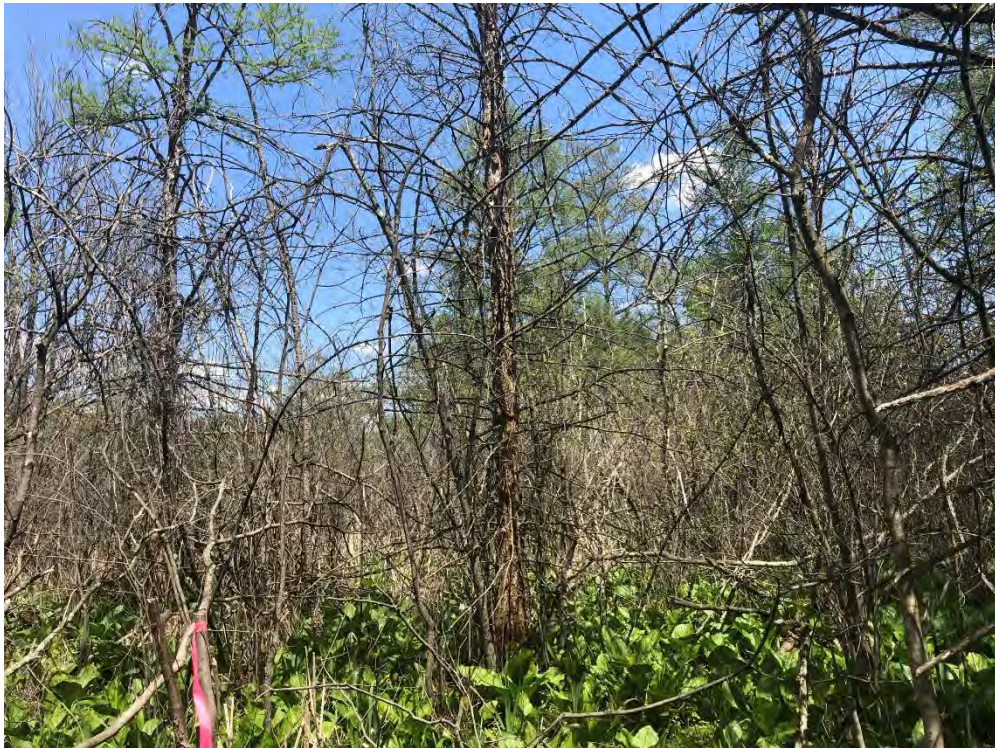
**Photo 29. Monitoring Site C3 facing north**

| Site | Current Notes |
|---|---|
| C3 | Approximately 10% of plot is inundated, deep muck present |

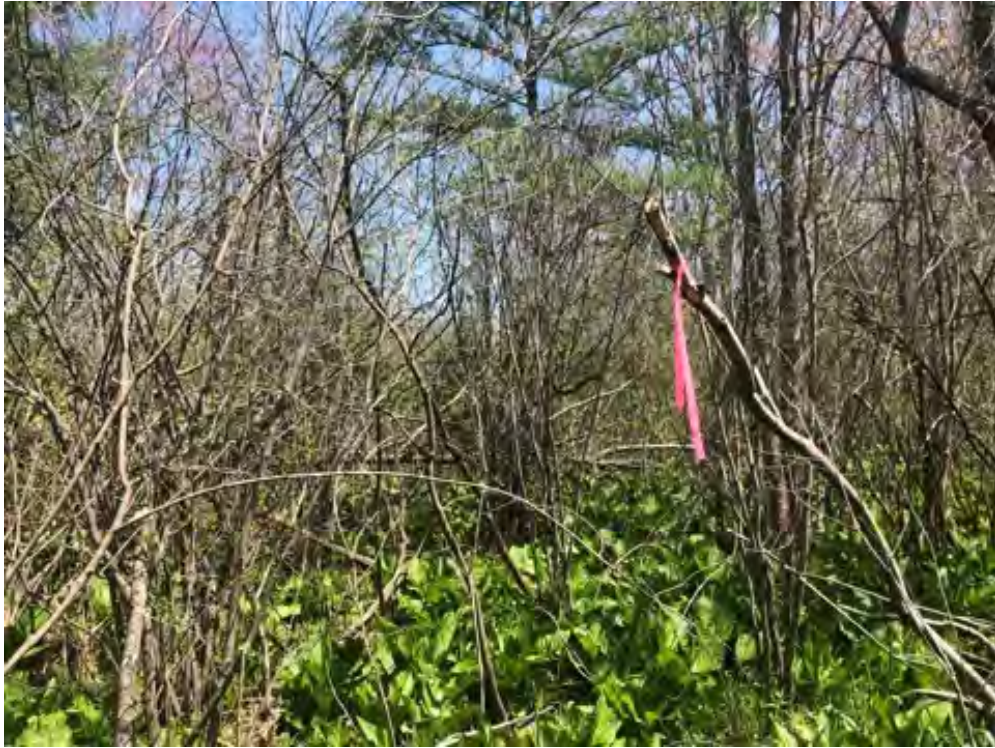
**Photo 33. Monitoring Site C5 facing north**

| Site | Current Notes |
|---|---|
| C5 | Approximately 10% of plot is inundated, deep muck present |
