# Charter Township of Texas Flood Study

# Texas Township Flood Mitigation

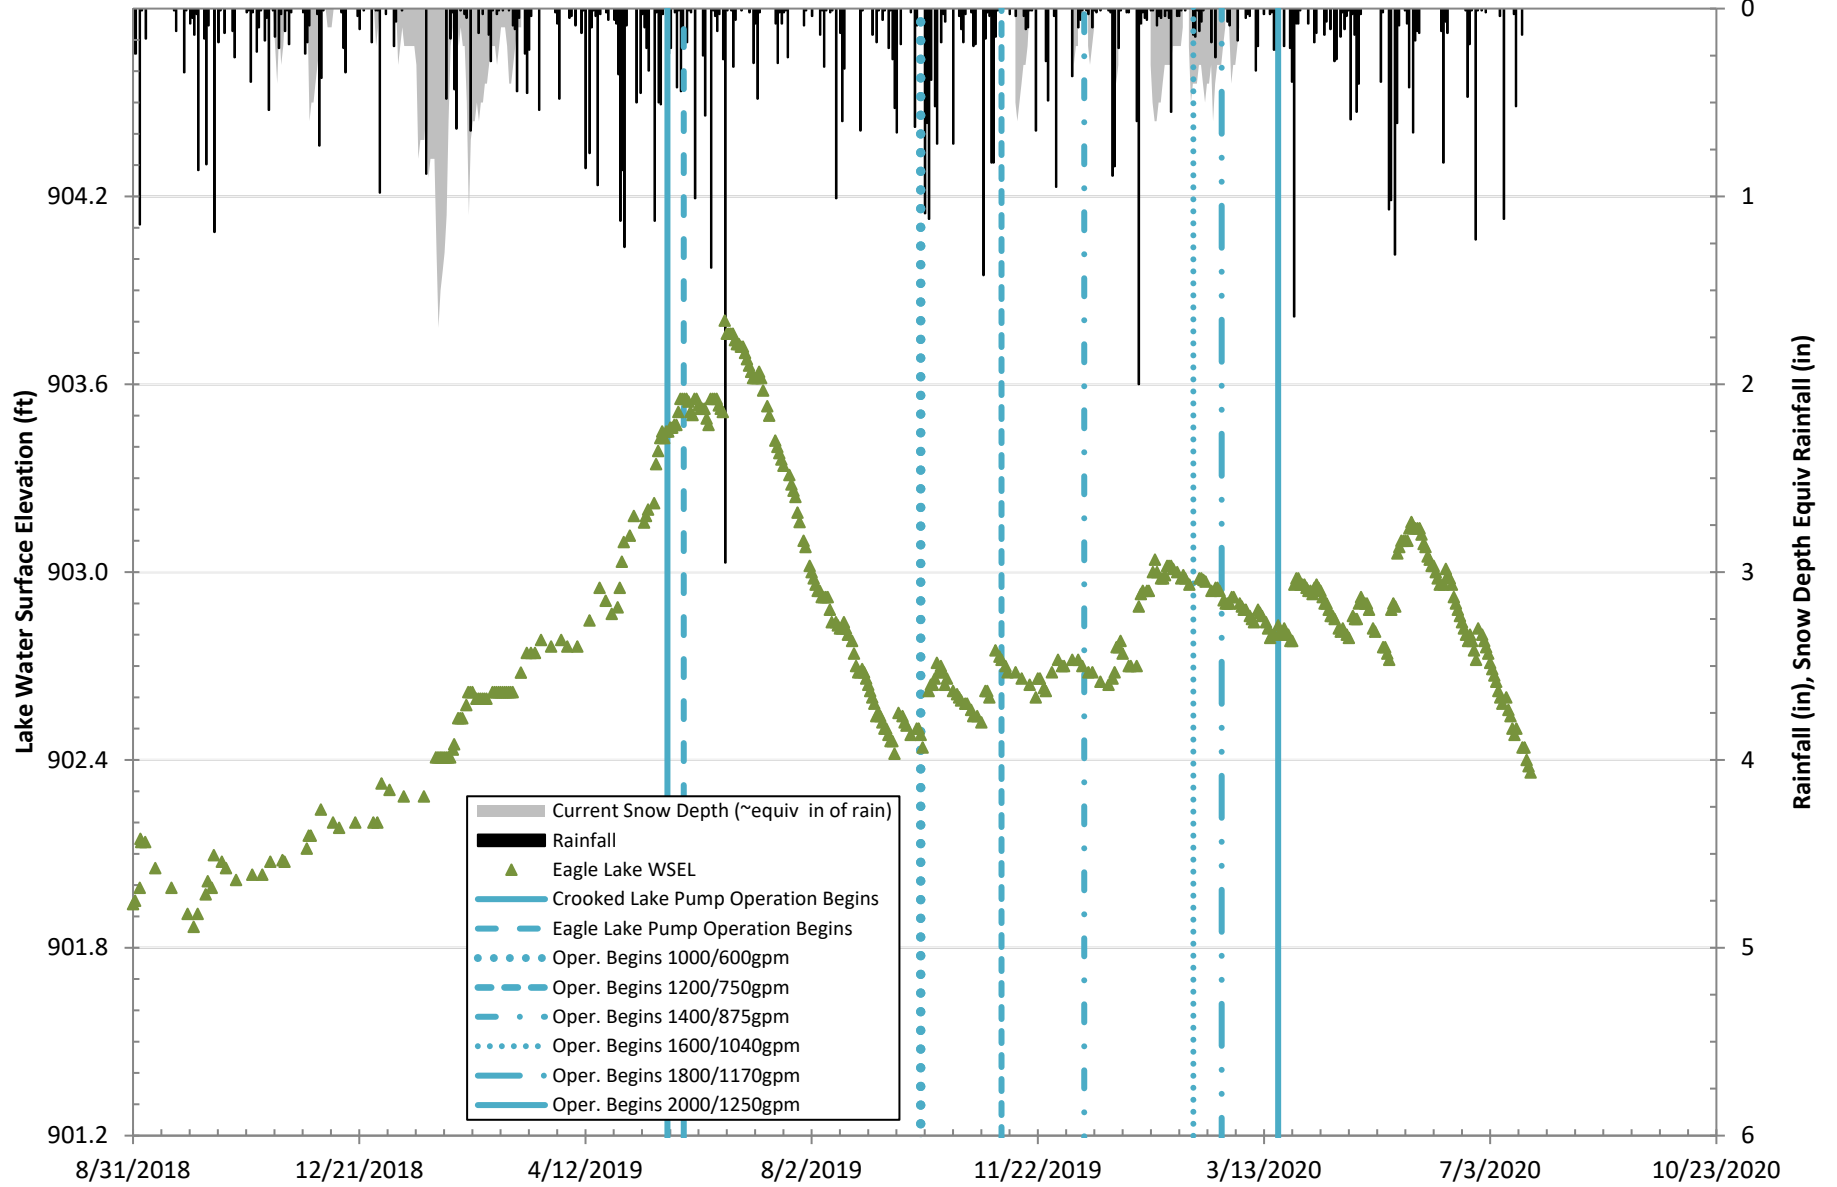
Charter Township of Texas Flood Study  
 Figure  
 Eagle Lake Monitoring Results through July 23, 2020

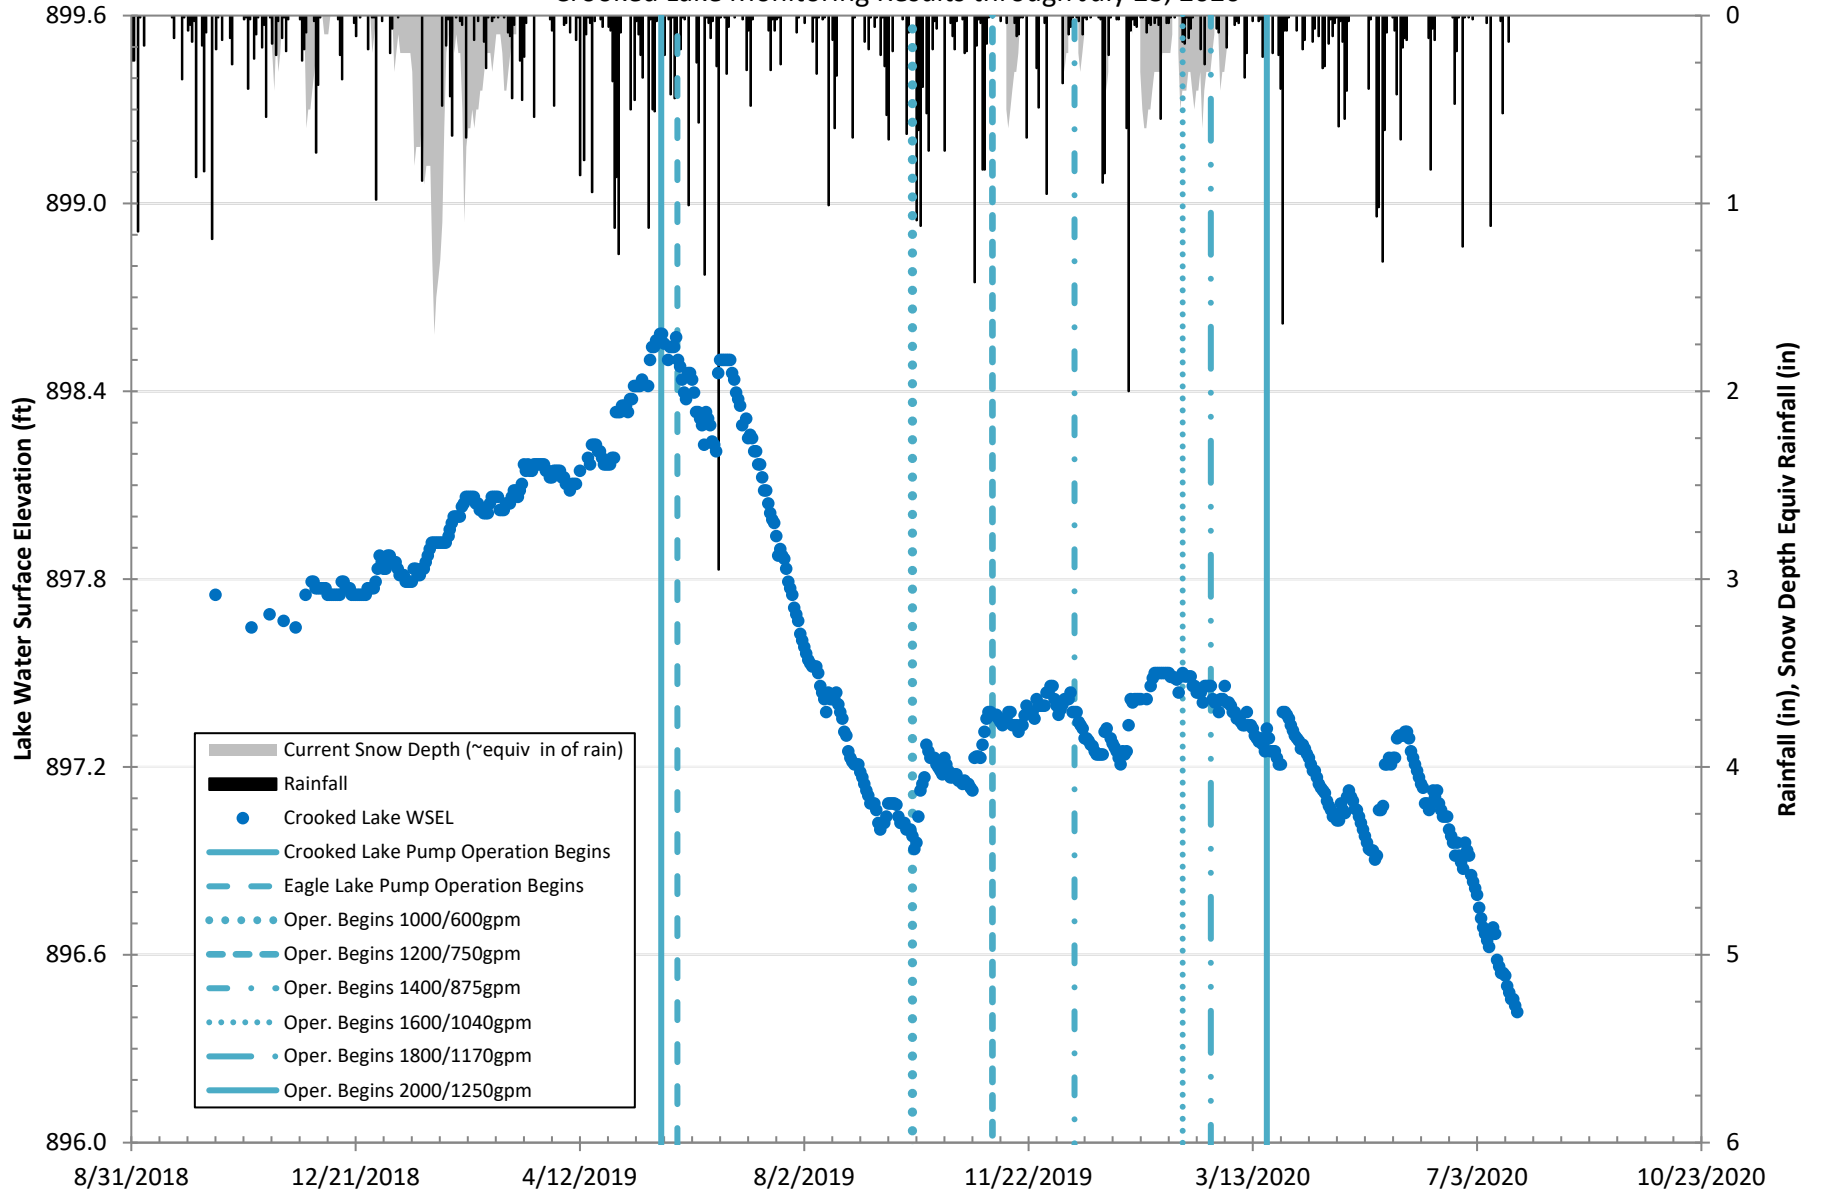
Charter Township of Texas Flood Study  
 Figure  
 Crooked Lake Monitoring Results through July 23, 2020

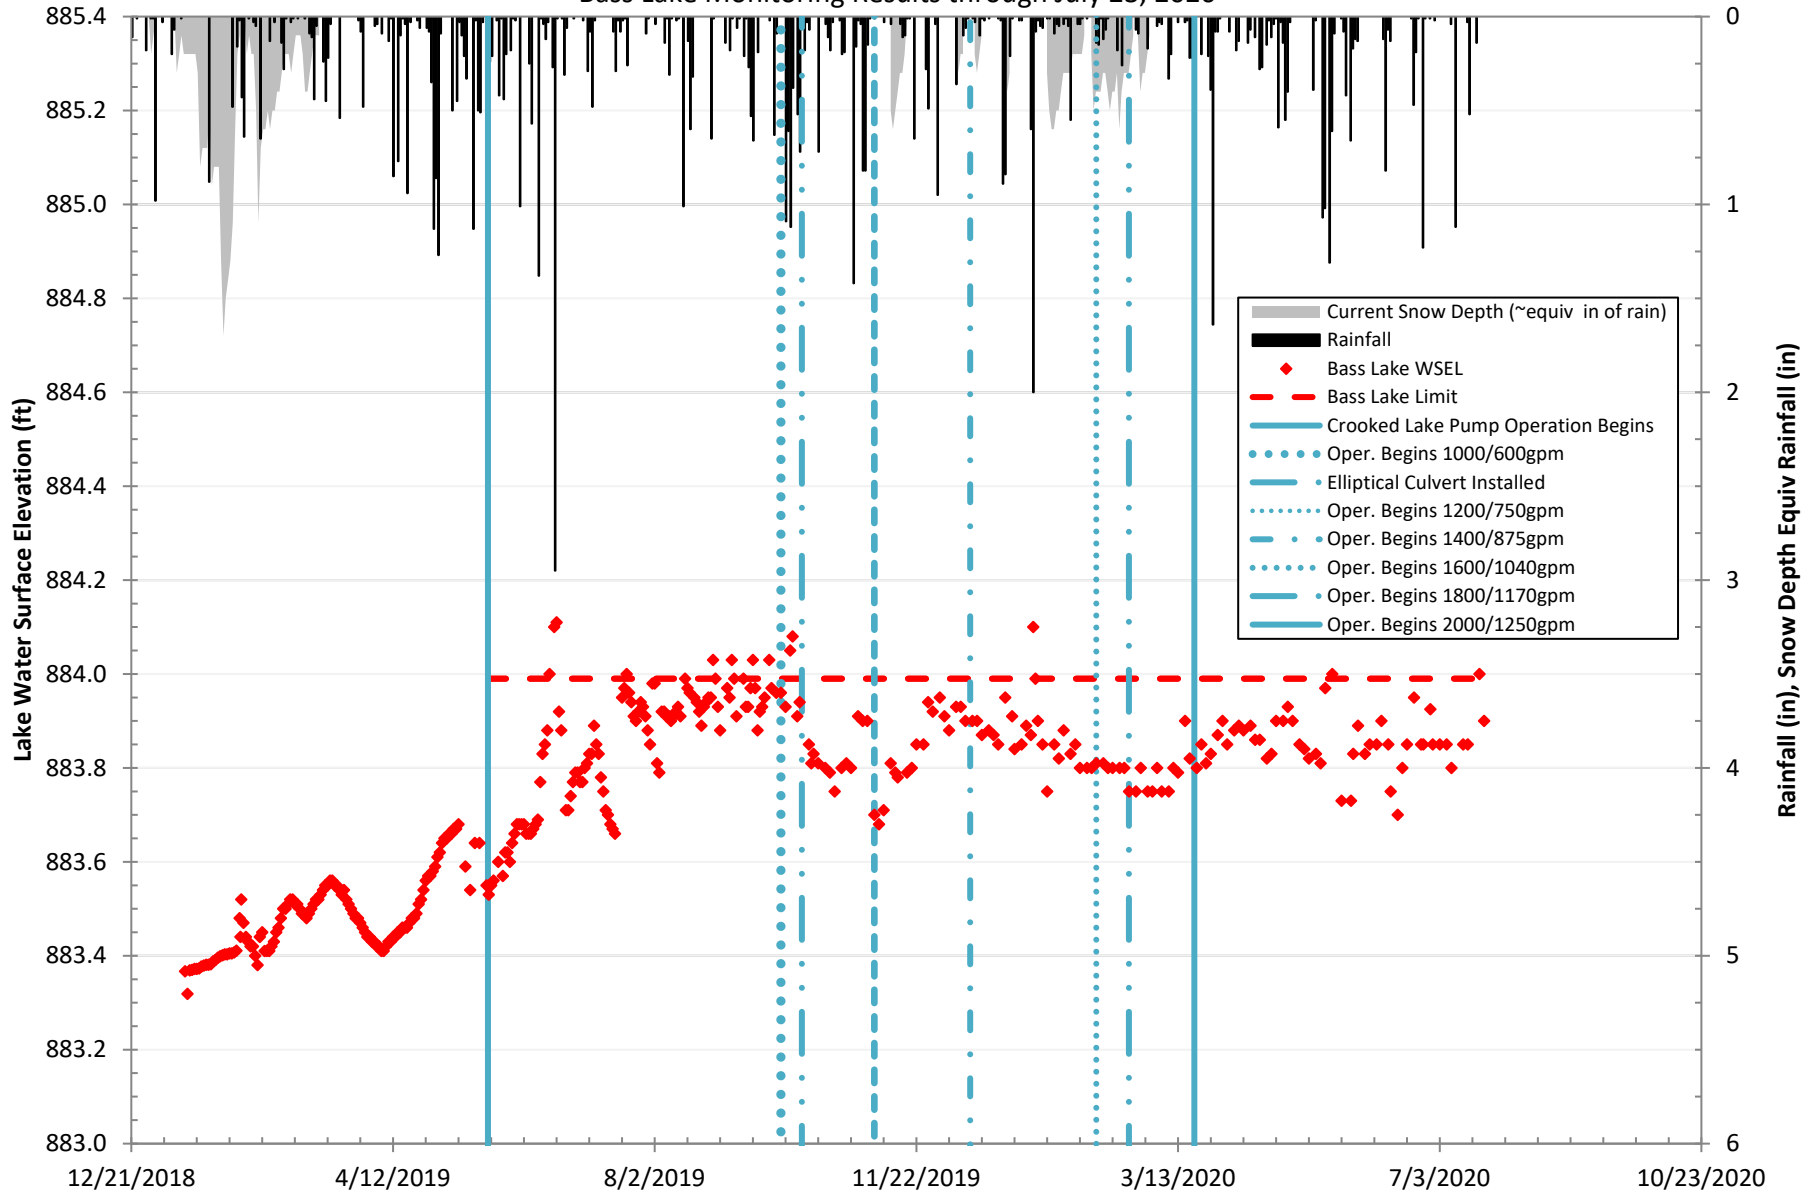
Charter Township of Texas Flood Study  
 Figure  
 Bass Lake Monitoring Results through July 23, 2020

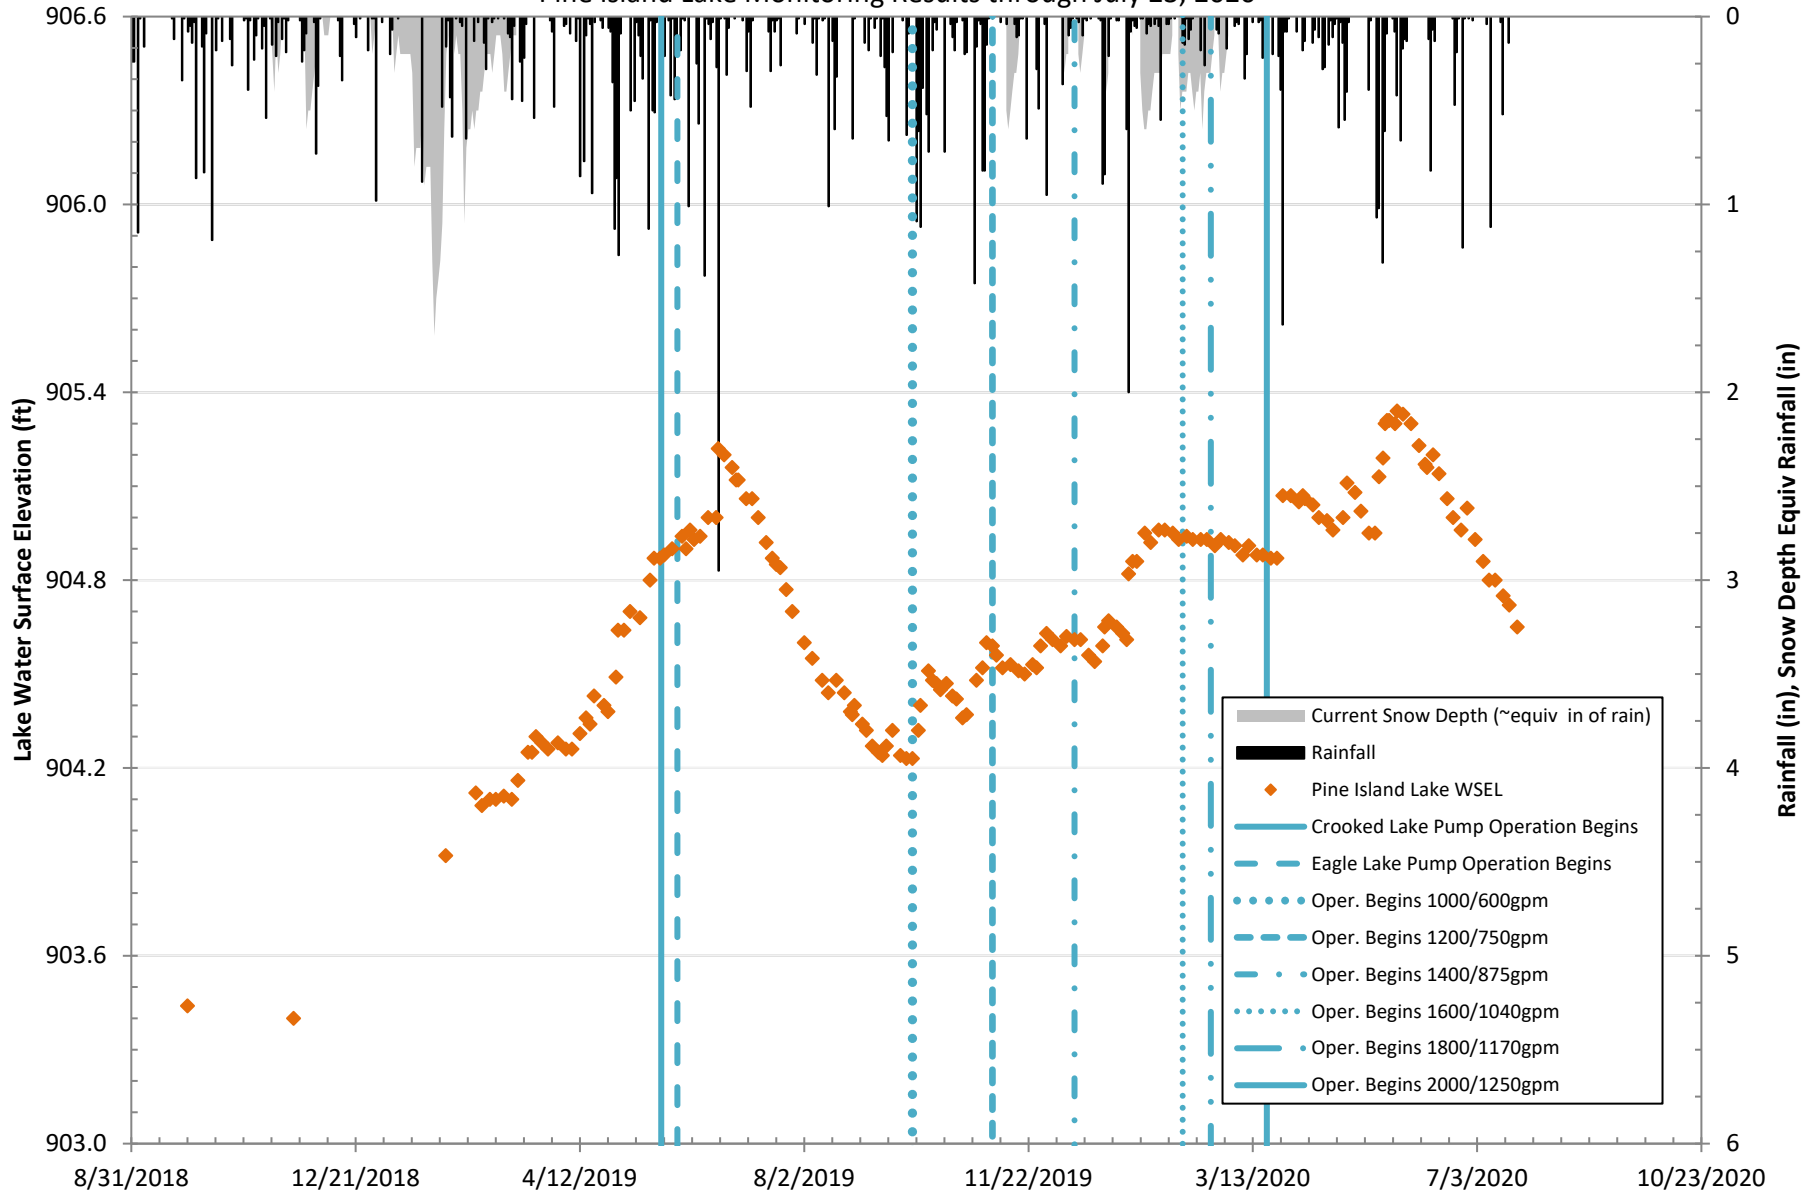
### Pine Island Lake Monitoring Results through July 23, 2020

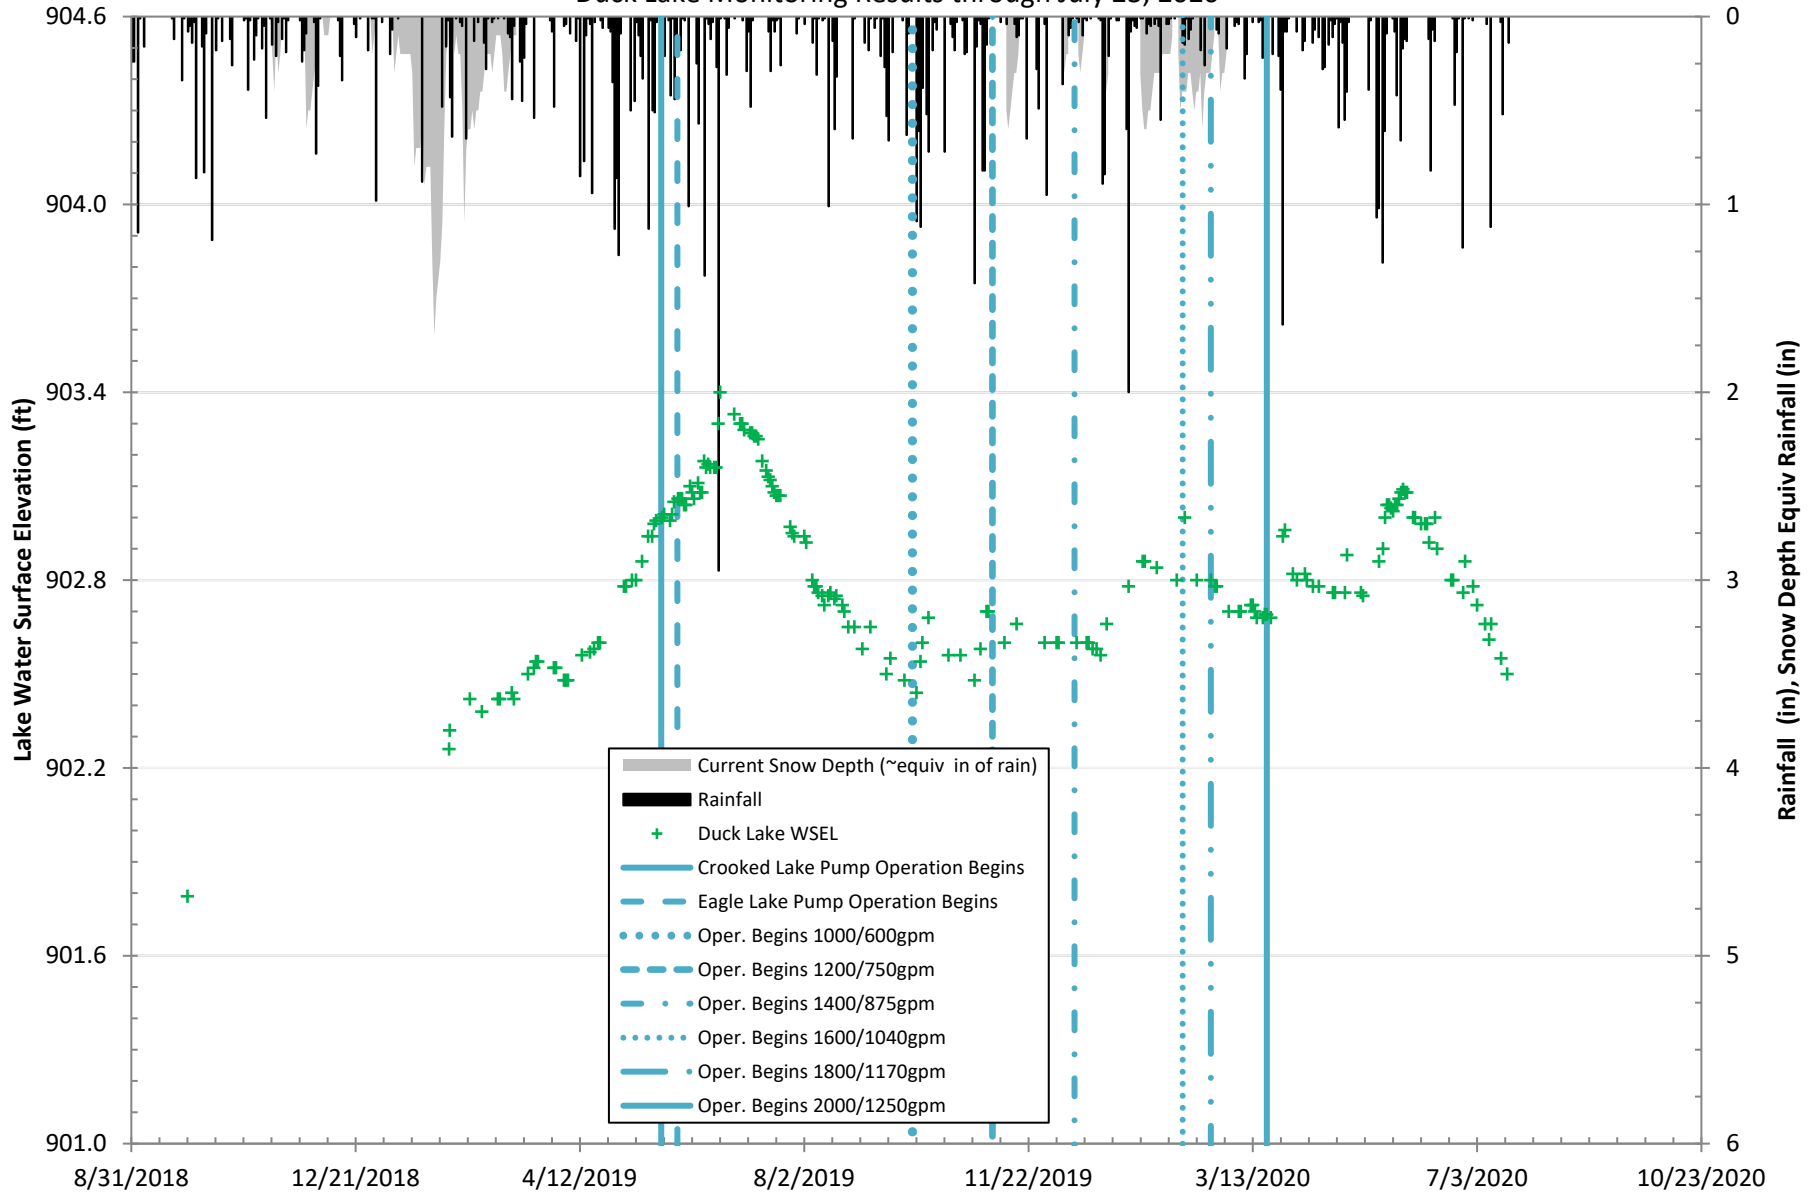
Charter Township of Texas Flood Study  
 Figure  
 Duck Lake Monitoring Results through July 23, 2020

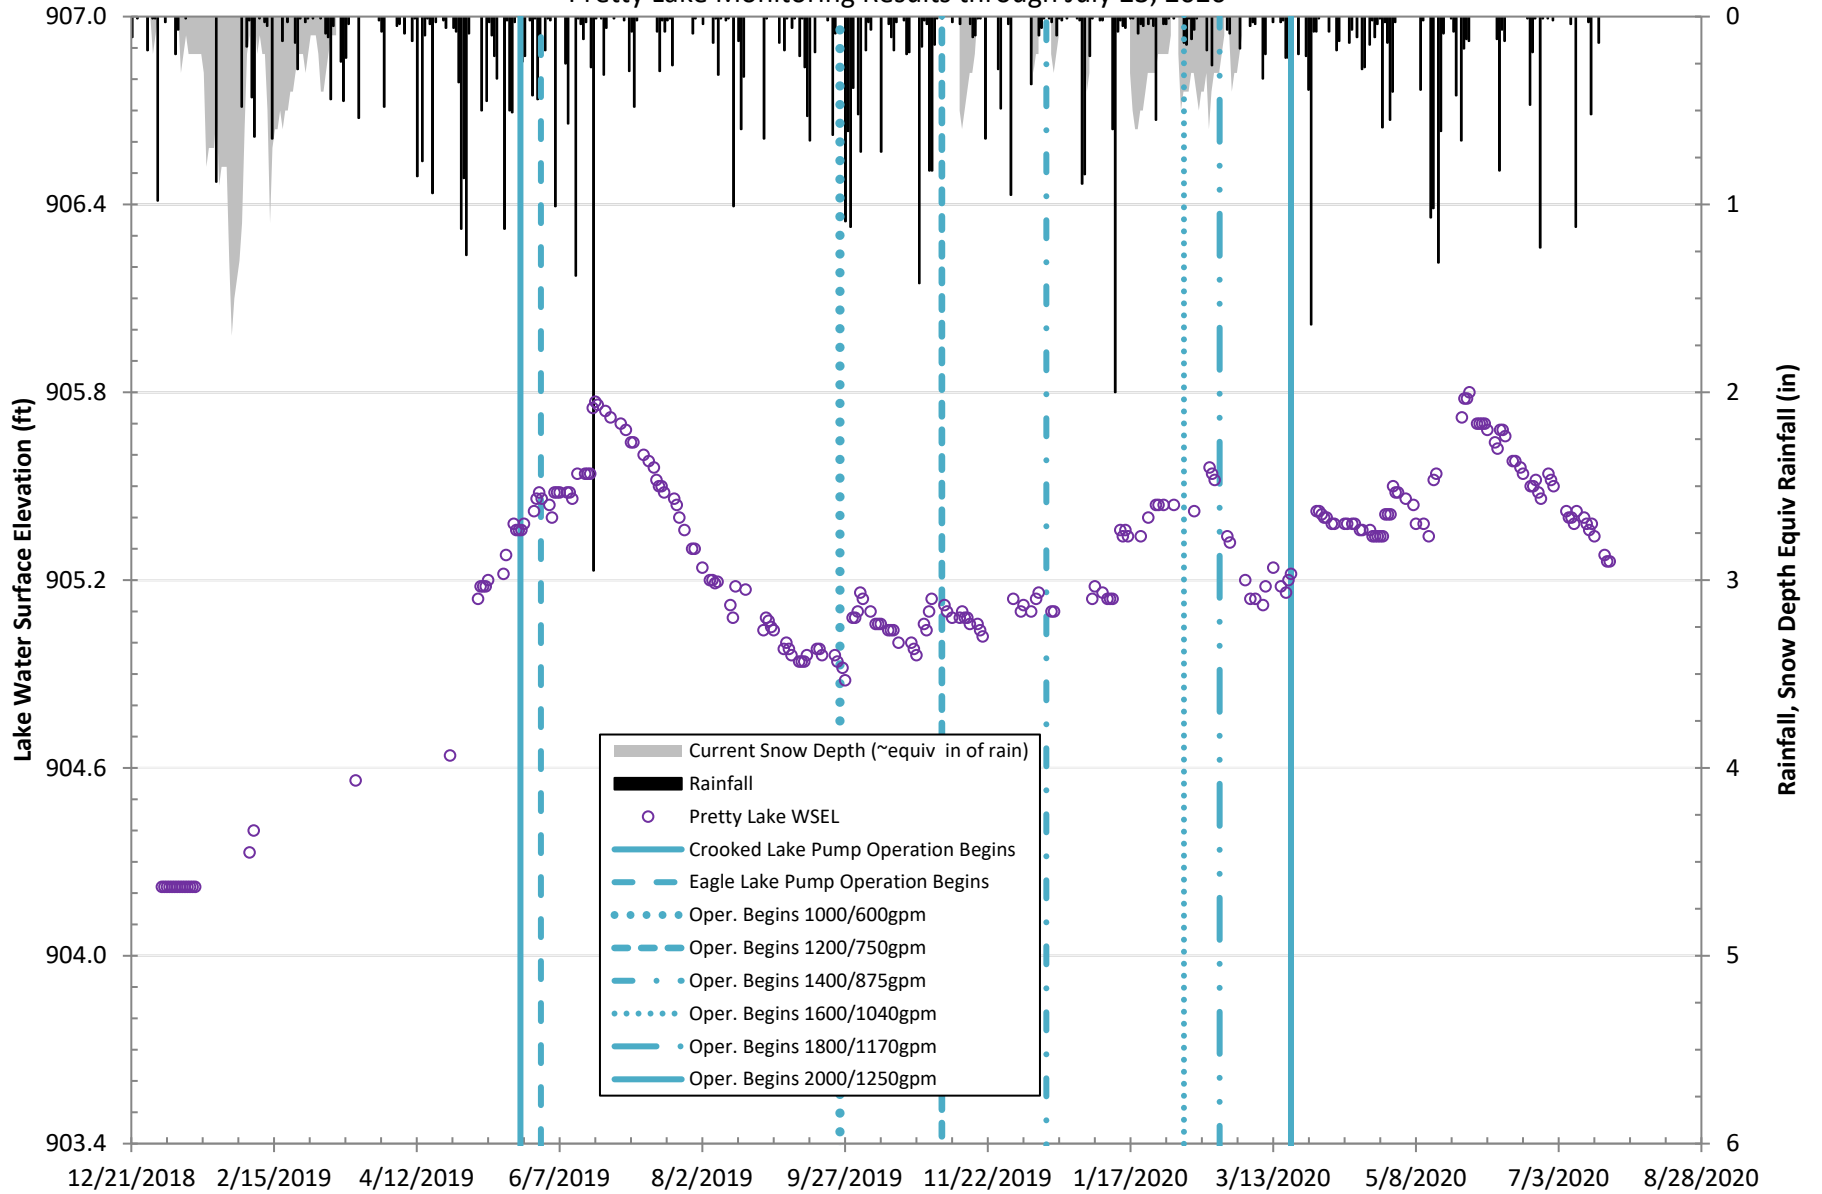
### Pretty Lake Monitoring Results through July 23, 2020

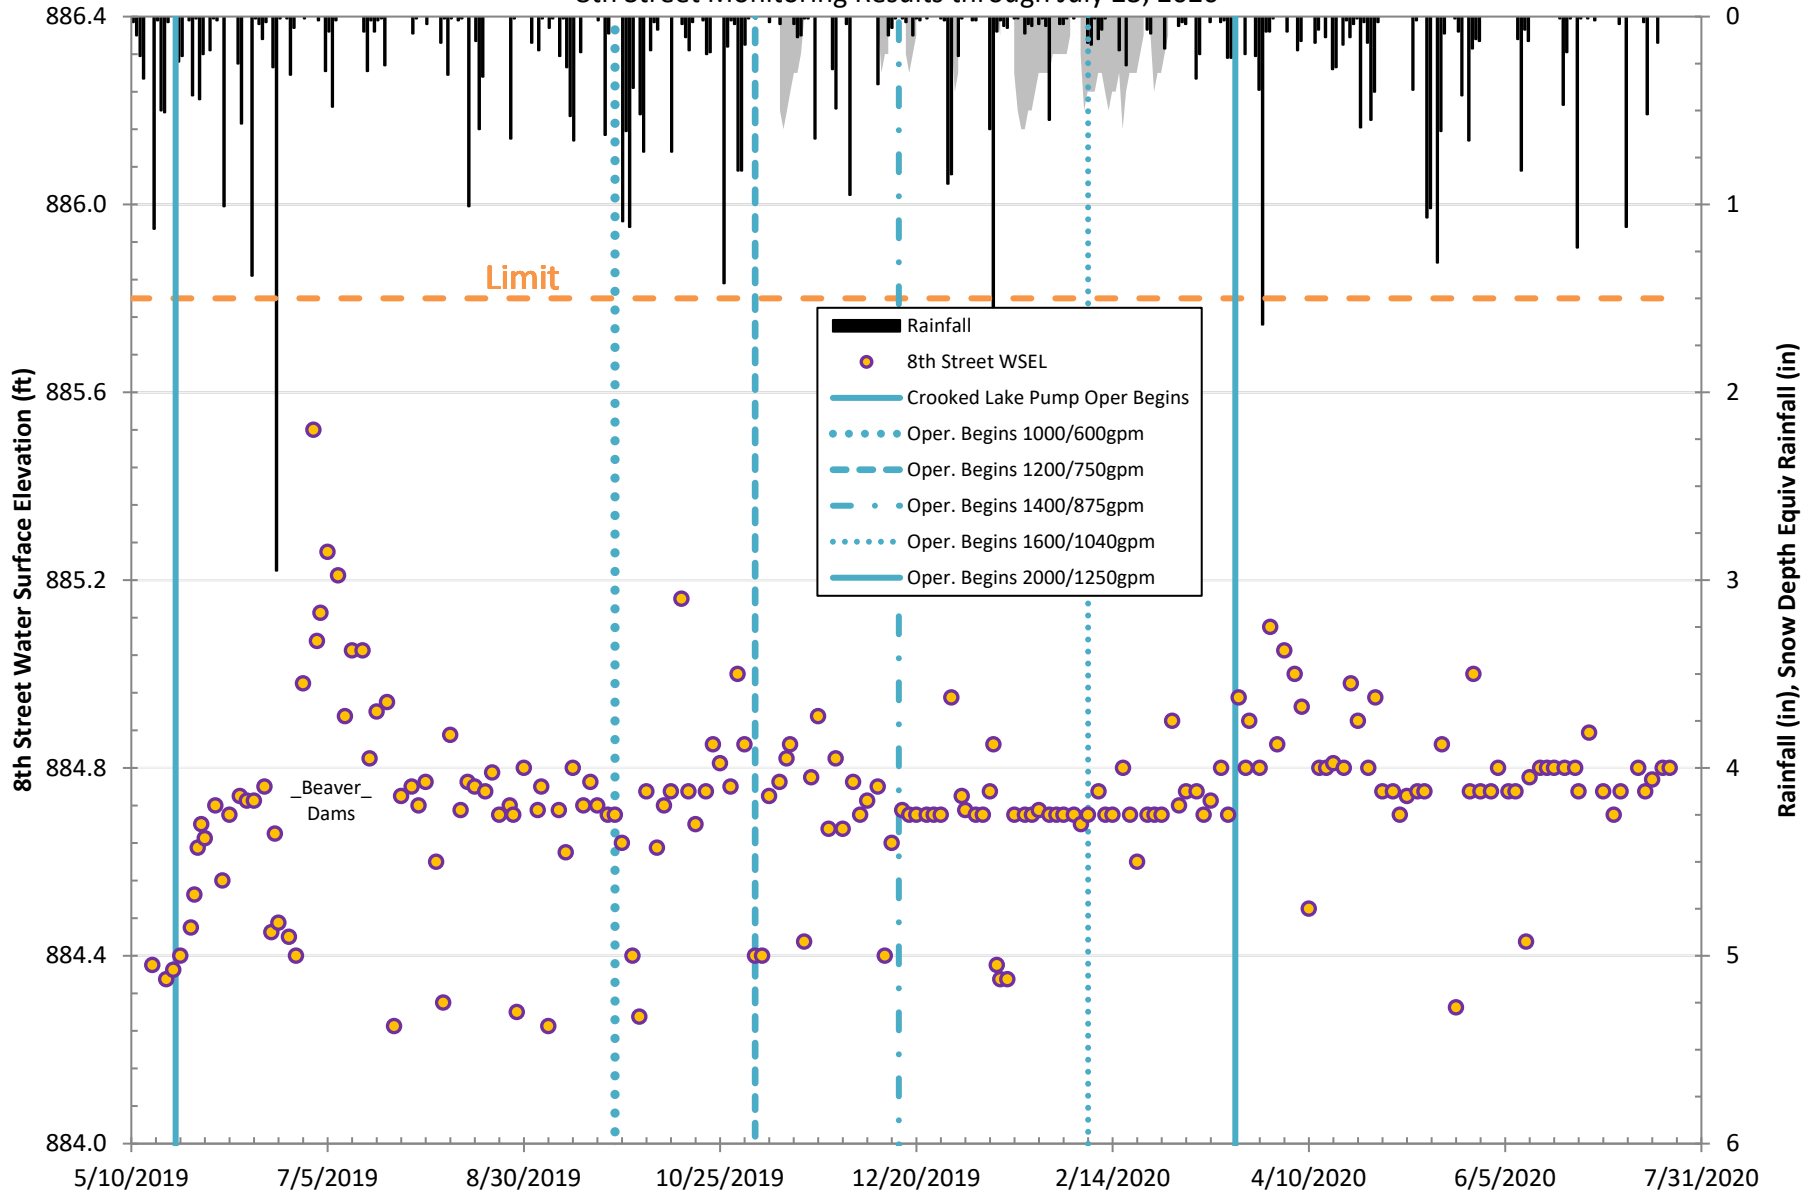
### 8th Street Monitoring Results through July 23, 2020

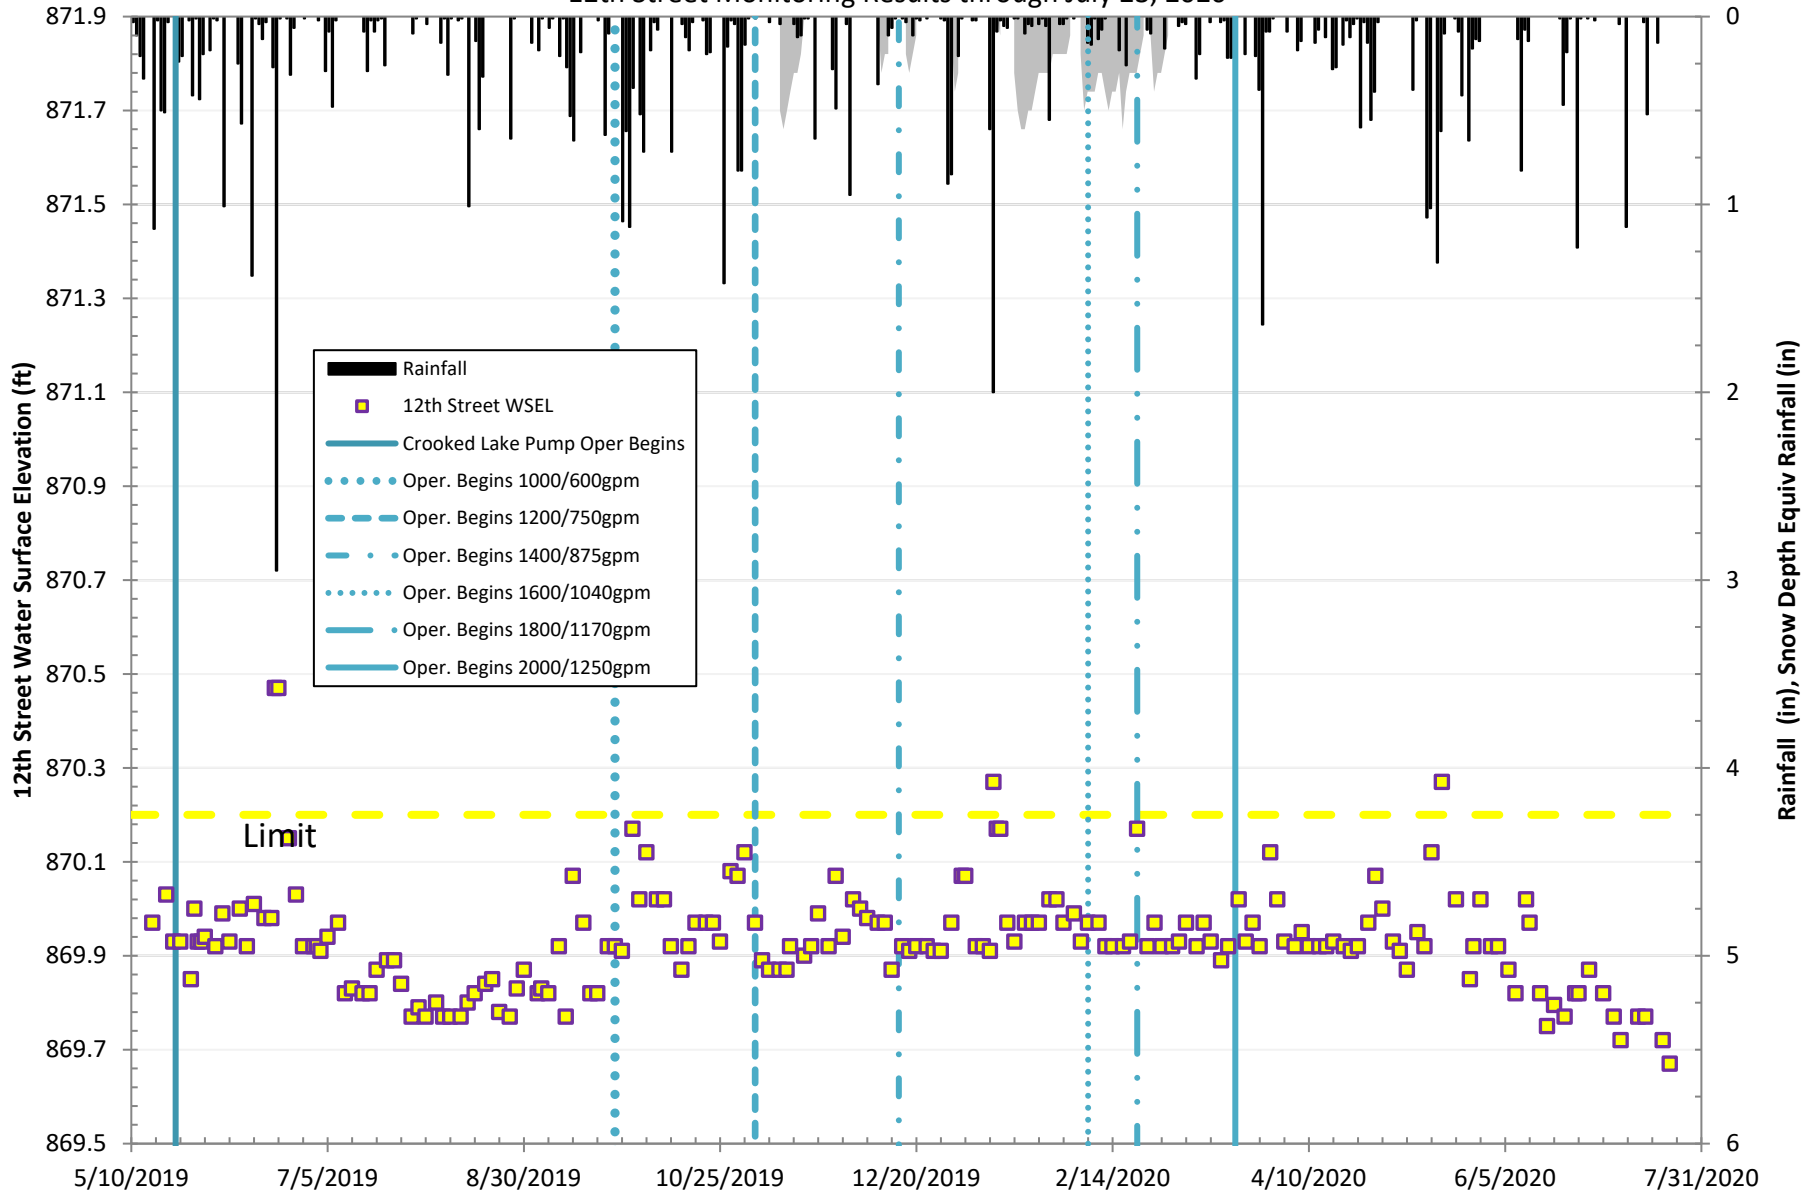
### 12th Street Monitoring Results through July 23, 2020

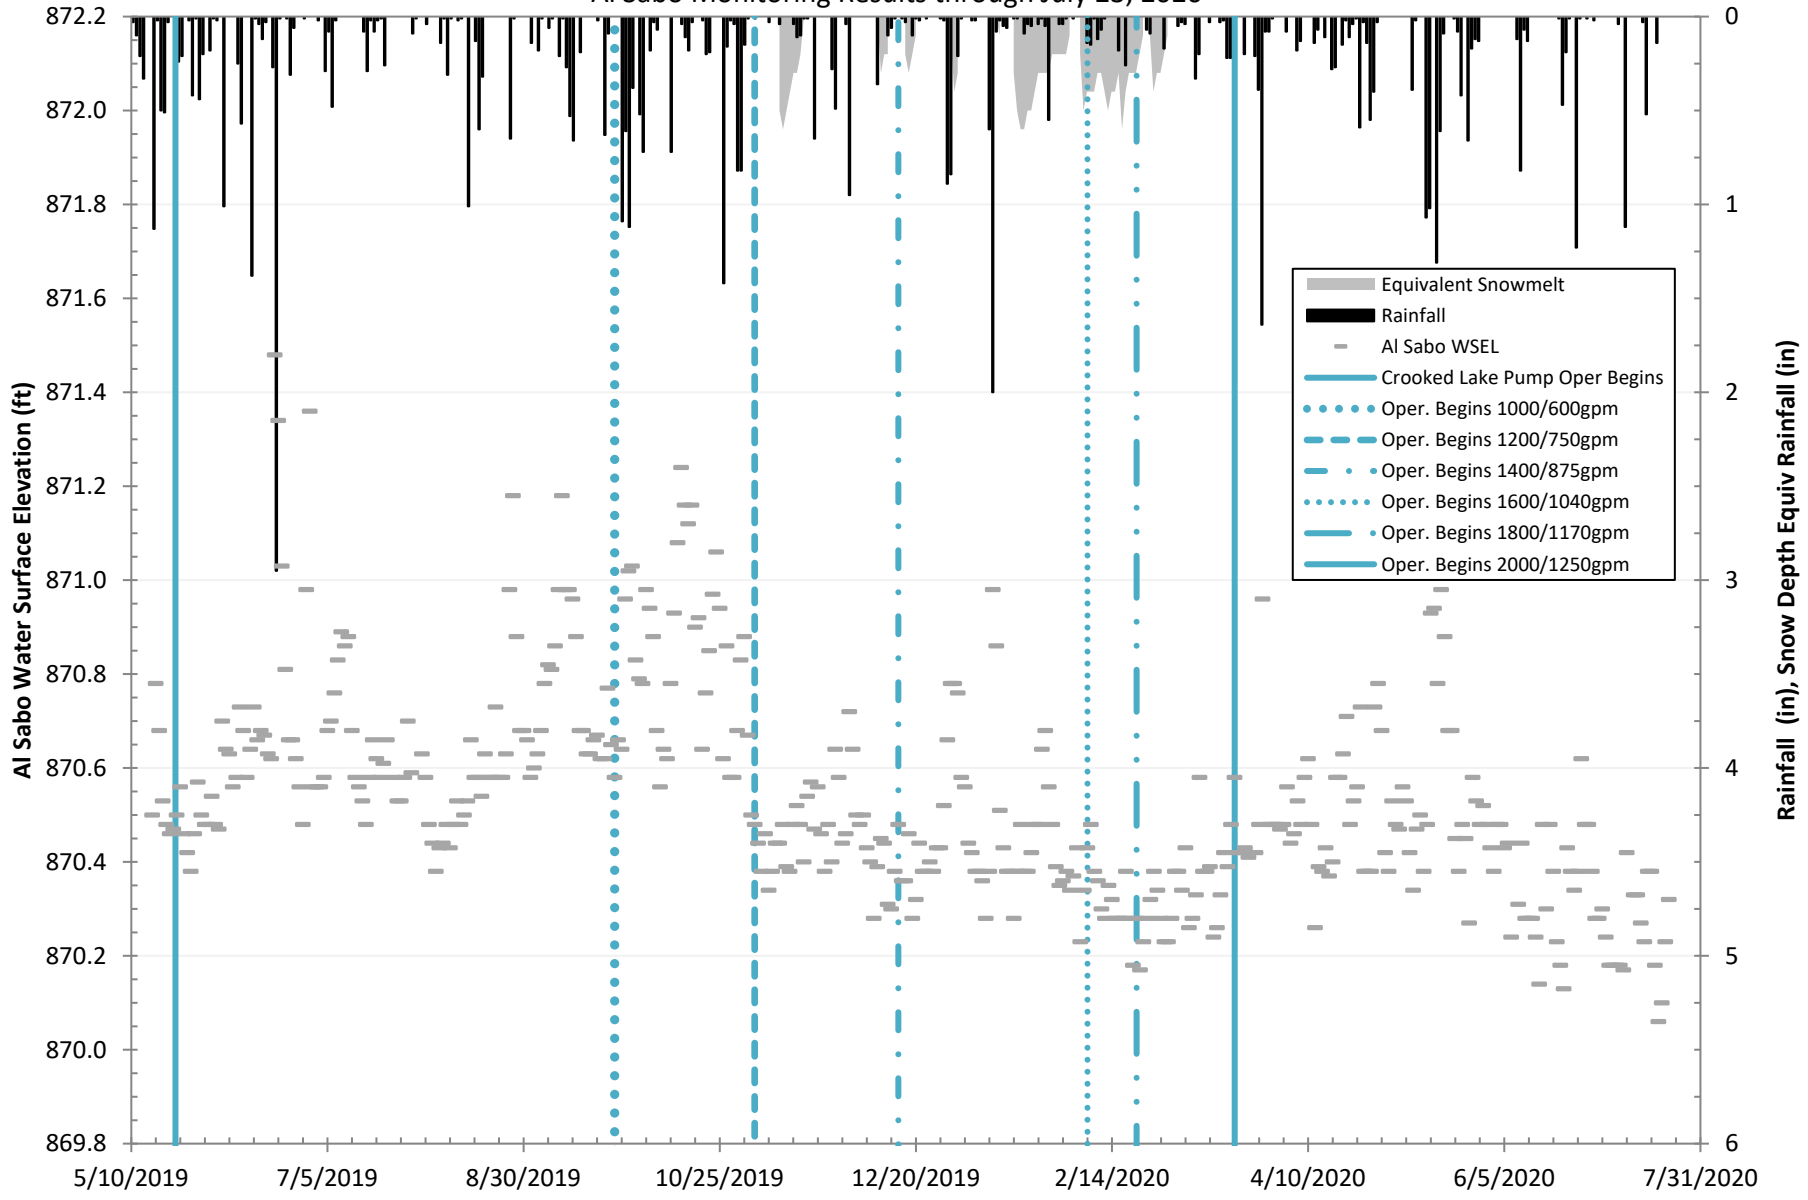
Charter Township of Texas Flood Study  
 Figure  
 Al Sabo Monitoring Results through July 23, 2020

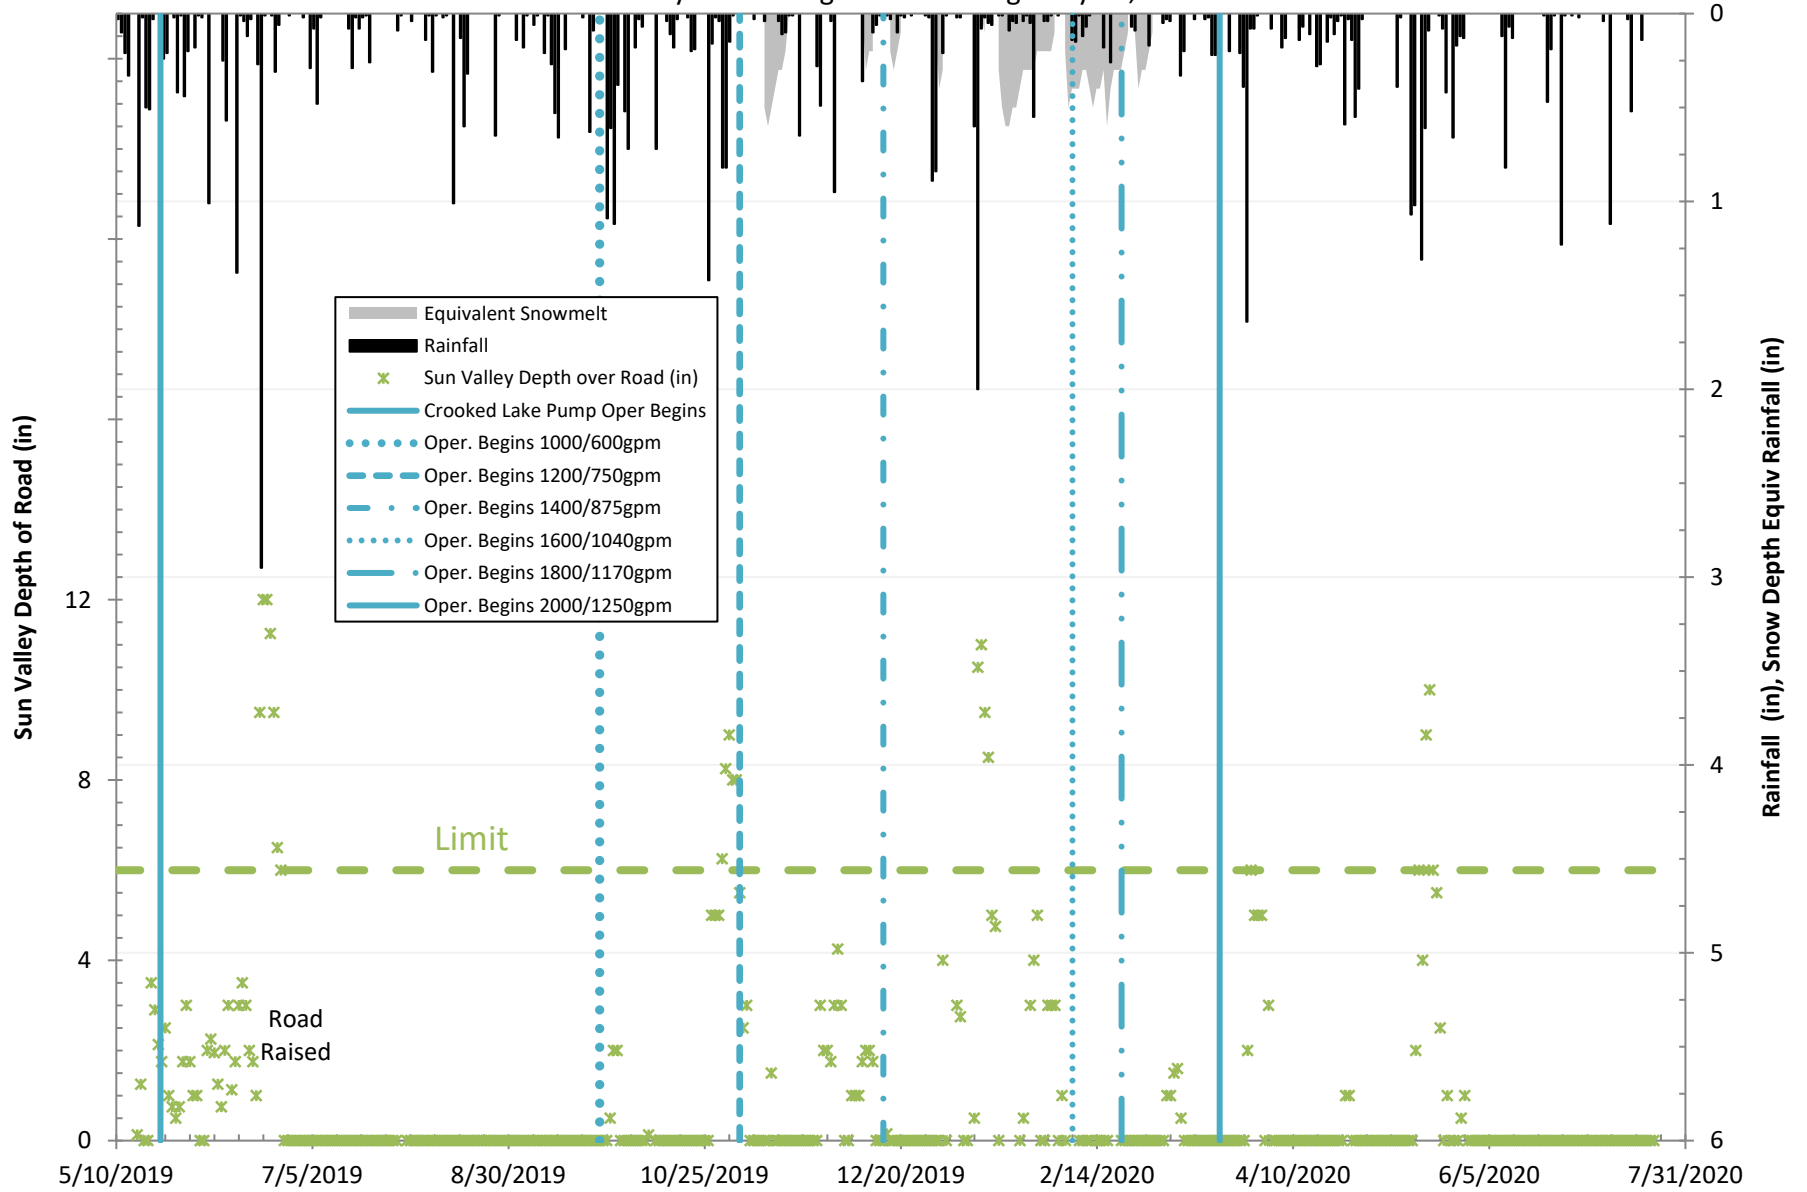
Charter Township of Texas Flood Study  
 Figure  
 Sun Valley Monitoring Results through July 23, 2020
