# Charter Township of Texas Flood Study

# Texas Township Flood Mitigation

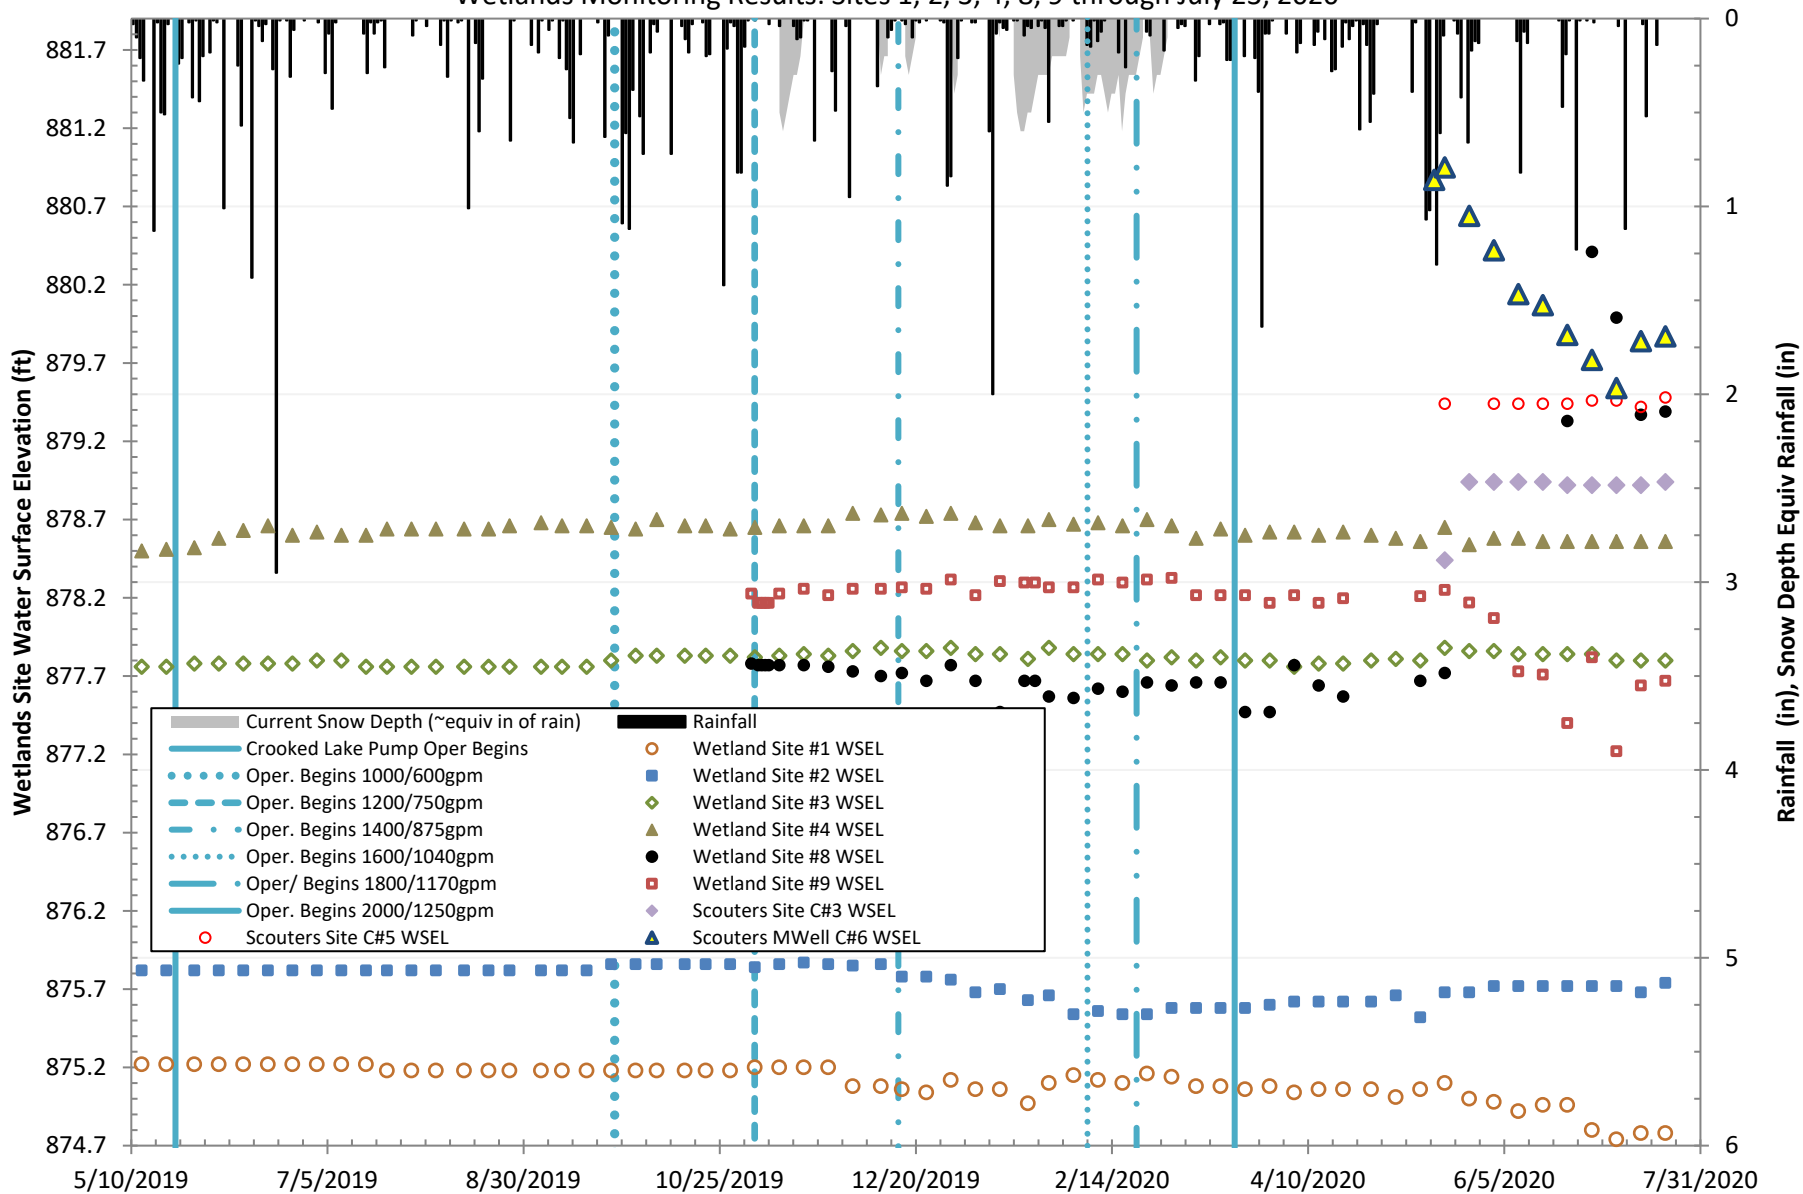
Wetlands Monitoring Results: Sites 1, 2, 3, 4, 8, 9 through July 23, 2020

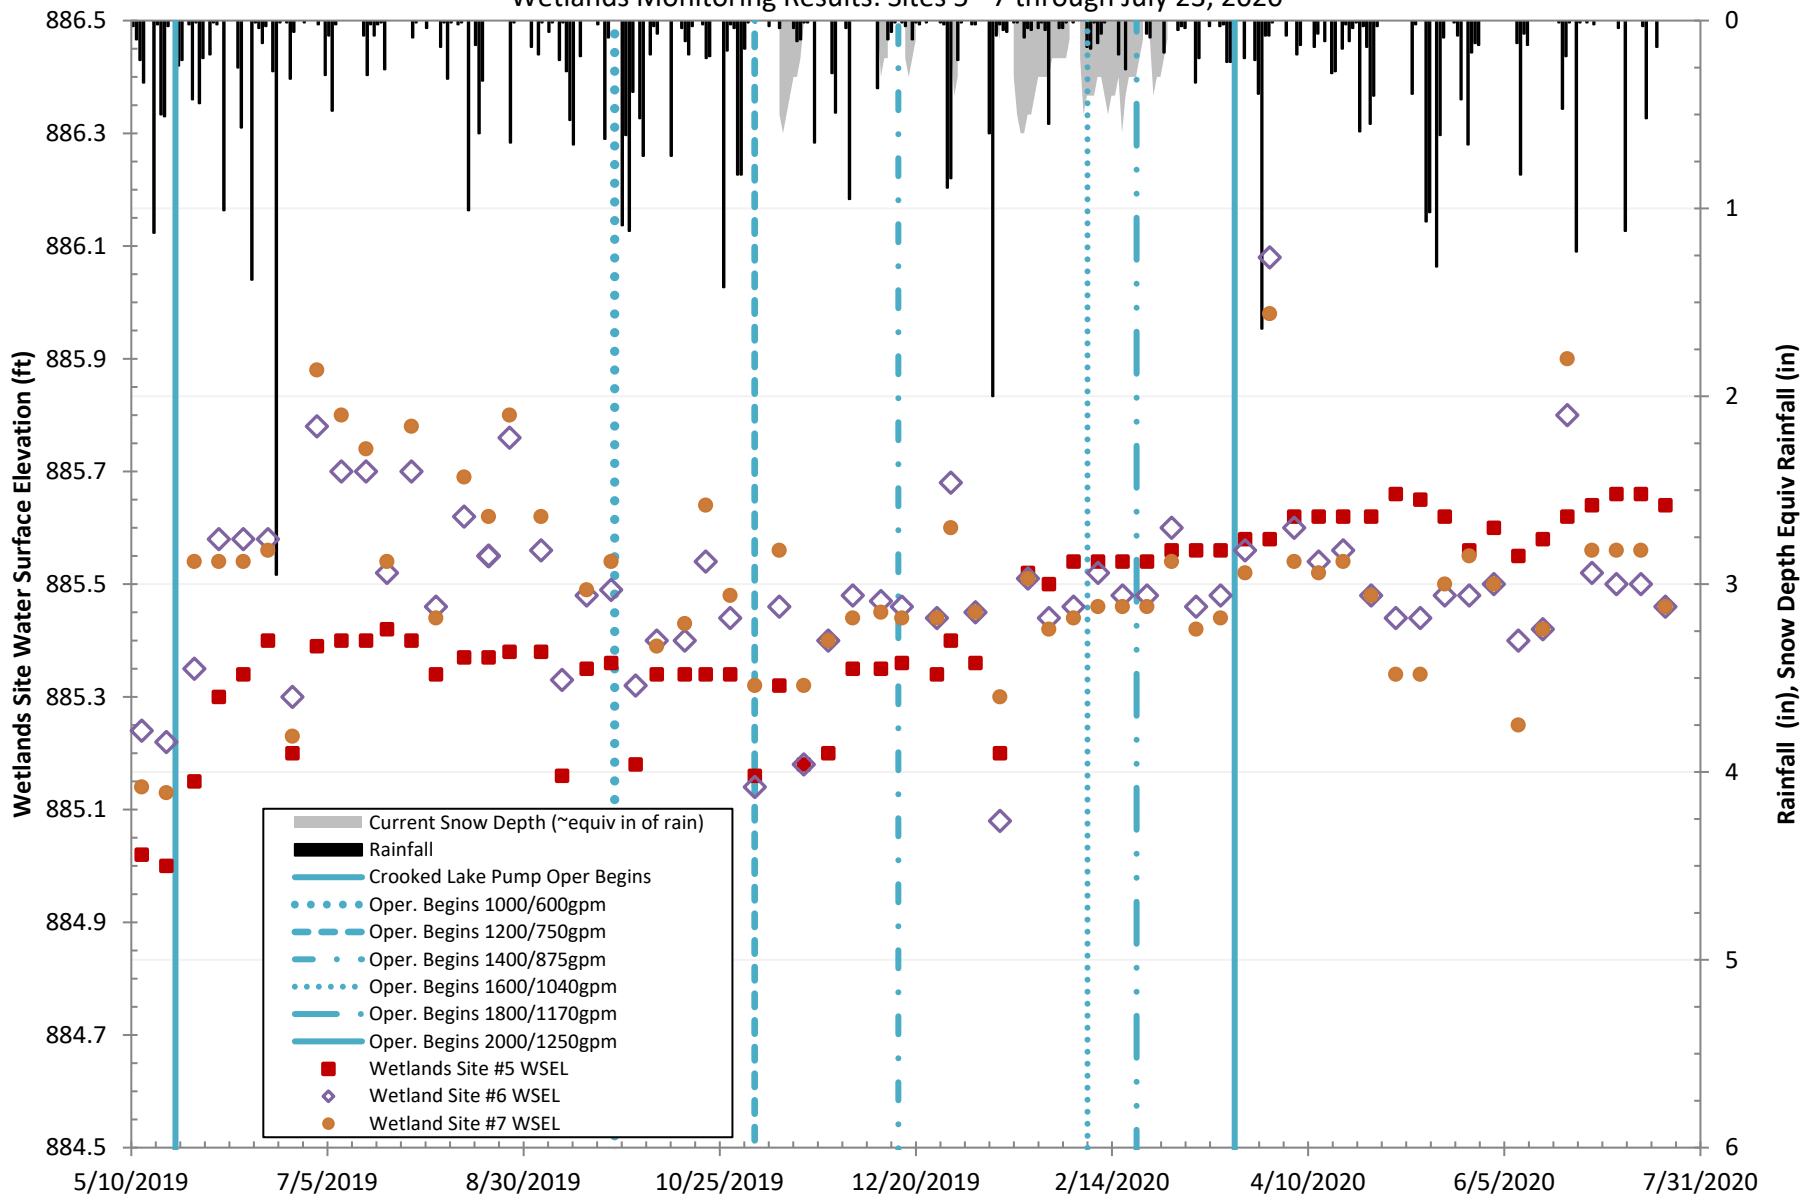
### Wetlands Monitoring Results: Sites 5 - 7 through July 23, 2020

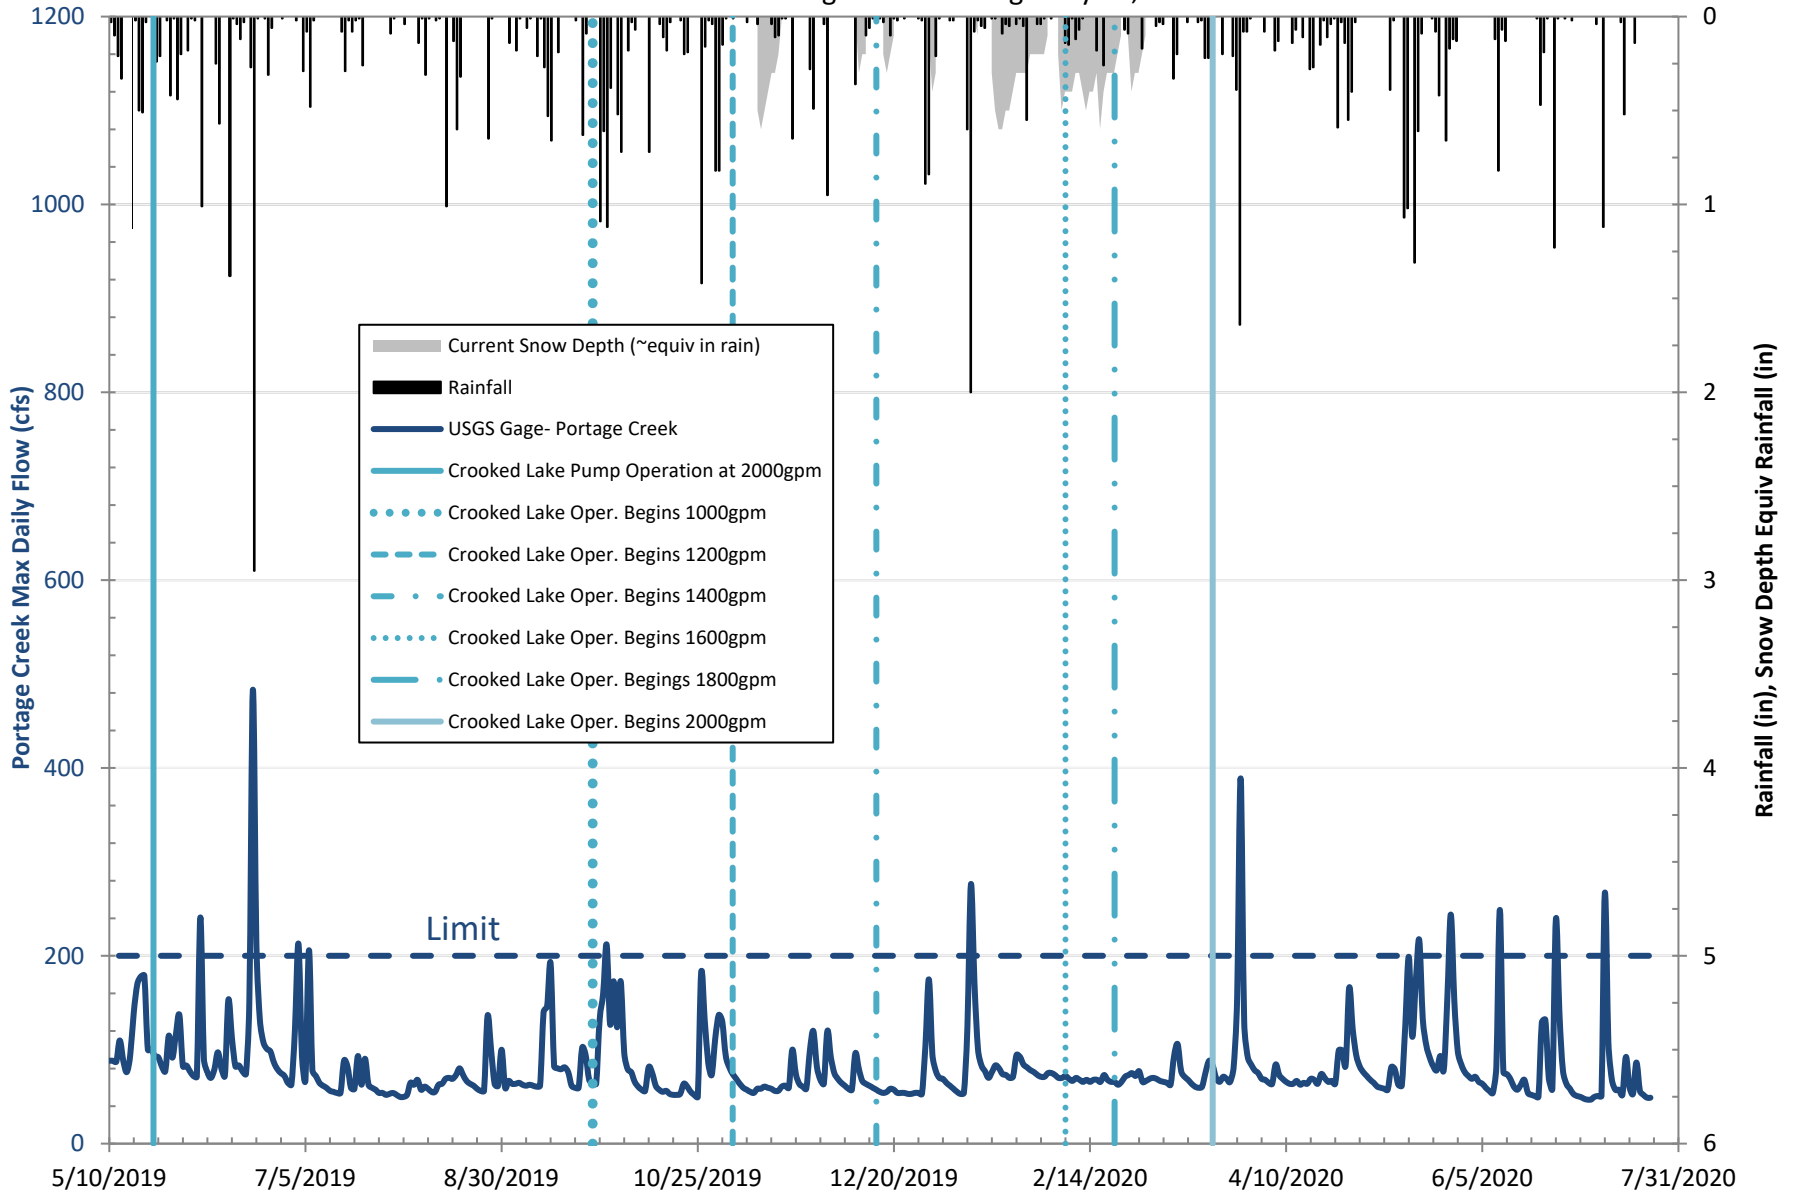
Charter Township of Texas Flood Study  
 Figure  
 USGS Monitoring Results through July 23, 2020

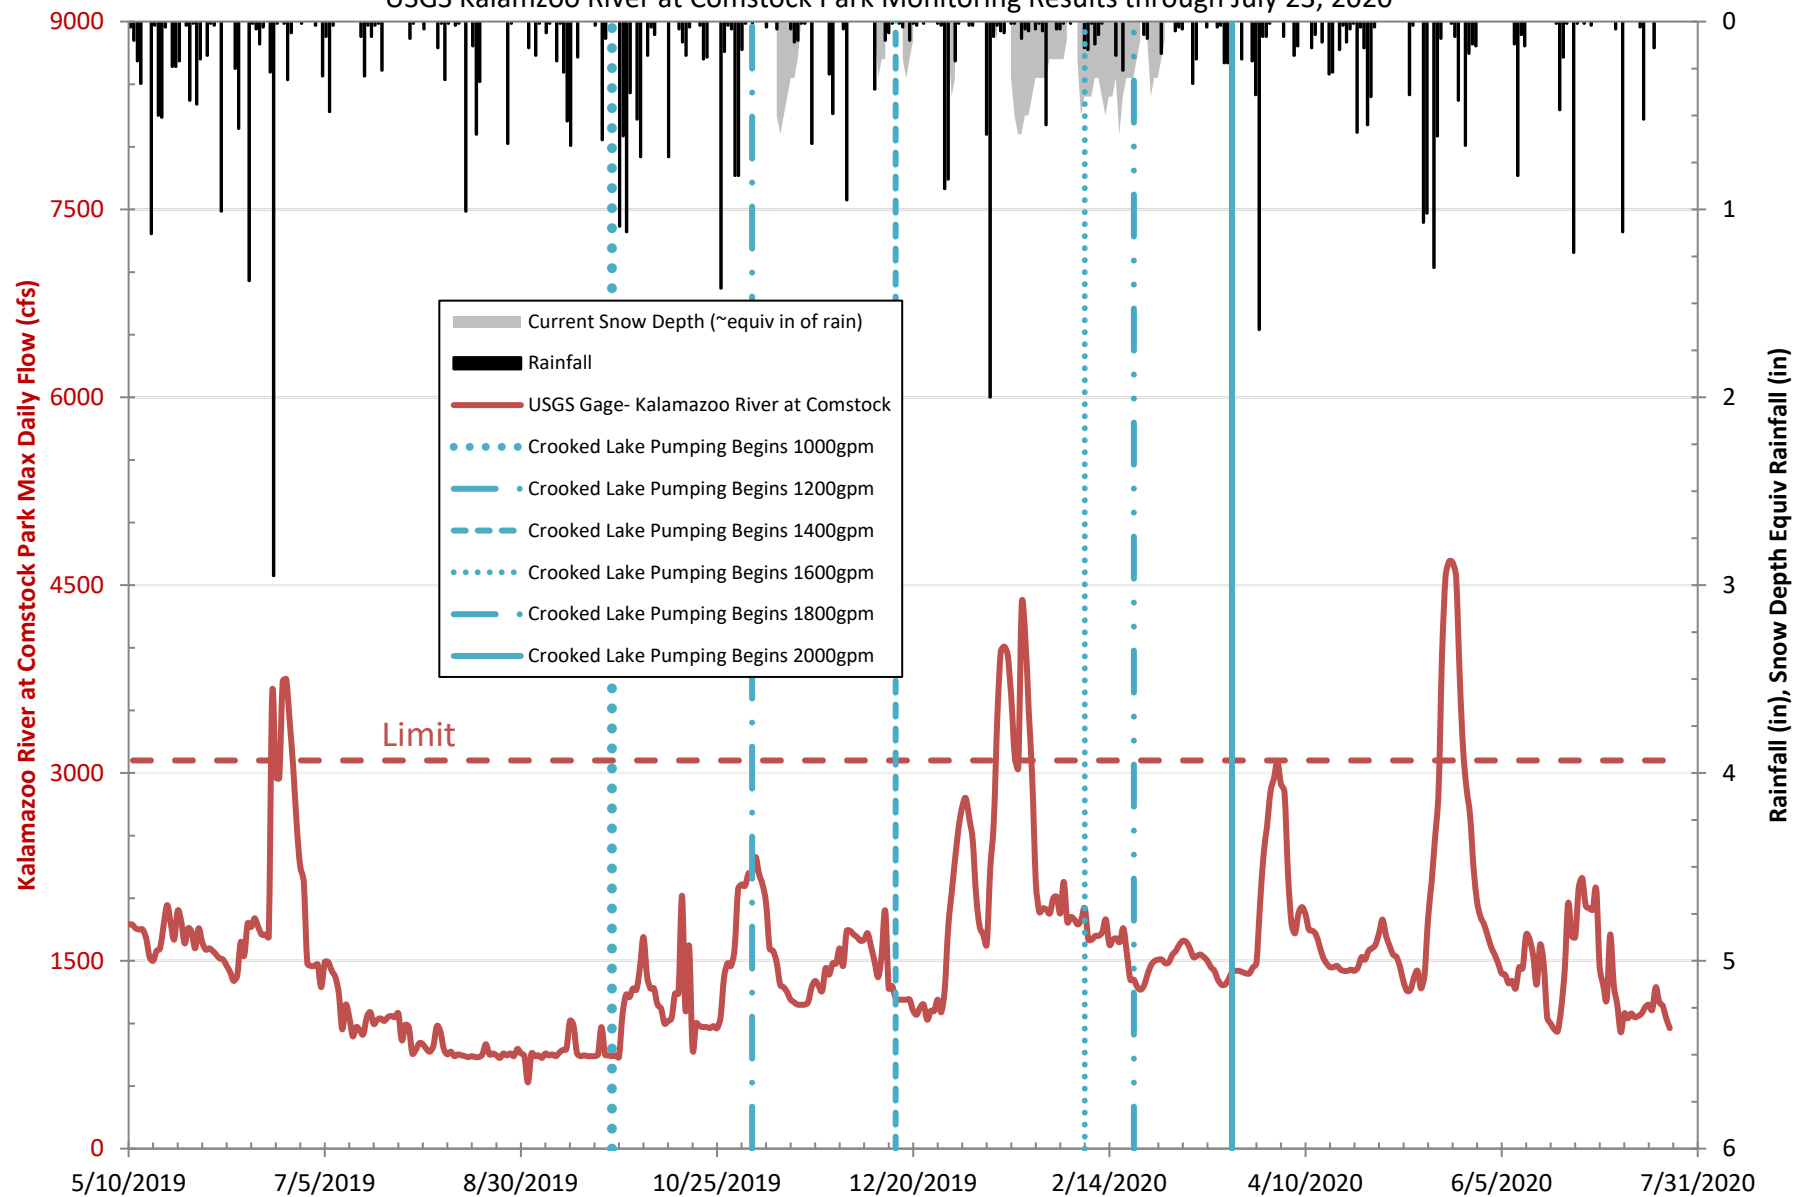
### USGS Kalamazoo River at Comstock Park Monitoring Results through July 23, 2020

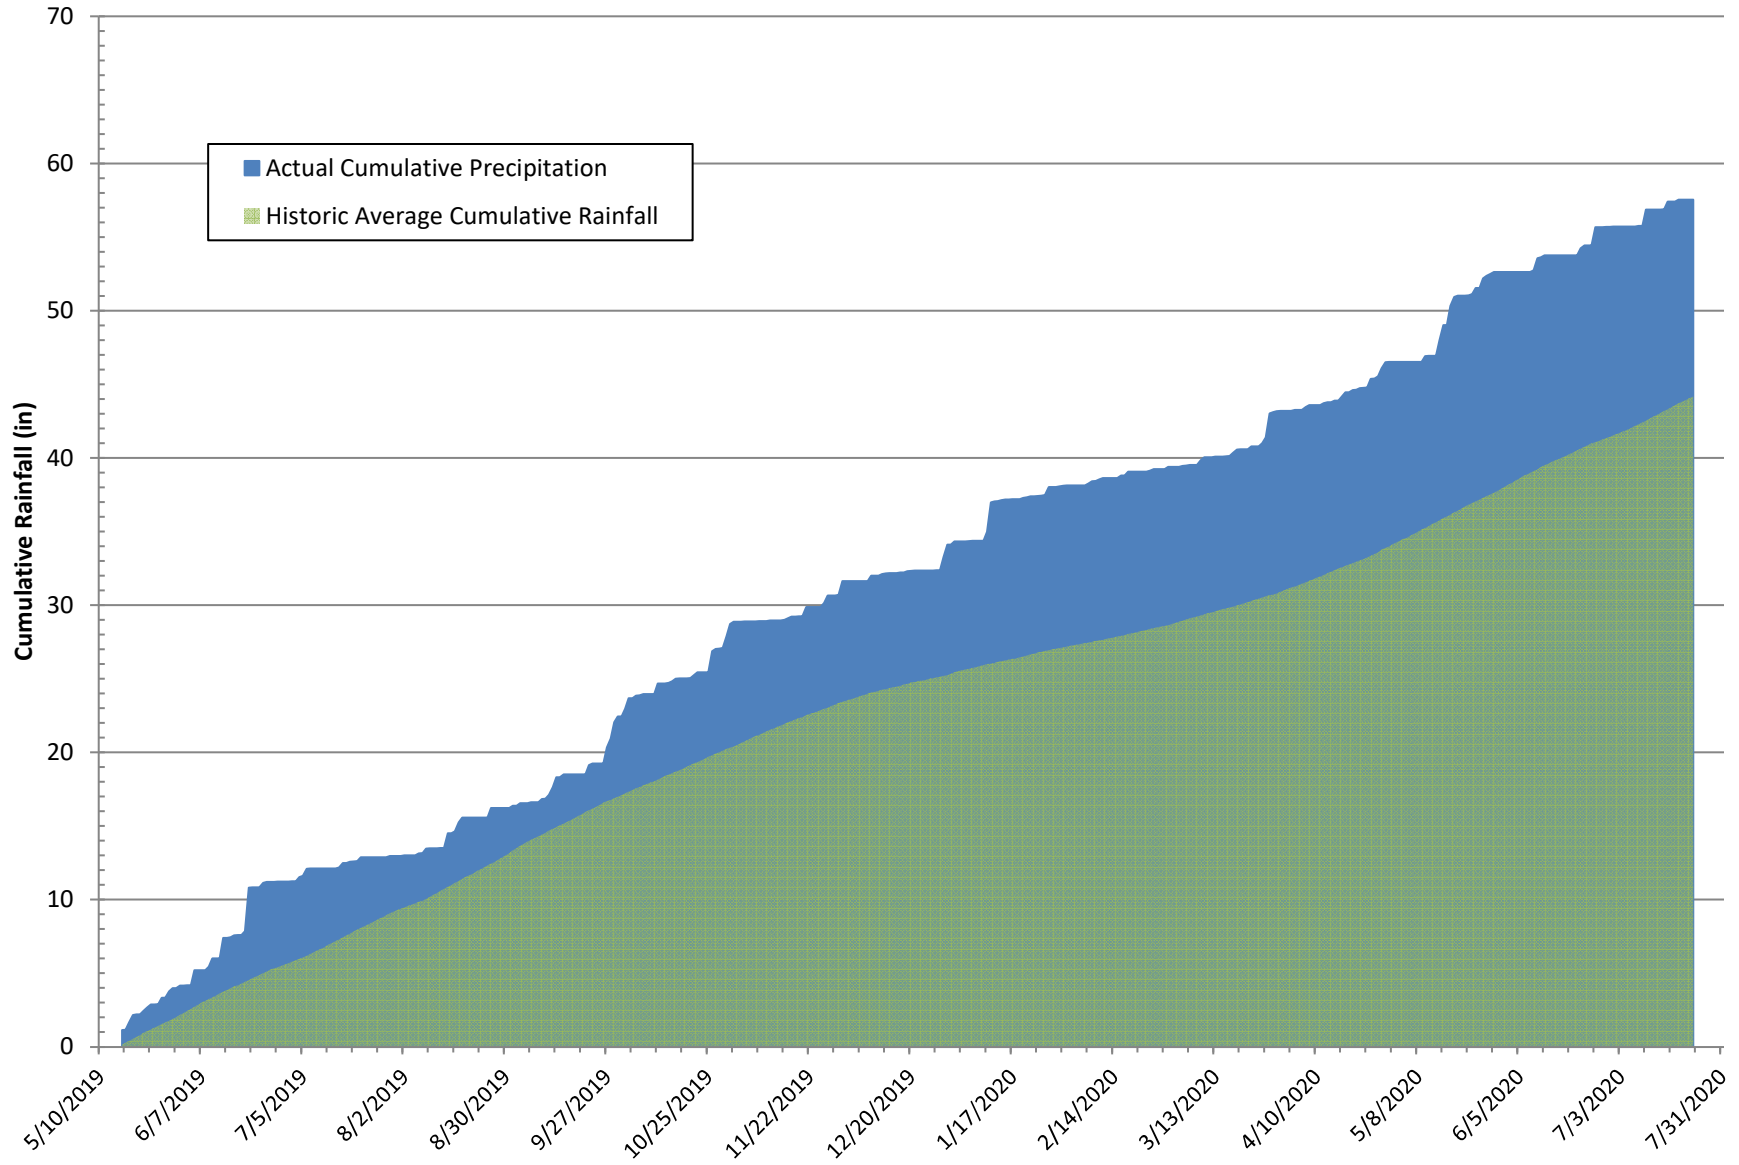
## Average Rainfall vs Actual Rainfall from May 16, 2019 through July 23, 2020

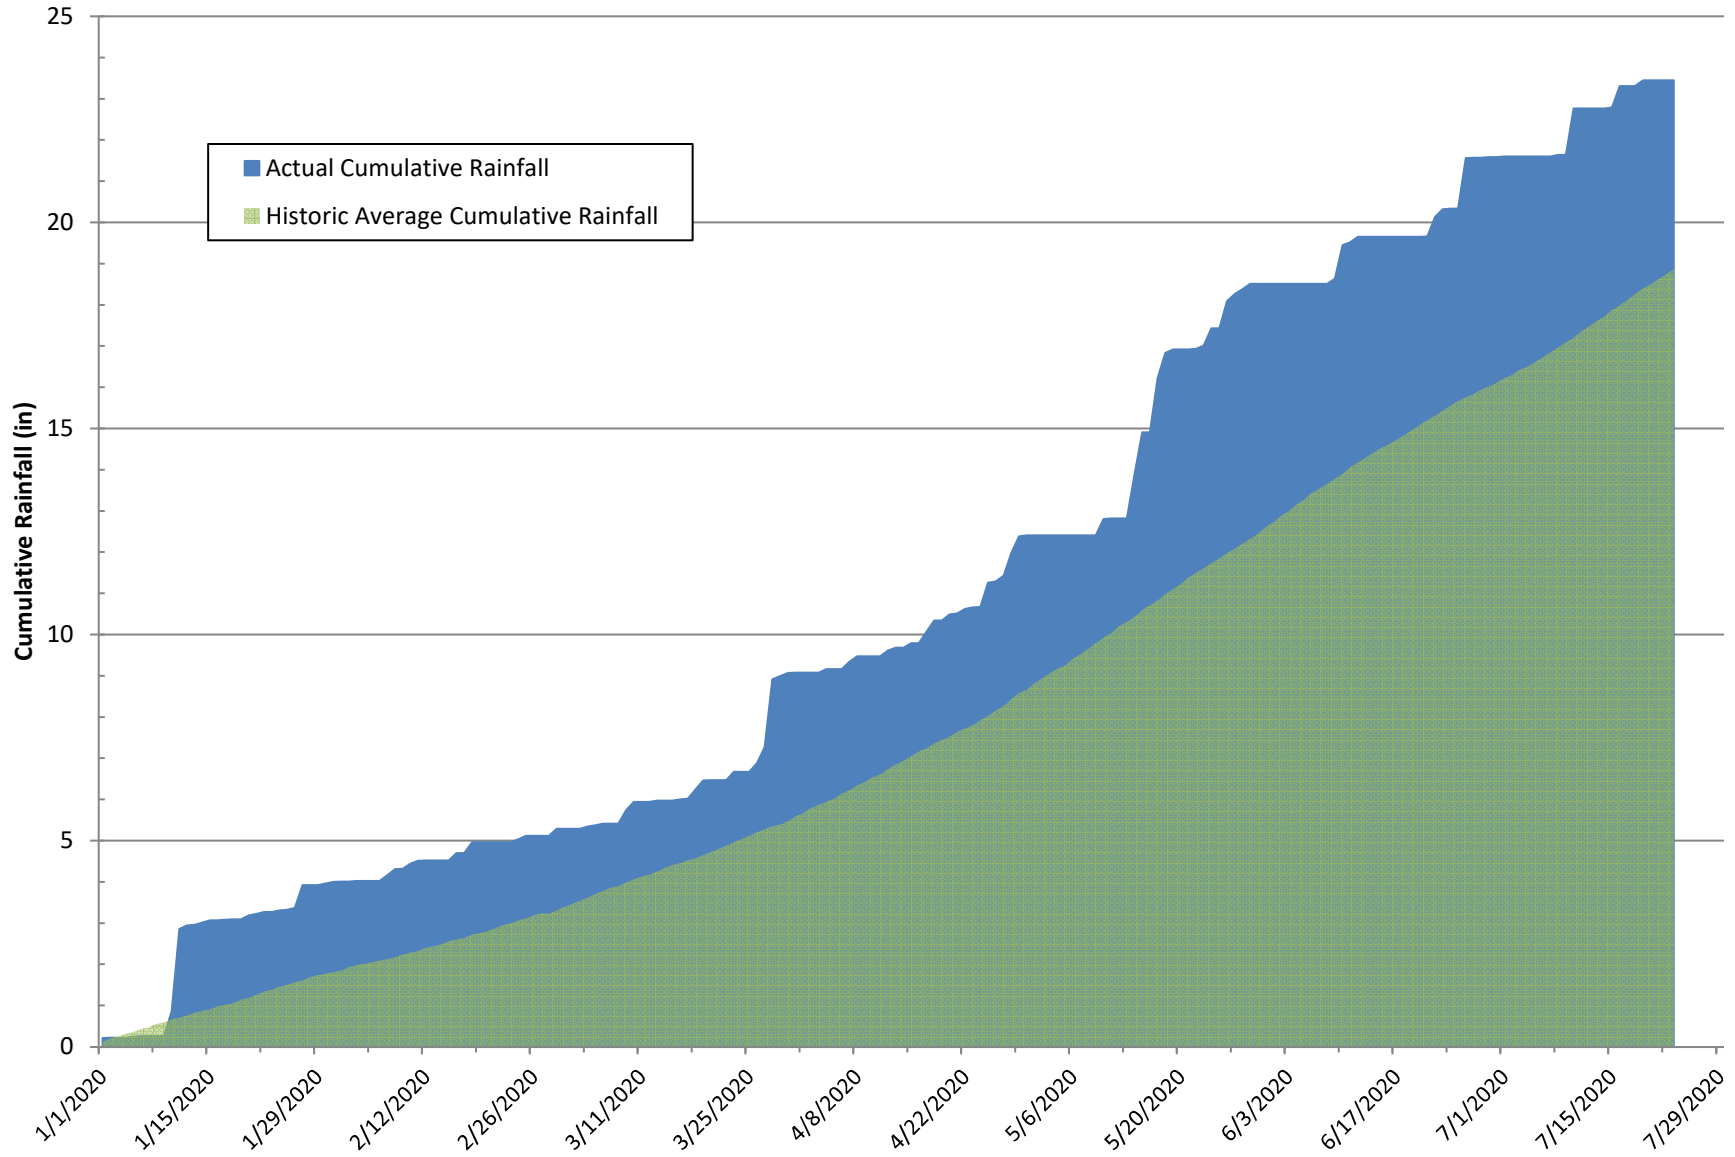
## Average Rainfall vs Actual Rainfall - January 1, 2020 through July 23, 2020

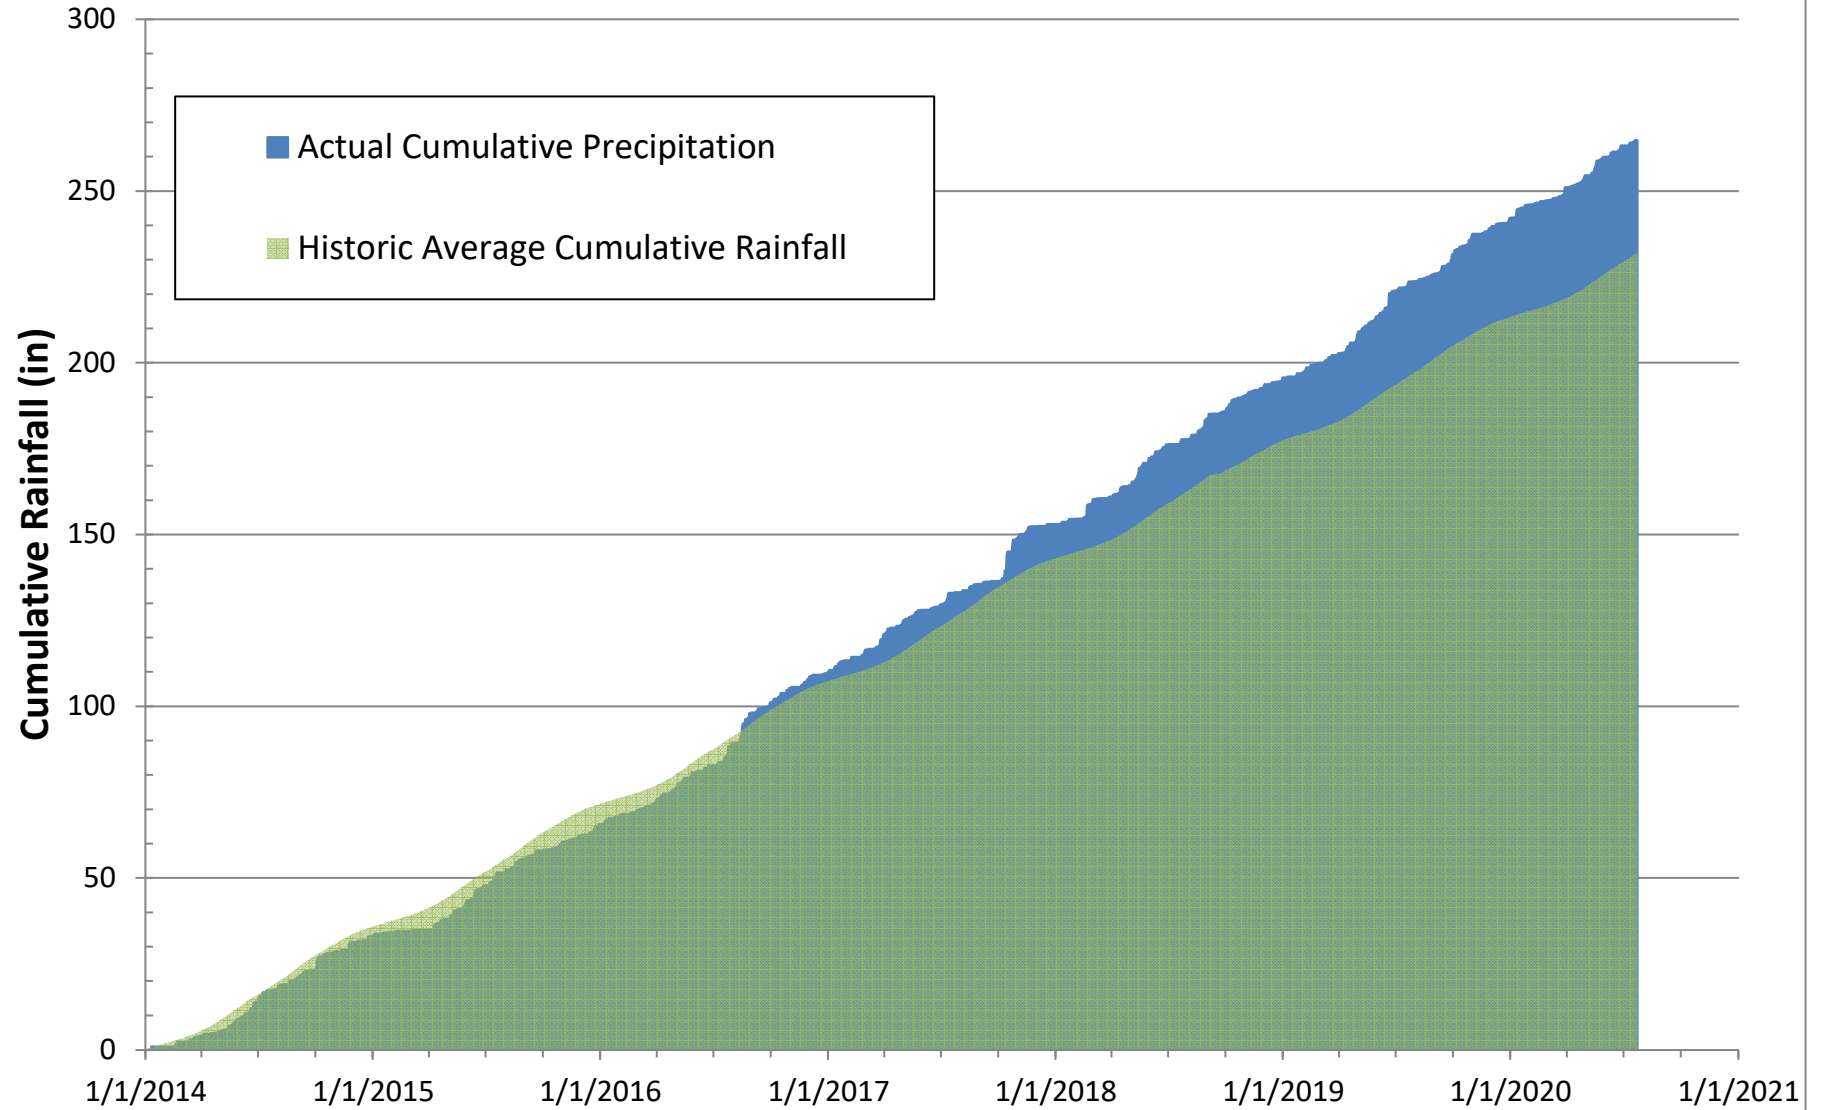
Average Rainfall vs Actual Rainfall - January 1, 2014 through July 23, 2020

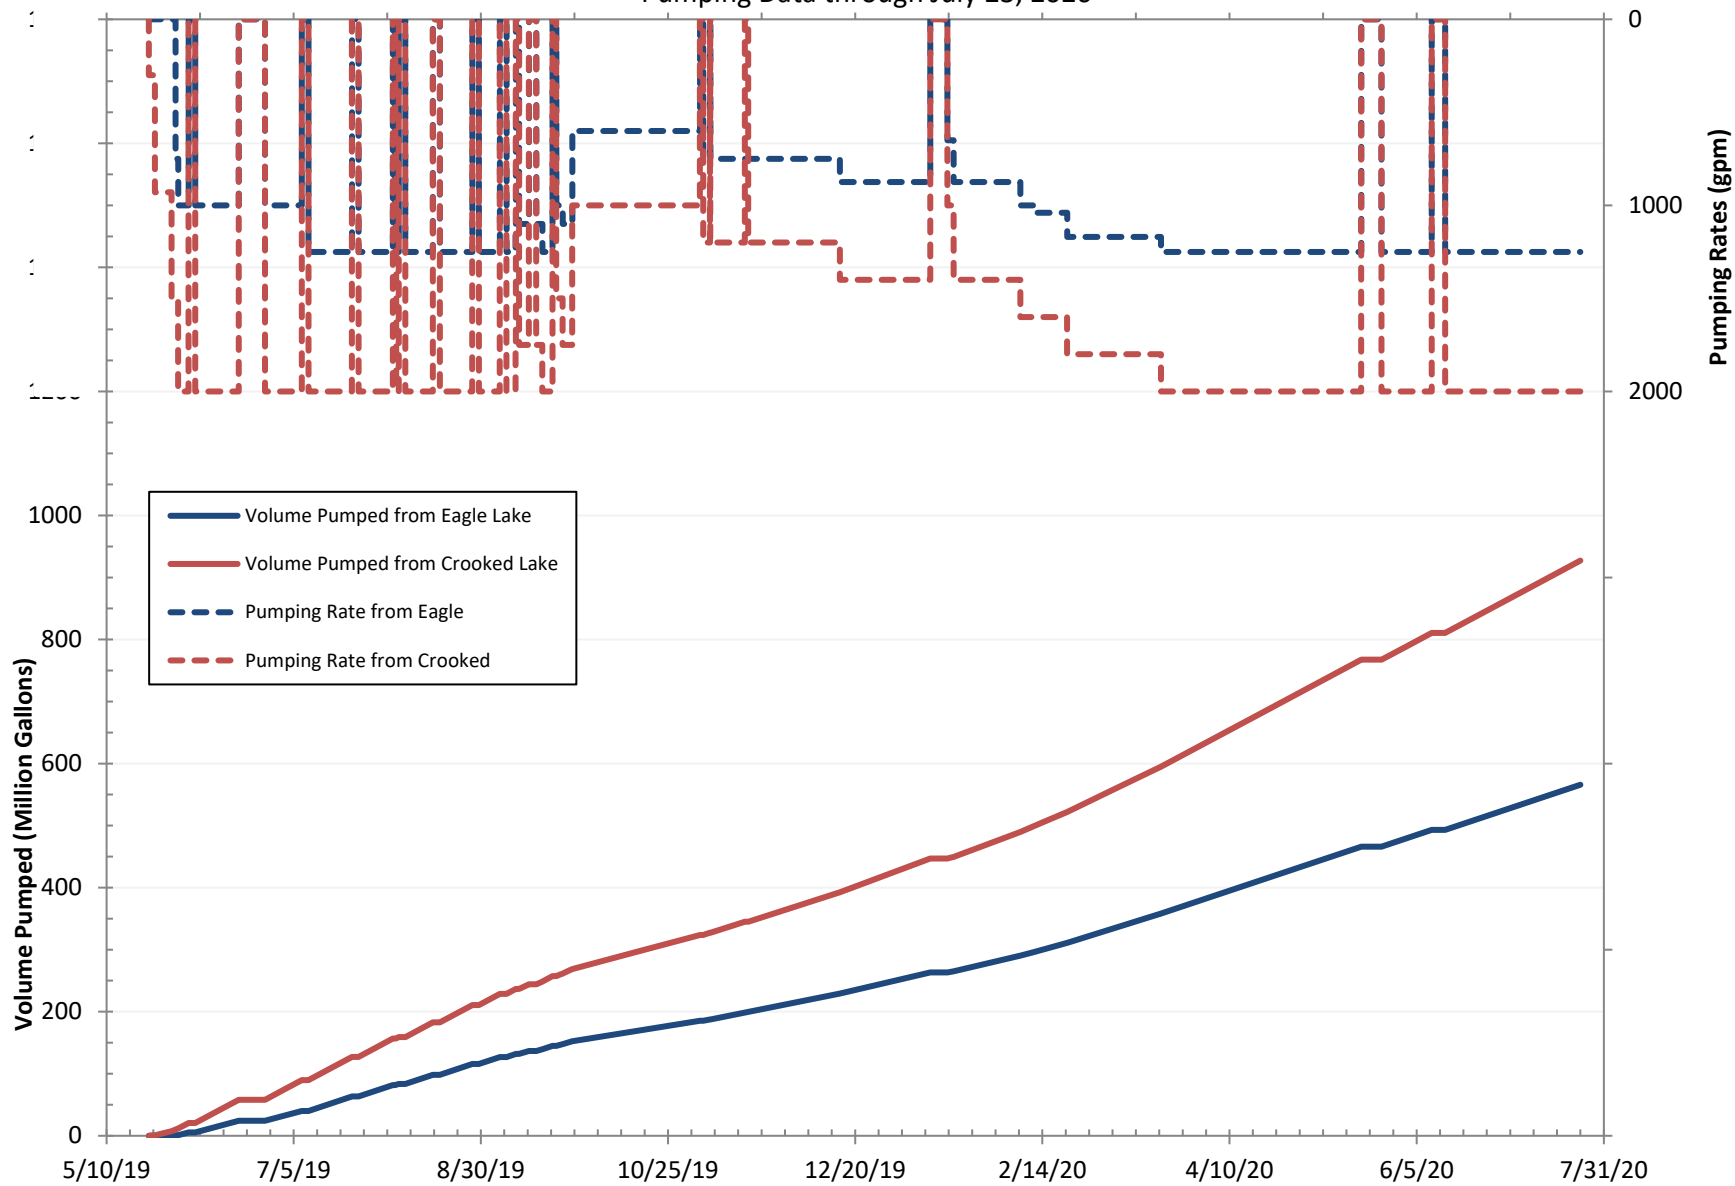
Charter Township of Texas Flood Study  
 Figure  
 Pumping Data through July 23, 2020

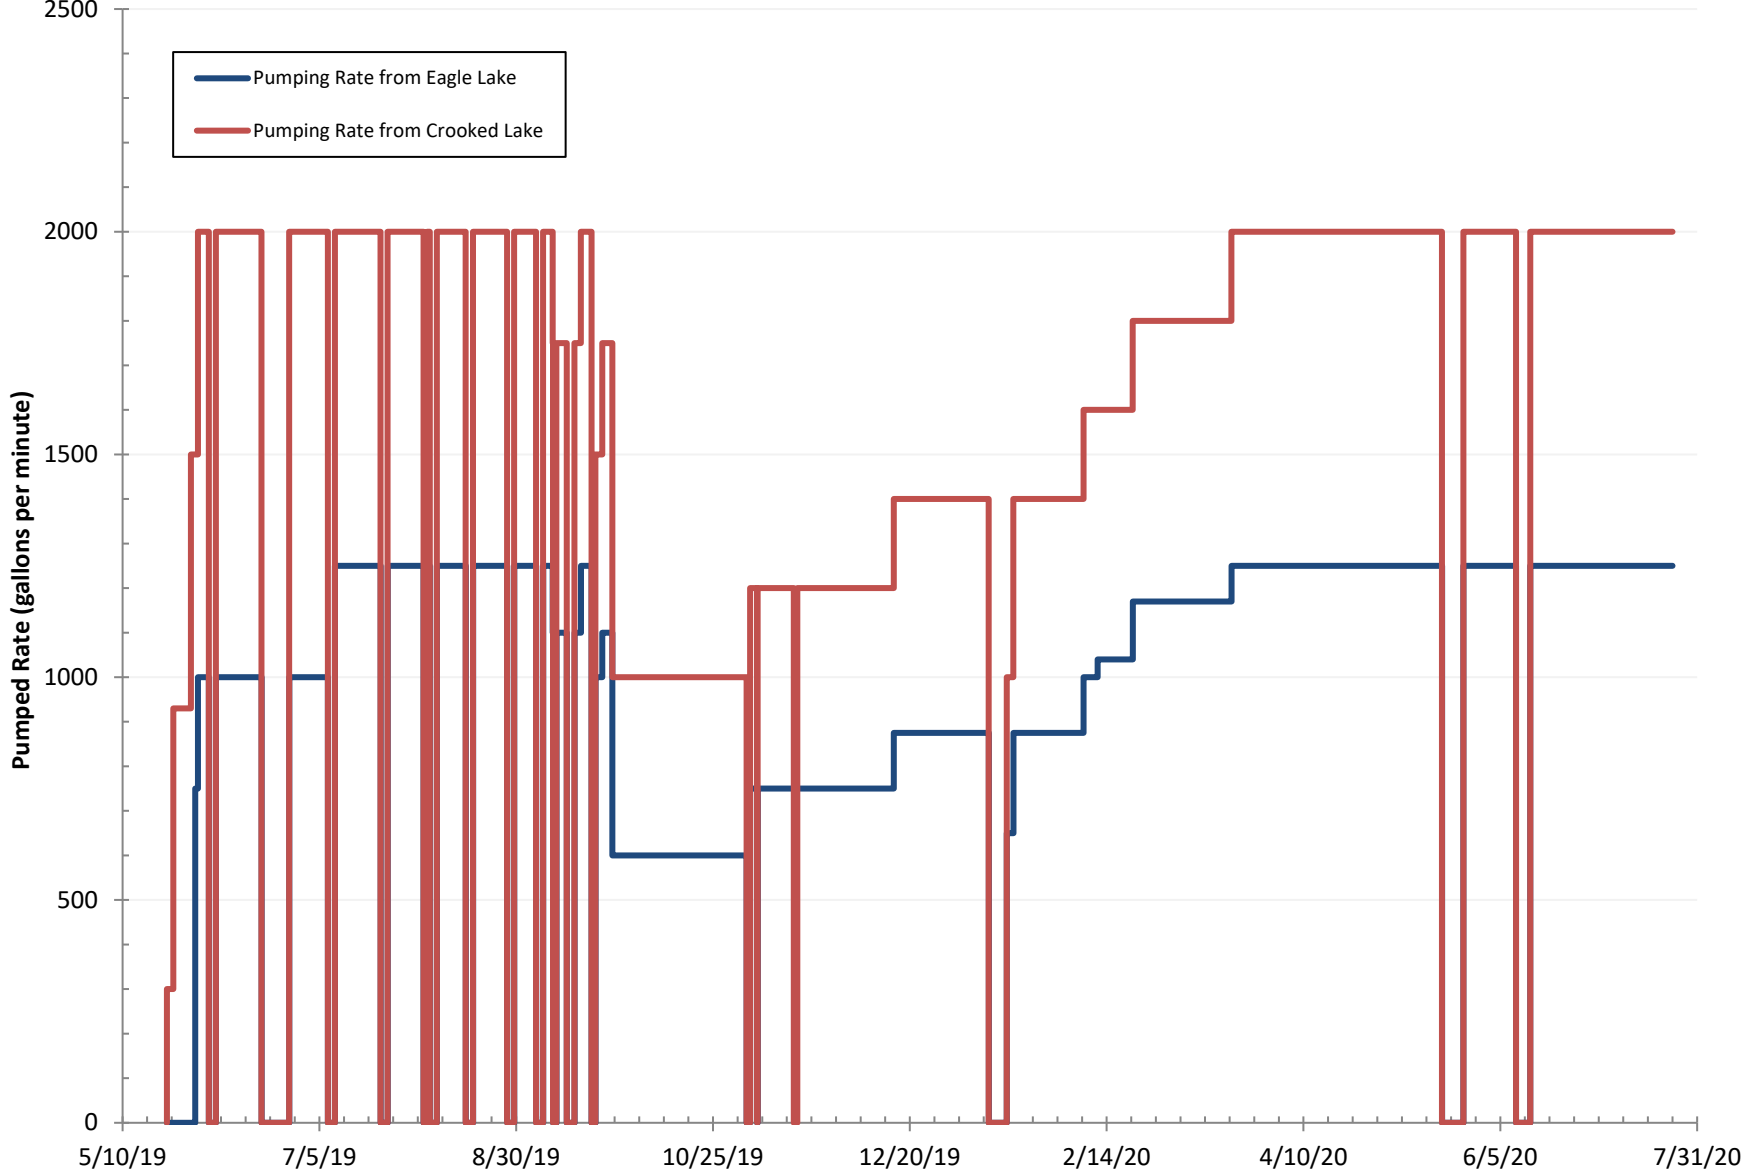
Charter Township of Texas Flood Study  
Figure  
Pumping Data through July 23, 2020

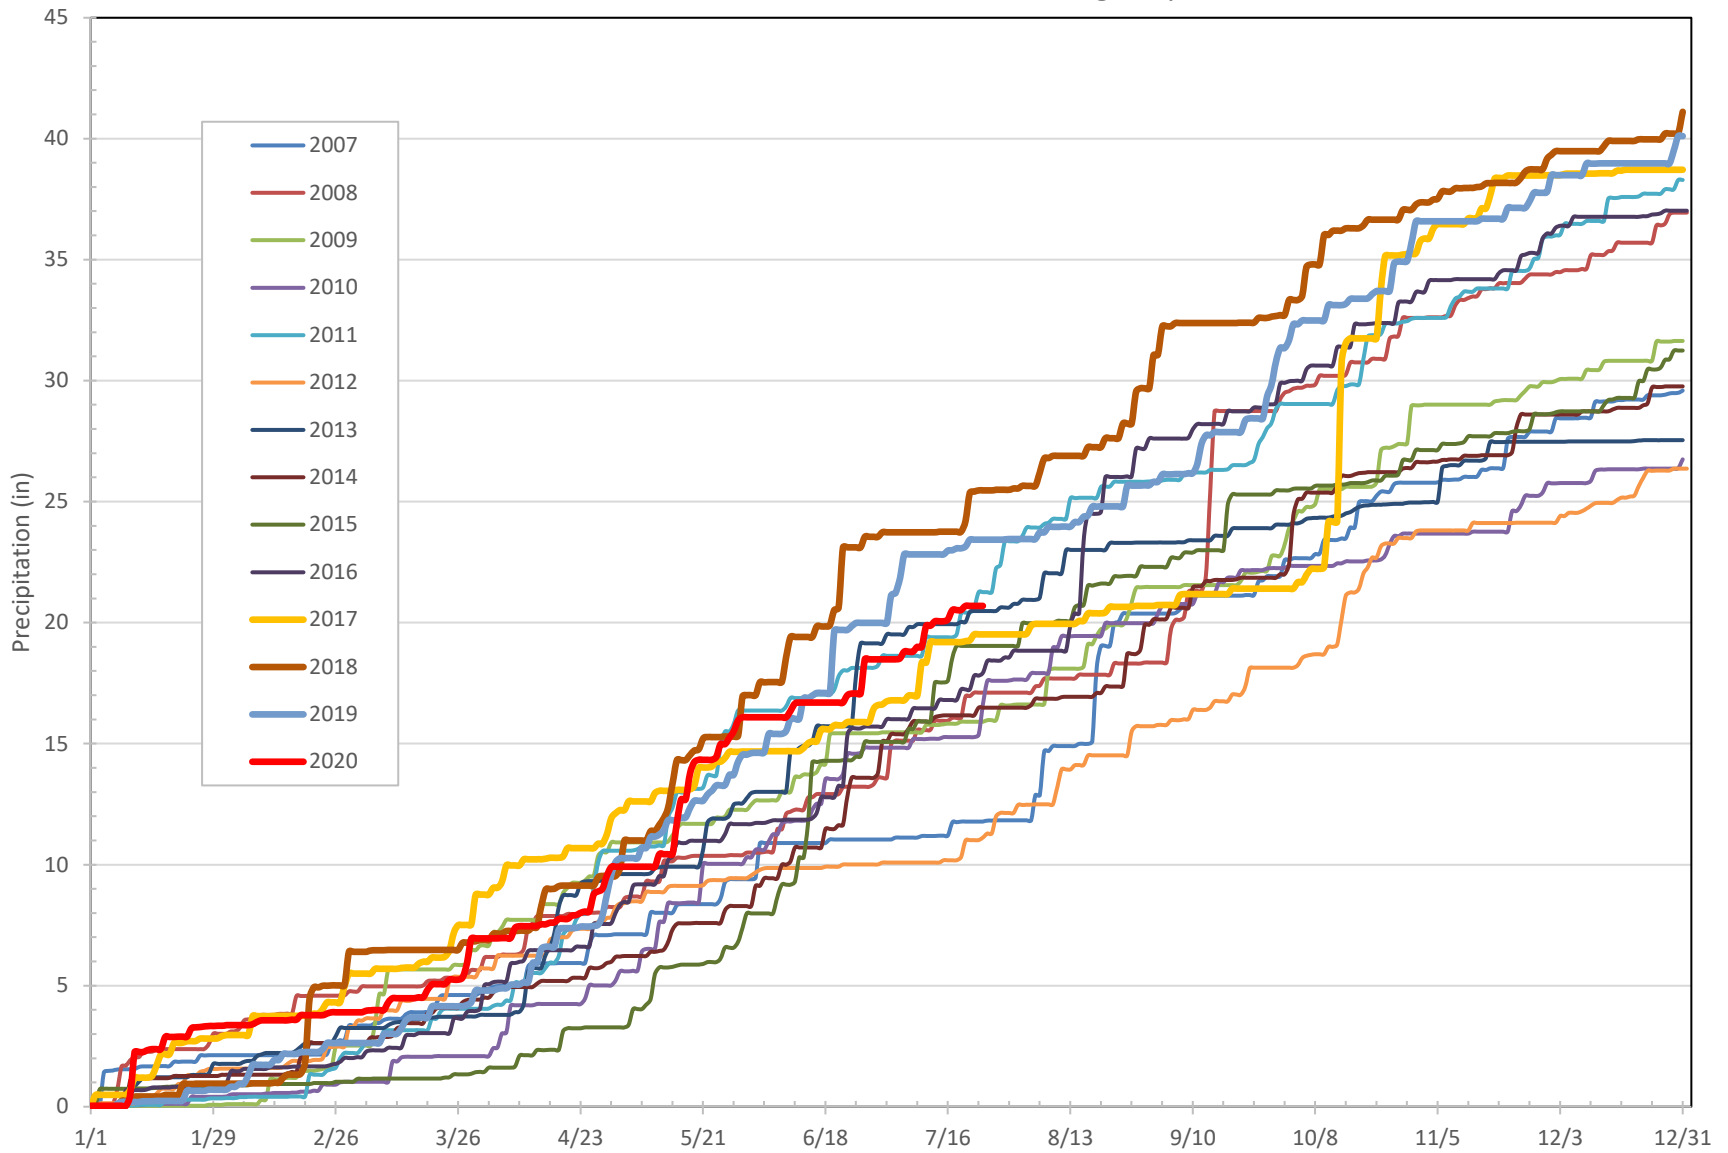
Charter Township of Texas Flood Study  
Figure  
Historic Cumulative Rainfall Data at Lawton, MI through July 23, 2020

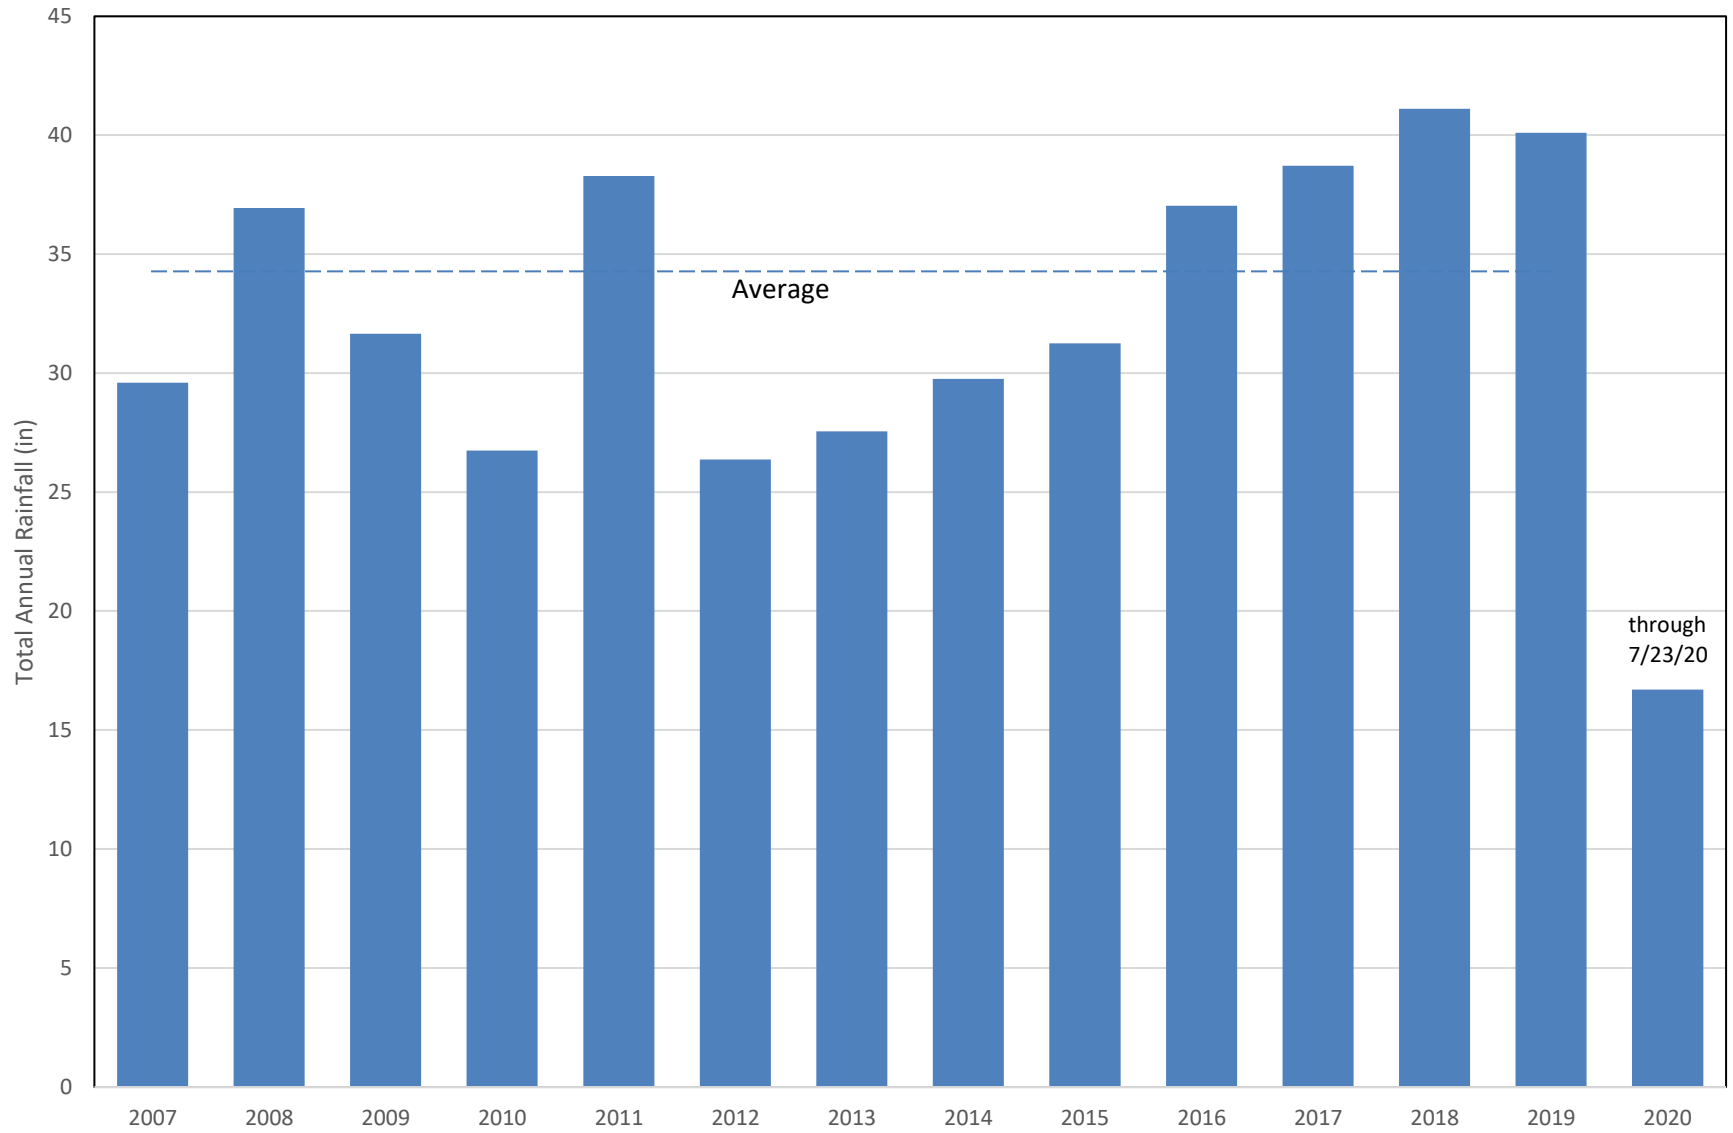
### Historical Annual Rainfall in Lawton, MI
